# Understanding High Energy Arcing Faults

Course No: E05-018

*This course was adapted from the NIST U.S. Department of Commerce, Publication No. NIST TN 2290, “Report on High Energy Arcing Fault Experiments”, which is in the public domain.*

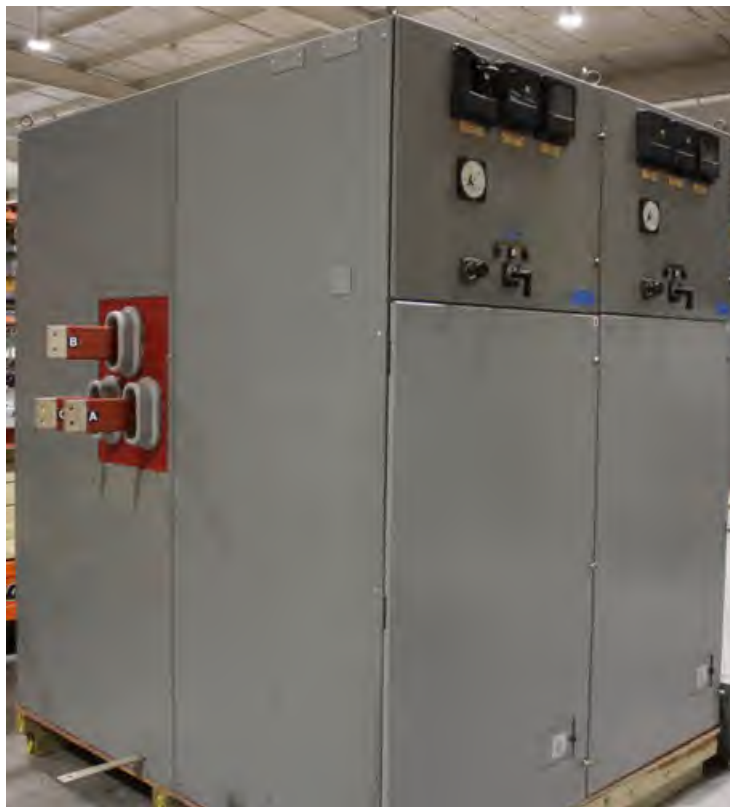
Fig. 9. Type M-36 Metal Clad Enclosure. Enclosure "J" shown left, "I" shown right.  
(note: bus bar extensions shown left, and breaker not shown)

The six metal-clad switchgear units were I-T-E<sup>2</sup> Type HK, used and refurbished from an ISO 9001-certified medium-voltage circuit breaker and electrical power distribution supplier. The units were approximately 90 cm (35 in) wide by 209 cm (82 in) long and 229 cm (90 in) high. Main buses were extended outside of the enclosure approximately 30 cm (12 in) to allow for connection to the laboratory's power supply. A grounding stab also extended outside the enclosure. Fig. 9 presents a photograph of a "lineup" configuration. Fig. 10 provides a drawing and isometric view of the enclosures.

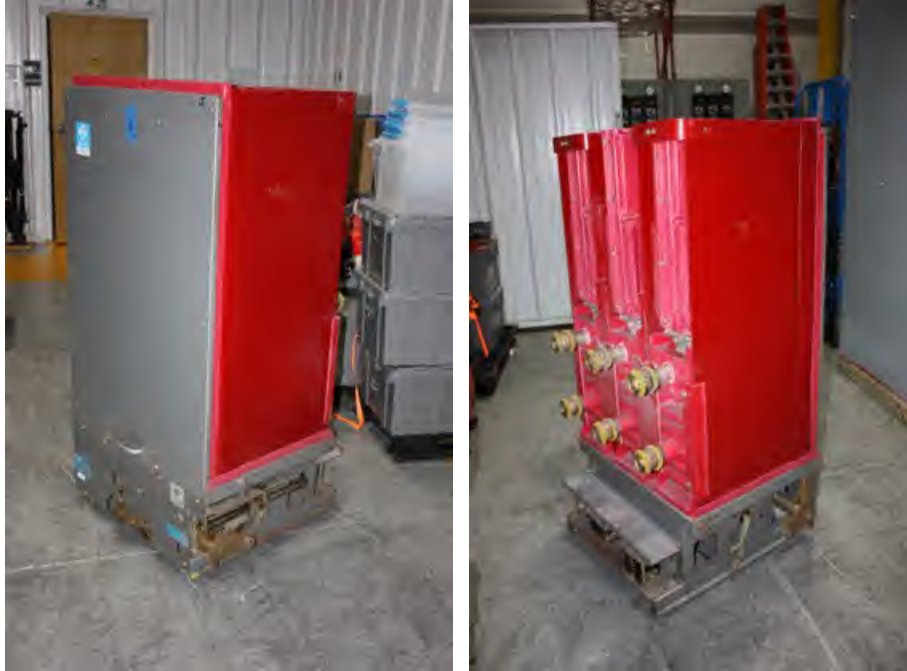
Fig. 11. Photo of GOULD I-T-E 7.5 HK-500 GE Magne-blast breaker

Table 2. Gould I-T-E Power Circuit Breaker Rating

Parameter	Value	Parameter	Value
Rated Max Voltage	8.25 kV	Breaker Type	7.5 HK
Rated Amps	1.2 kA	Rated voltage range factor	1.2
Frequency	60 Hz	Impulse Withstand	95 kV
Rated Short Circuit Amps	35 kA	Close / Latch Capability	66 kA
Weight	485 kg (1 070 lb.)	Date Manufactured	February 1978

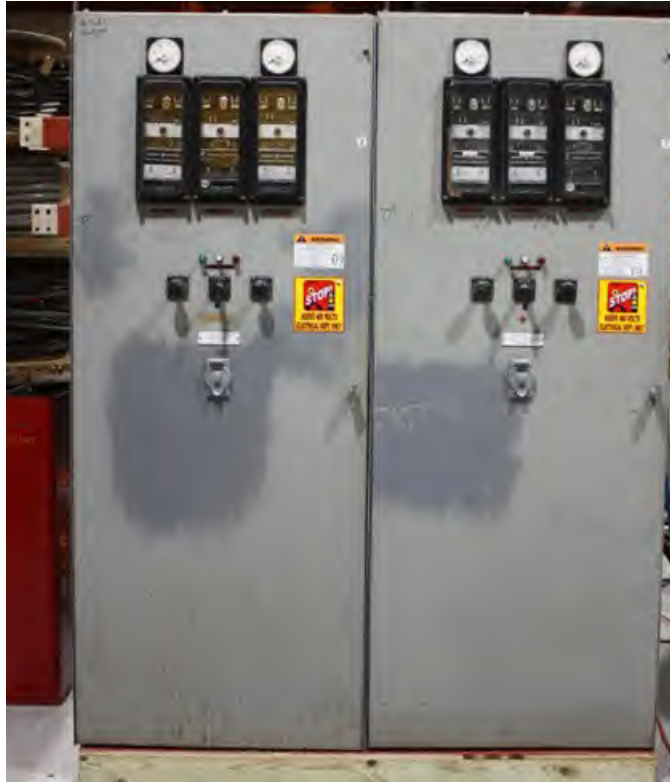
The two metal-clad switchgear units were General Electric Type M-36, used and refurbished from an ISO 9001-certified medium-voltage circuit breaker and electrical power distribution supplier. The units were approximately 92 cm (36 in) wide by 202 cm (79.5 in) long and 229 cm (90 in) high. Main buses were extended outside of the enclosure approximately 25 cm (10 in) to allow for connection to the laboratory's power supply. A shorter grounding stab also extended outside the enclosure. Fig. 12 presents a photograph of a "lineup" configuration. Fig. 13 provides a drawing and isometric view of the enclosures.

Fig. 12. Type M-36 Metal Clad Enclosure. Enclosure “O” shown left, “P” shown right.  
(note: bus bar extensions shown left, and breaker not shown)

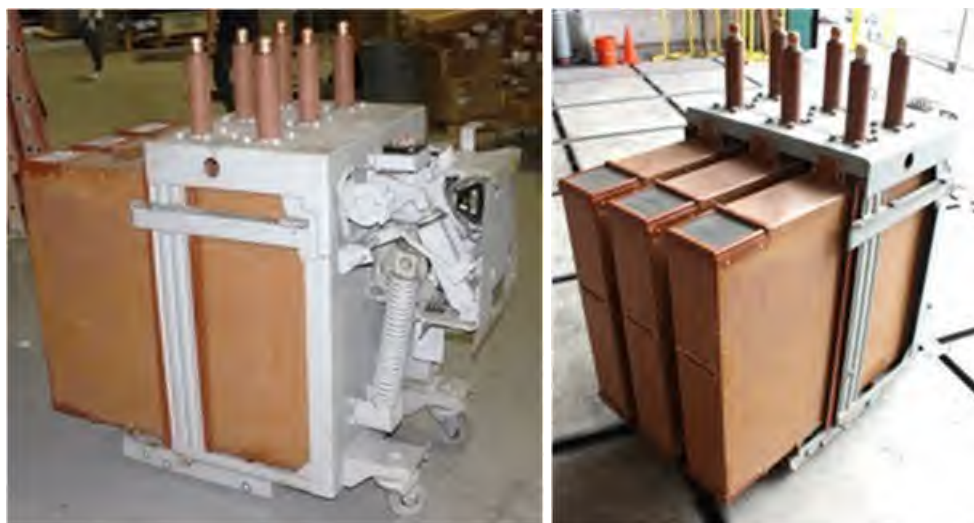
Fig. 14. Photo of AM-7.2-500 GE Magne-blast breaker

Each unit contained one medium-voltage circuit breaker. All breakers were GE Magne-blast Type AM-7.2-500 circuit breakers. The breaker ratings are shown in Table 3 and a photo of a breaker removed from the enclosure is shown in Fig. 14. After receipt of the equipment, the breakers were tested by the electrical contractor to ensure functionality. The breaker in the experiment enclosure was open prior to and remained open during arc experiment. The location of the arc did not require the breakers to be closed. Prior to the experiments, Megger testing was performed with the breaker open to ensure the equipment was functional.

Table 3. GE AM-7.2 Breaker Rating

Parameter	Value	Parameter	Value
Rated Max Voltage	8.25 kV	Breaker Type	AM-7.2-500
Rated Amps	1.2 kA	Rated voltage range factor	1.25
Frequency	60 Hz	Impulse Withstand	95 kV
Rated Short Circuit Amps	33 kA	Close / Latch Capability	66 kA
Weight	680 kg (1 500 lb.)	Date Manufactured	February 1976

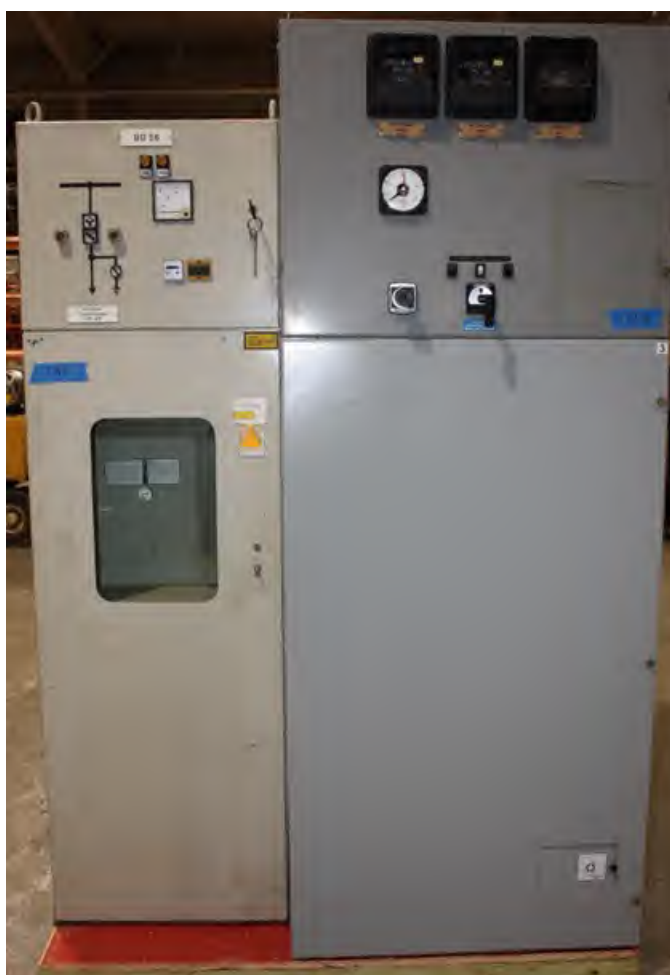
One metal-clad switchgear unit was an ABB Type BA/BB, used and contributed to the program by one of the OECD/NEA HEAF 2 member countries. Limited information was provided on the equipment design and specification, which were documented in the German language. The equipment was not provided with bus conductors, and solid bars stock were procured to support experiments. The breaker was SF6 type and SF6 was removed from the devices prior to arrival in the United States. The units were approximately 63 cm (25 in) wide by 150 cm (59 in) long and 211 cm (83 in) high. Main buses were extended outside of the enclosure approximately 25 cm (10 in) to allow for connection to the laboratory's power supply. A grounding stab also extended outside the enclosure. Fig. 15 presents a photograph of a "lineup" configuration. Fig. 16 provides a drawing and isometric view of the enclosures.

Fig. 15. Type BA/BB Metal Clad Enclosure. Enclosure "H" shown left, Enclosure "N" shown right.  
(note: bus bar extensions and breaker not shown)

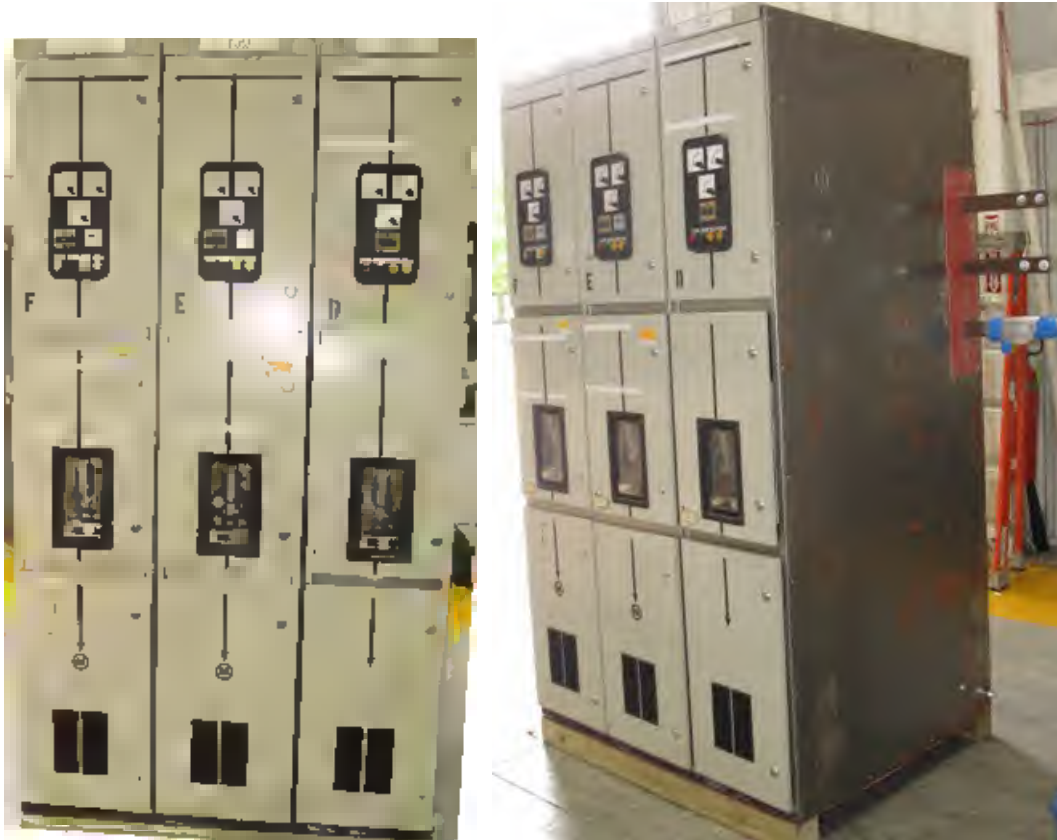
Nine low-voltage metal-clad switchgear units were contributed to the program by OECD/NEA HEAF 2 member countries. Two of these units were previously experiments (see Appendix E). A third unit is reserved for heat release rate experiments to be performed in the future. The units were approximately 41 cm (16 in) wide by 102 cm (40 in) long and 220 cm (86 in) high. Main buses were extended outside of the enclosure approximately 25 cm (10 in) to allow for connection to the laboratory's power supply. Fig. 17 presents a photograph of a "lineup" configuration. Fig. 18 provides an isometric view of the enclosures.

Fig. 17. Photographs of the low-voltage lineup configuration.

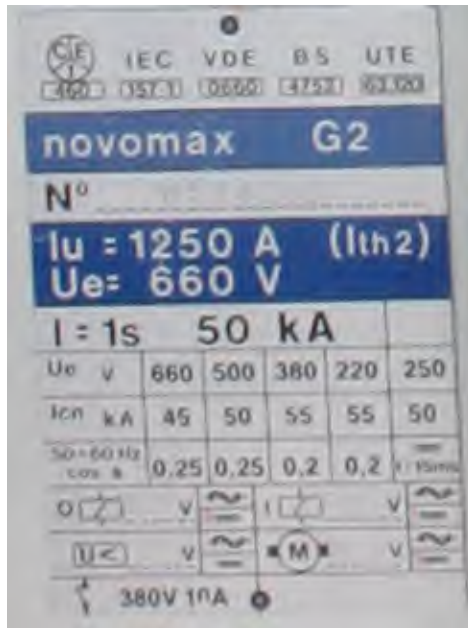
Each vertical section contained one low-voltage circuit breaker. All breakers were ABB. Limited information was provided with this donated equipment. The breaker nameplate is shown in Fig. 19. A photo of the breaker is shown in Fig. 20.

Fig. 19. Photo of LV breaker name plate

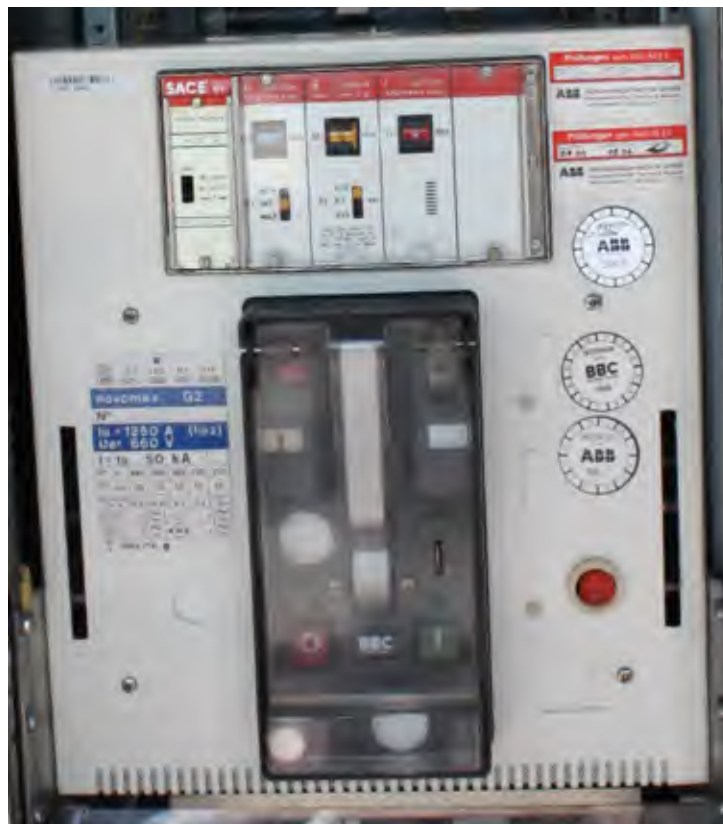
Fig. 20. Photo of ABB Breaker

Fig. 20. Photo of ABB Breaker ..... 24

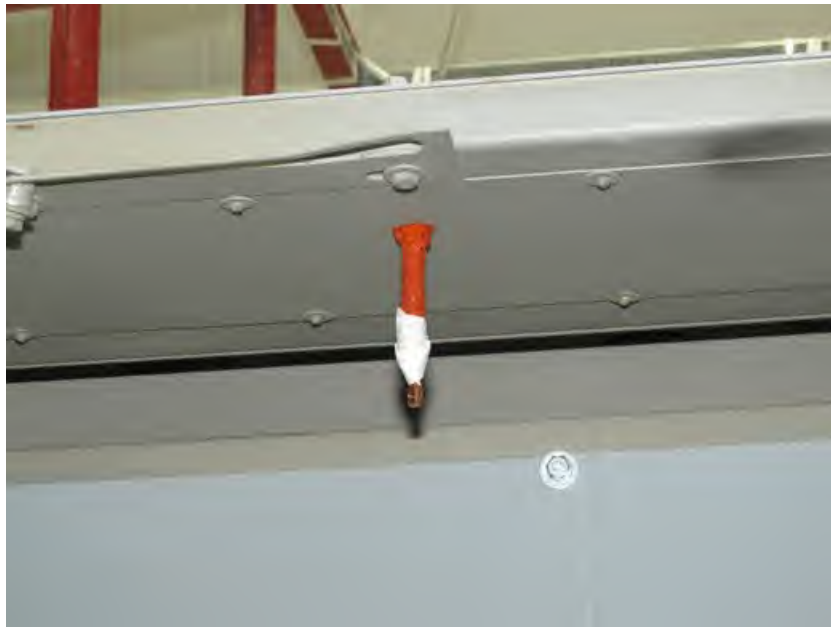
The fiber optic temperature sensors passed through a hole in the top of the electrical equipment, with a typical installation shown in Fig. 22. The fiber optic cable was protected with silicone tubing, and the intersection of the sheath and the copper connector ring were wrapped with glass tape. The pass-through hole in the top of the electrical equipment was sealed with high-

Fig. 22. Typical fiber optic sensor in top compartment of electrical switchgear, protected by silicone tubing and glass tape.

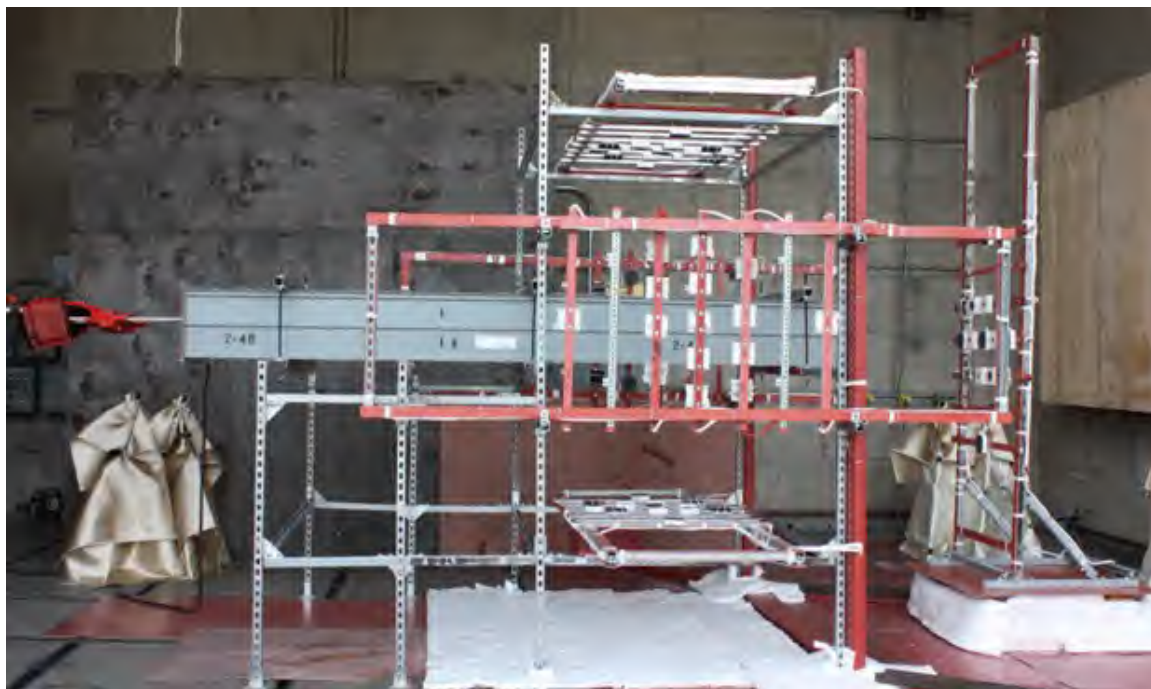
Fig. 28. Photo of bus duct instrumentation configuration prior to experiment

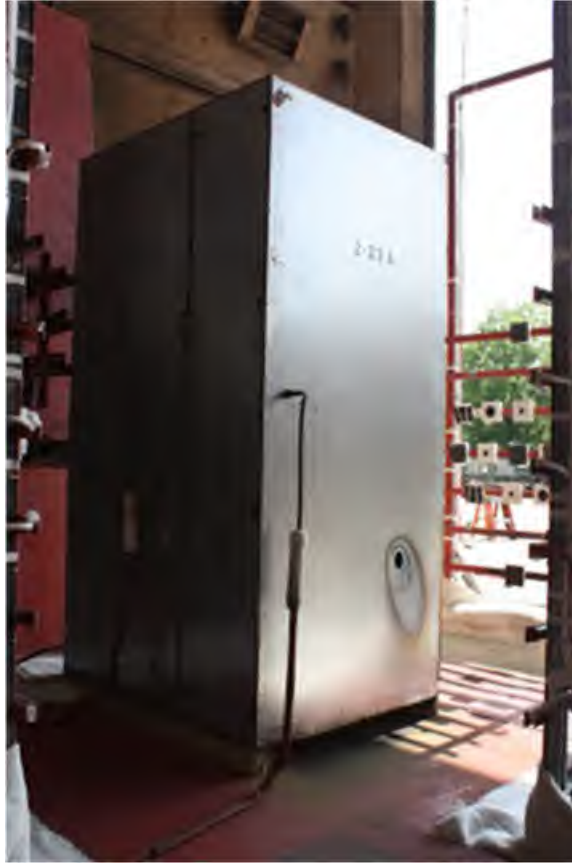
Fig. 32. Enclosures Post-Experiment 2-33A. Note the external breach on the lower portions of Enclosure 'C'.

A photograph of the enclosures following the experiment is presented in Fig. 32. The enclosures did experience a breach on the exterior and internal panel on Enclosure 'C' (EV53). Detailed photos are shown in Appendix D. Due to the limited damage; the bus bars were not removed for mass loss weight measurements. The equipment was re-wired instead for an additional experiment as documented in Section 3.2.

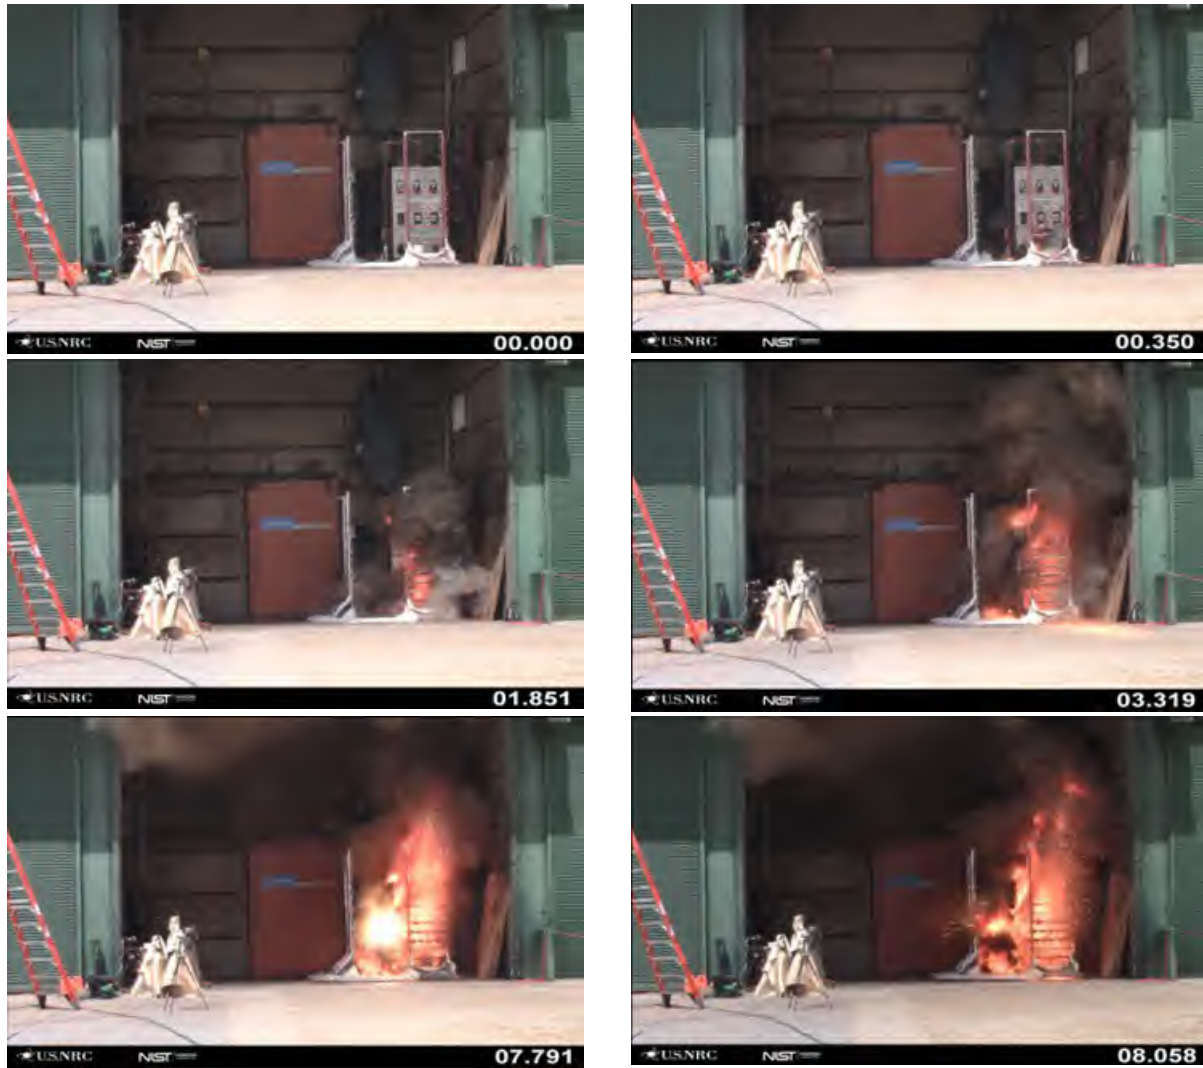
Fig. 35. Sequence of Images from Experiment 2-33B (image time stamps are in seconds).

<b>Time (ms)</b>	<b>Observation</b>
<b>0</b>	Initial light observed
<b>350</b>	Smoke reaches front rack
<b>1 851</b>	Flames emanating from top of switchgear
<b>3 319</b>	Significant amount of arc ejecta expelled from front of switchgear
<b>7 791</b>	Side breach of enclosure
<b>8 058</b>	End of arc

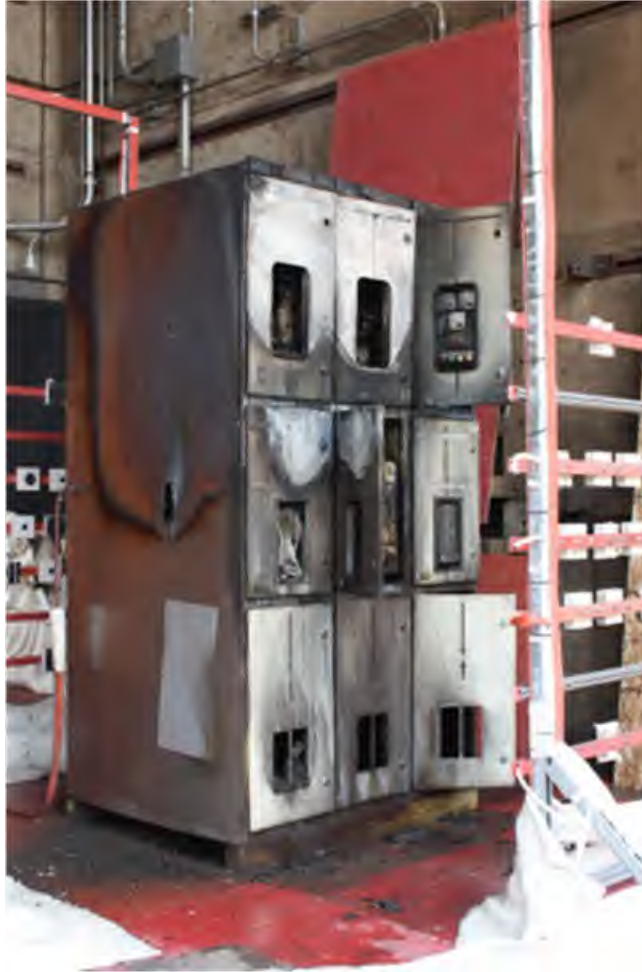
Fig. 37. Enclosures Post-Experiment 2-33B. Note the external breach on the middle side panel of Enclosure ‘C’.

A photograph of the enclosures following the experiment is presented in Fig. 37. The enclosures did experience a breach on the exterior and internal panel of Enclosure ‘C’ (EV53). Internal panels also experienced damage and material loss. The internal breach mass loss was estimated at approximately 283.0 g and the exterior mass loss was estimated at approximately 61.8 g. Detailed photos are provided in Appendix D.

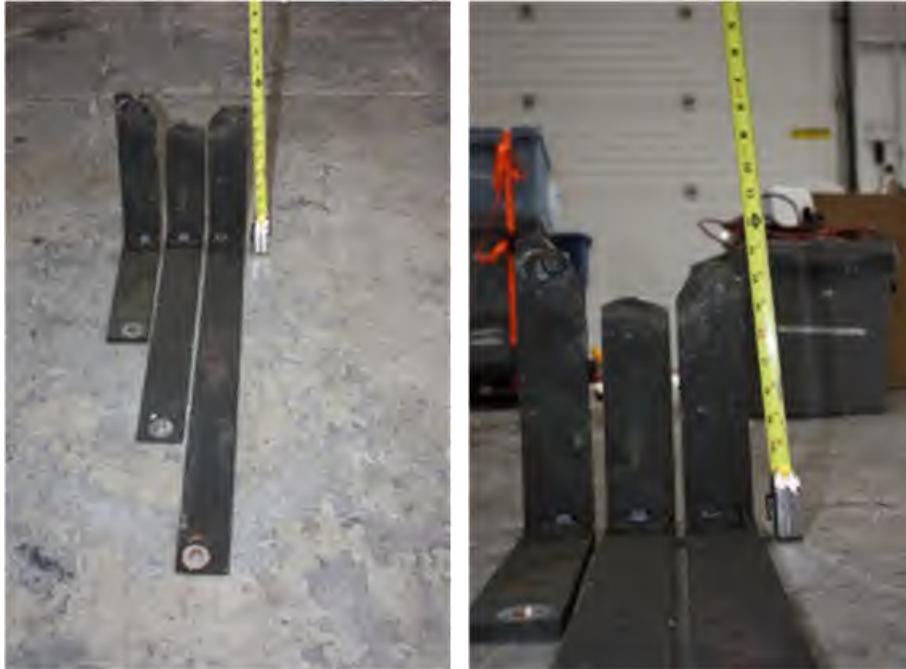
Images of the bus bars removed from the enclosure after the experiment are shown in Fig. 38. The total mass loss of the bus bars was approximately 4 612.0 g. Additional details are presented in Appendices C and D.

Fig. 38. Photos of Experiment 2-33B vertical supply bus bars post-experiment. Location with material loss (top of image) is where the bus connected to the breaker. Bar orientation as shown in photo is C-B-A.

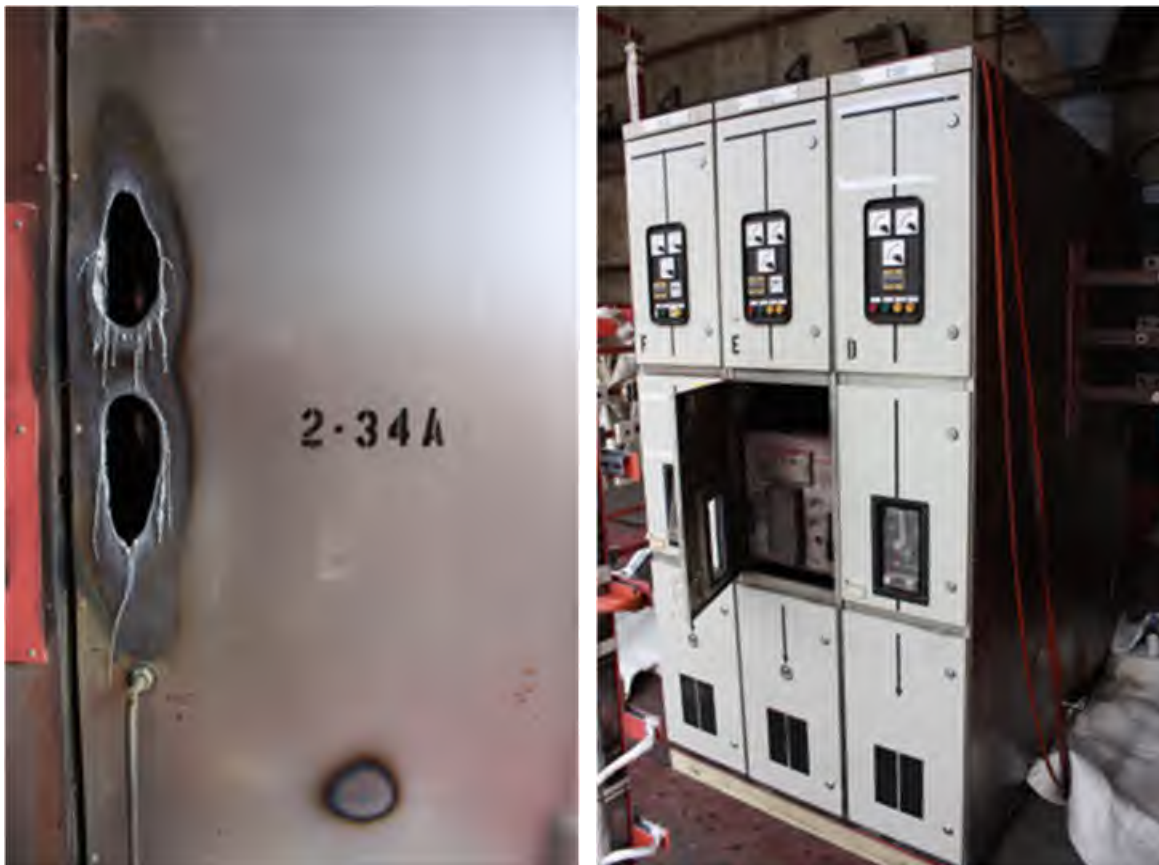
Photographs of the enclosures following the experiment are presented in Fig. 43. Enclosure ‘F’ did experience two breaches with a total estimated mass loss of approximately 314 g.

Fig. 43. Enclosures Post-Experiment 2-34. Left – enclosure breach on side of Enclosure ‘F’ (EU53), Right – front view of enclosures showing open door on breaker cubicle of Enclosure ‘E’ (EU52).

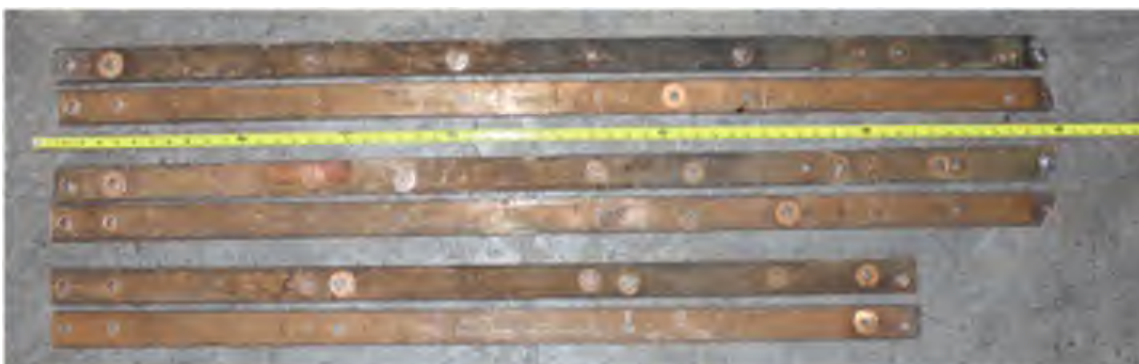
An image of the bus bars removed from the enclosures after the experiment are shown in Fig. 44. The total mass loss of the bus bars was approximately 176.0 g. Additional details are presented in Appendix C and D.

Fig. 44. Photo of Experiment 2-34 bus bars post-experiment (arc location shown right).

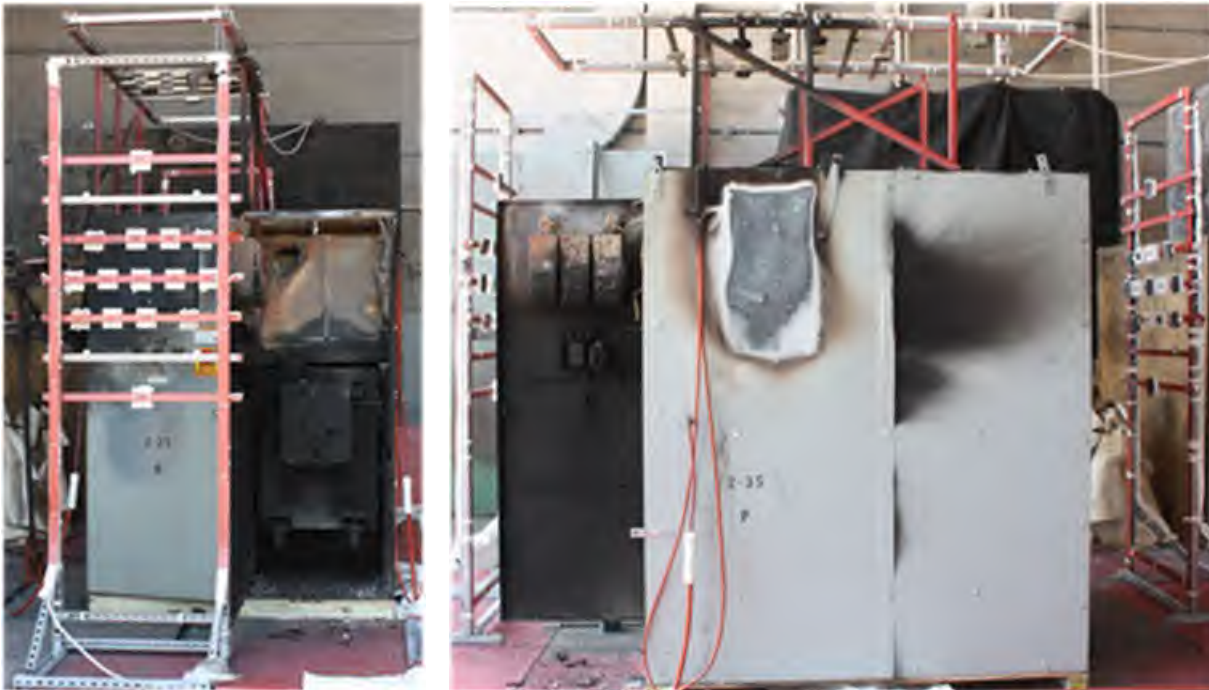
Fig. 49. Enclosure Post-Experiment 2-35 (Left – front view with Rack #1 in front of Enclosure “O”, Right – side of Enclosure “P”).

Photographs of Enclosure “O” and “P” following the experiment is presented in Fig. 49. Enclosure “P” experienced a breach on the inner left panel and openings were created in the upper portion of the enclosure. The total estimated mass loss was approximately 1 938.0 g. Significant heat damage also occurred on the side of Enclosure “P”, but no external enclosure burn-through. Detailed photos presented in Appendix D.

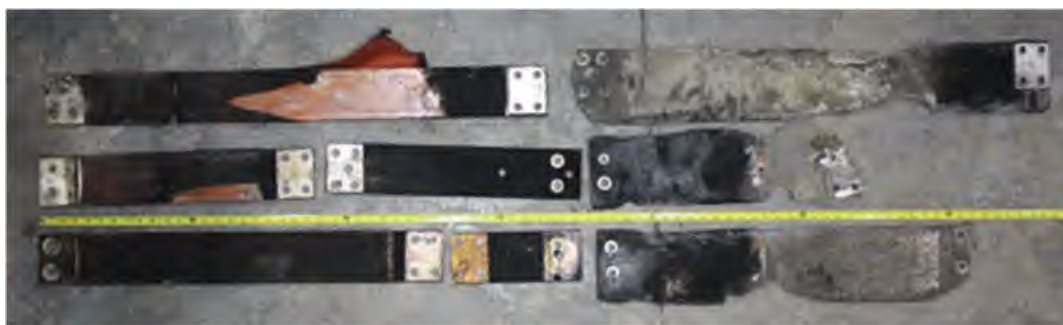
An image of the bus bars removed from the enclosure after the experiment are shown in Fig. 50. The total mass loss of the copper bus bars located in Enclosure “O” was approximately 54.0 g and the total mass loss of the aluminum bus bar located in Enclosure “P” was approximately 2 559.5 g.

Fig. 50. Photo of Experiment 2-31 bus bars post-experiment (arc location shown right).

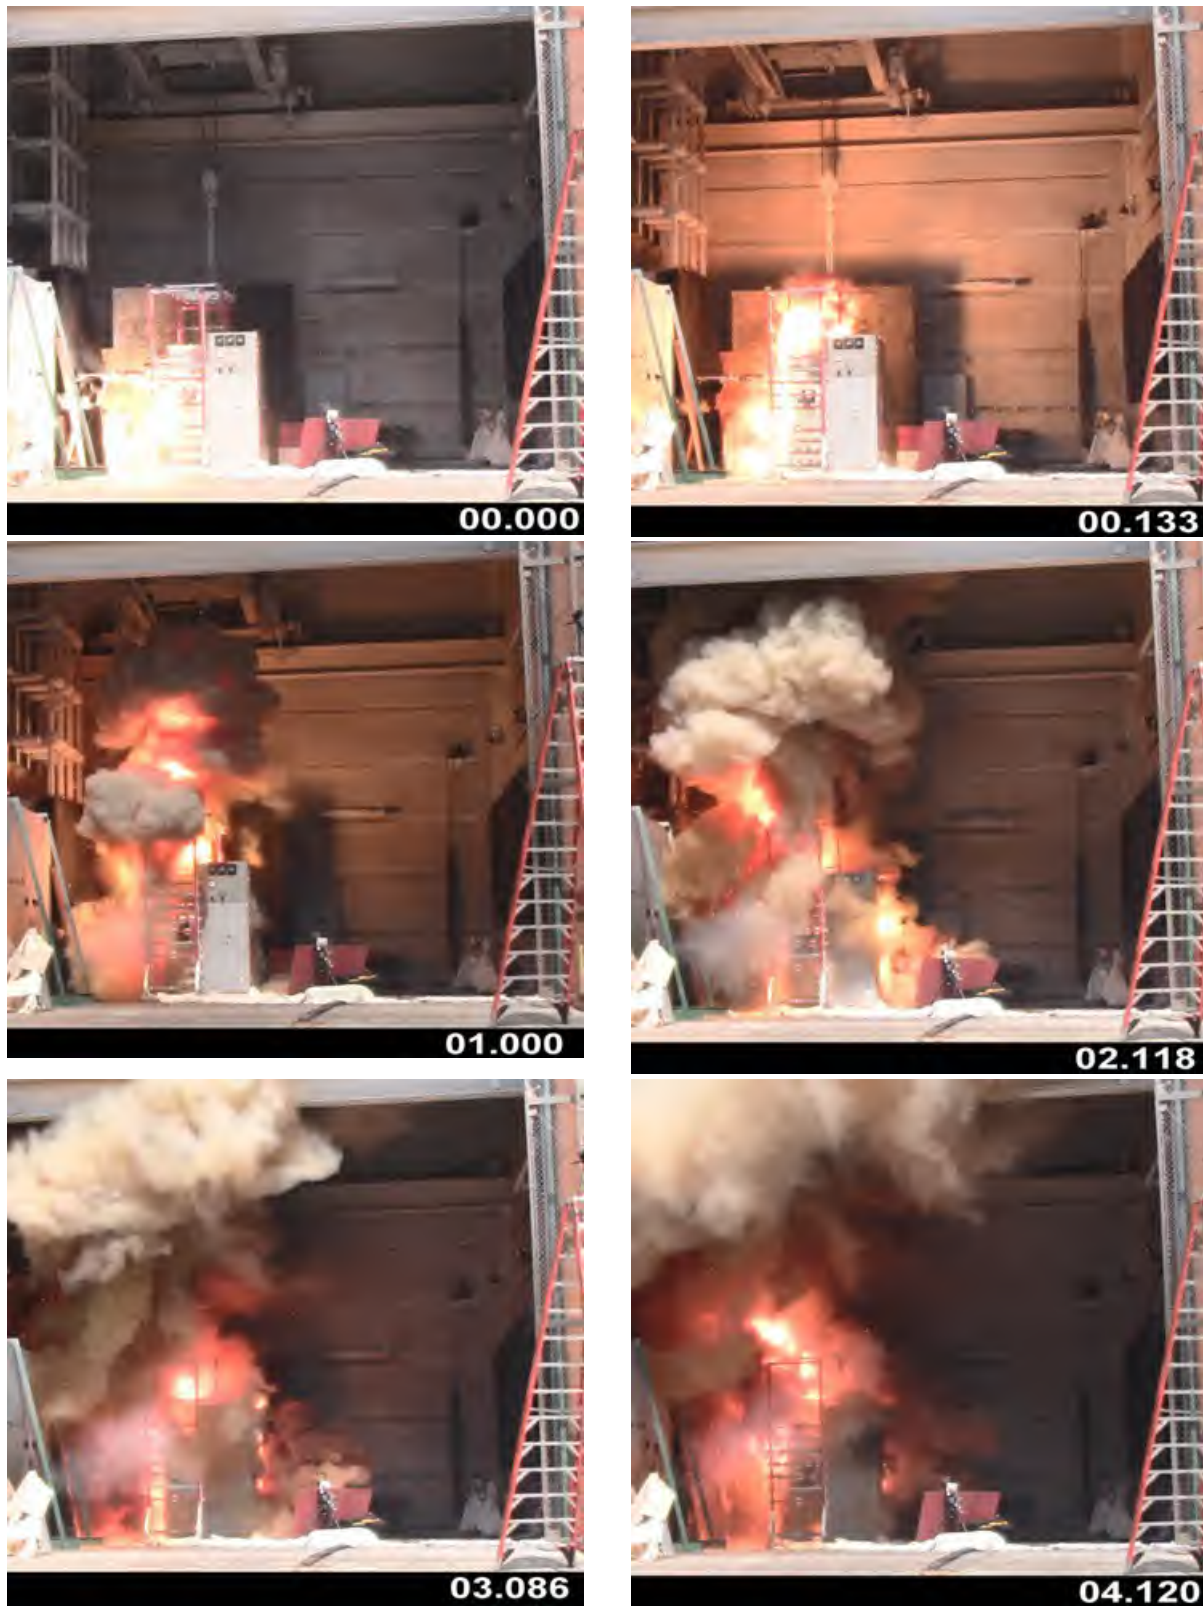
Fig. 53. Sequence of Images from Experiment 2-36 (image time stamps are in seconds).

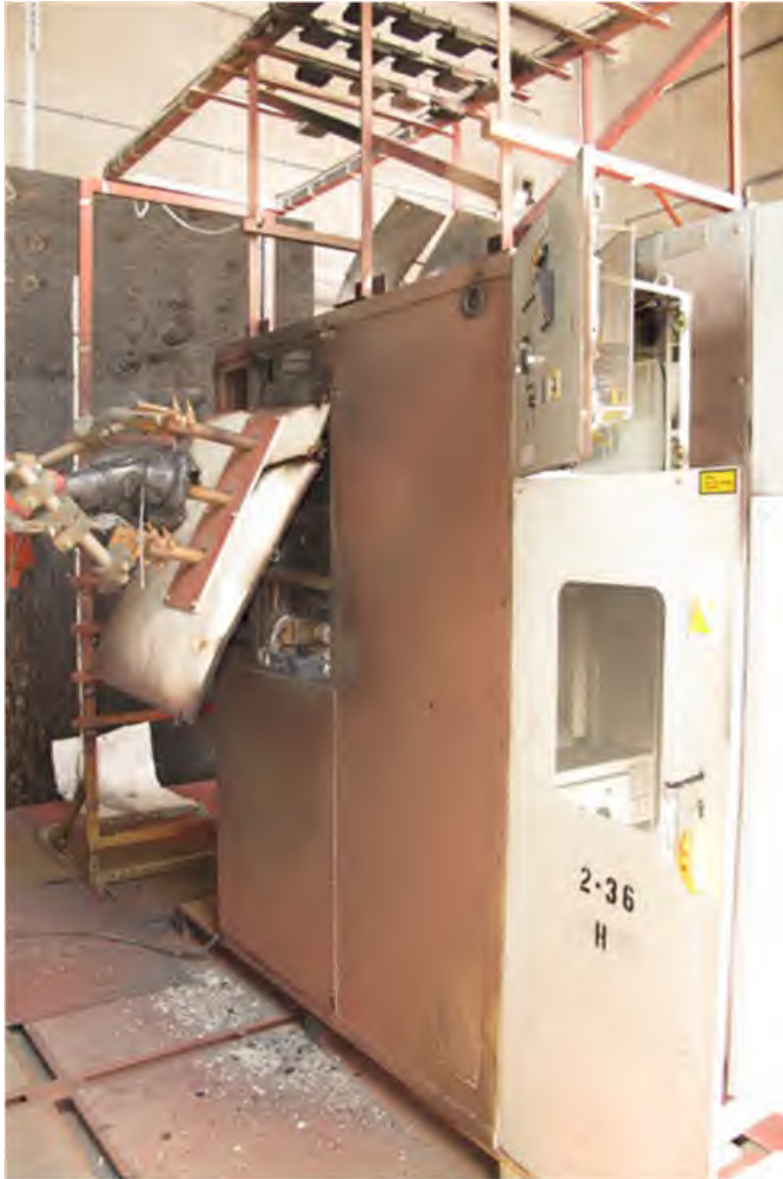
Fig. 55. Enclosure Post-Experiment 2-36. Note, the phenolic panel was separated from the switchgear side, and two adjacent top panels were deformed but remained attached.

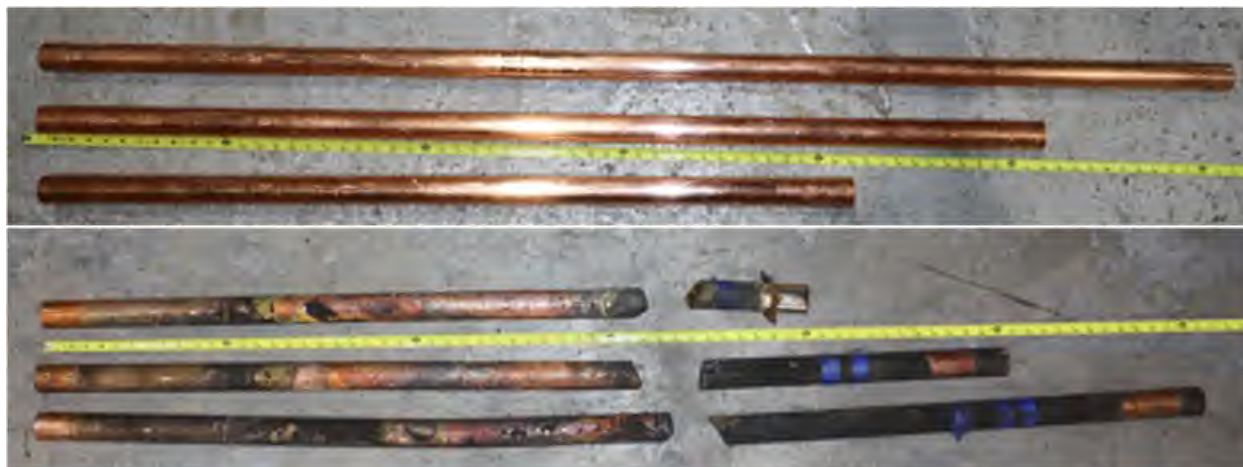
An image of the bus bars removed from the enclosure after the experiment are shown in Fig. 56. The total mass loss of the bus bars was 4 842 g.

Fig. 56. Photo of Experiment 2-36 bus bars. Top – pre-experiment, Bottom – post-experiment.

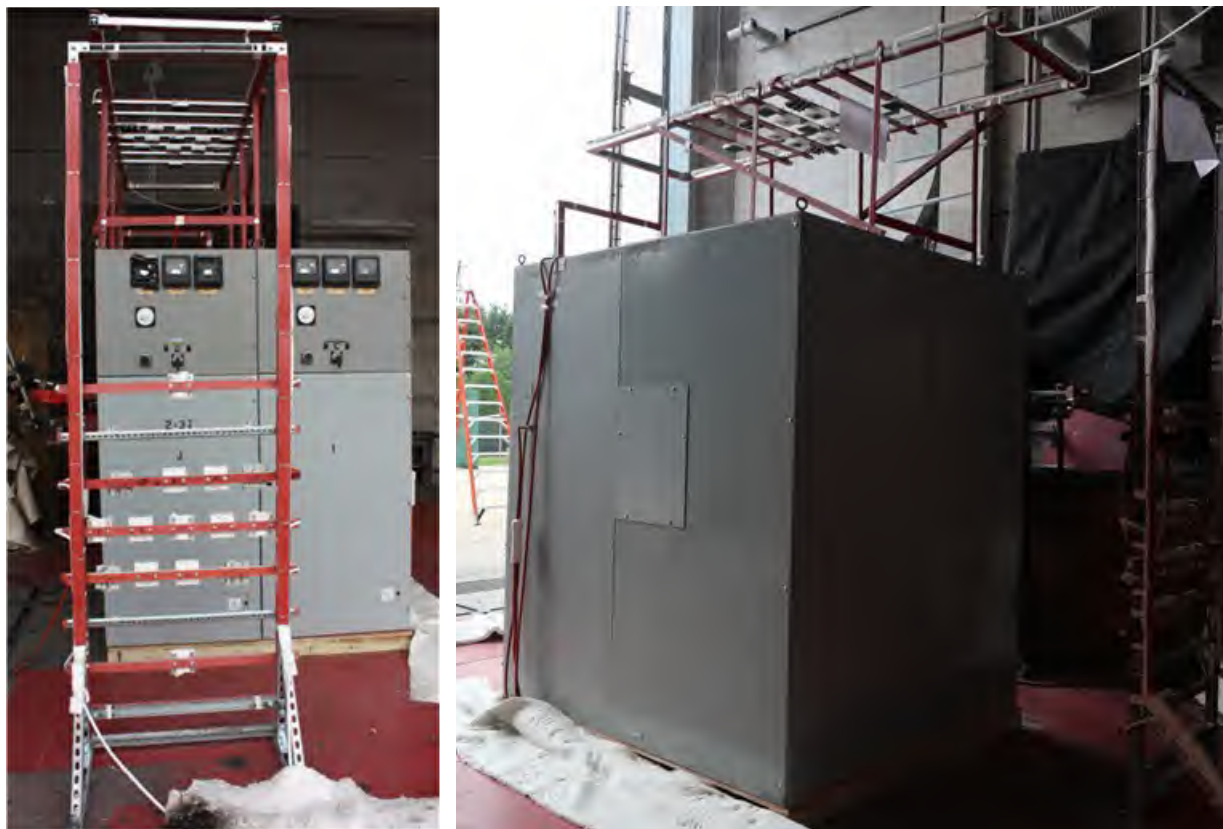
This experiment used two medium-voltage (MV) electrical enclosures. Both enclosures were of a horizontal draw-out design (ITE Type HK). Both enclosures contained copper bus and were connected to the power supply via main bus extensions outside of Enclosure “J”. The arc wire was located on the breaker stab in Enclosure “J”. The arcing wire was installed between all three phases, and marked-up illustrations of the arc wire location is presented in Fig. 58. Fig. 59 shows the experimental setup. Three instrumentation racks were used and surrounded Enclosure “J”.

Fig. 59. Pre-experimental setup for experiment 2-37. Left – Front of switchgear showing Enclosure "J" left where arc was initiated on breaker stabs and Enclosure "I" to the right, Right– rear angle view showing general experimental configuration with Enclosure "I" to the left.

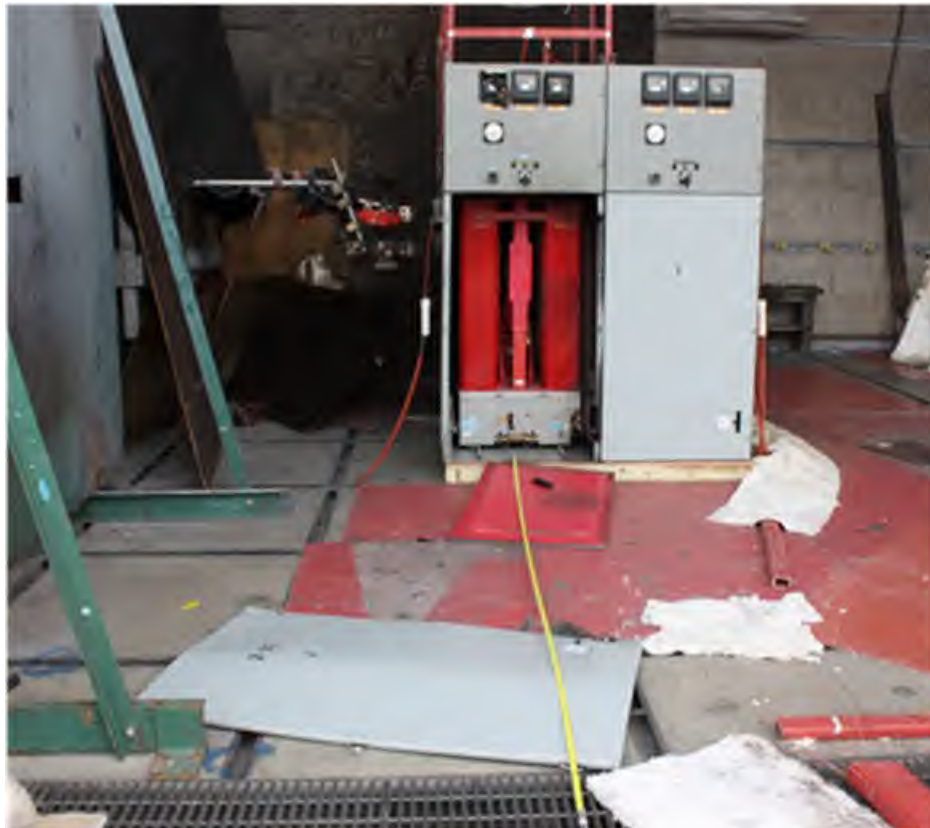
Fig. 60. Post-Experiment photo of Experiment 2-37 showing resting place of Enclosure “J” front door and breaker front cover.

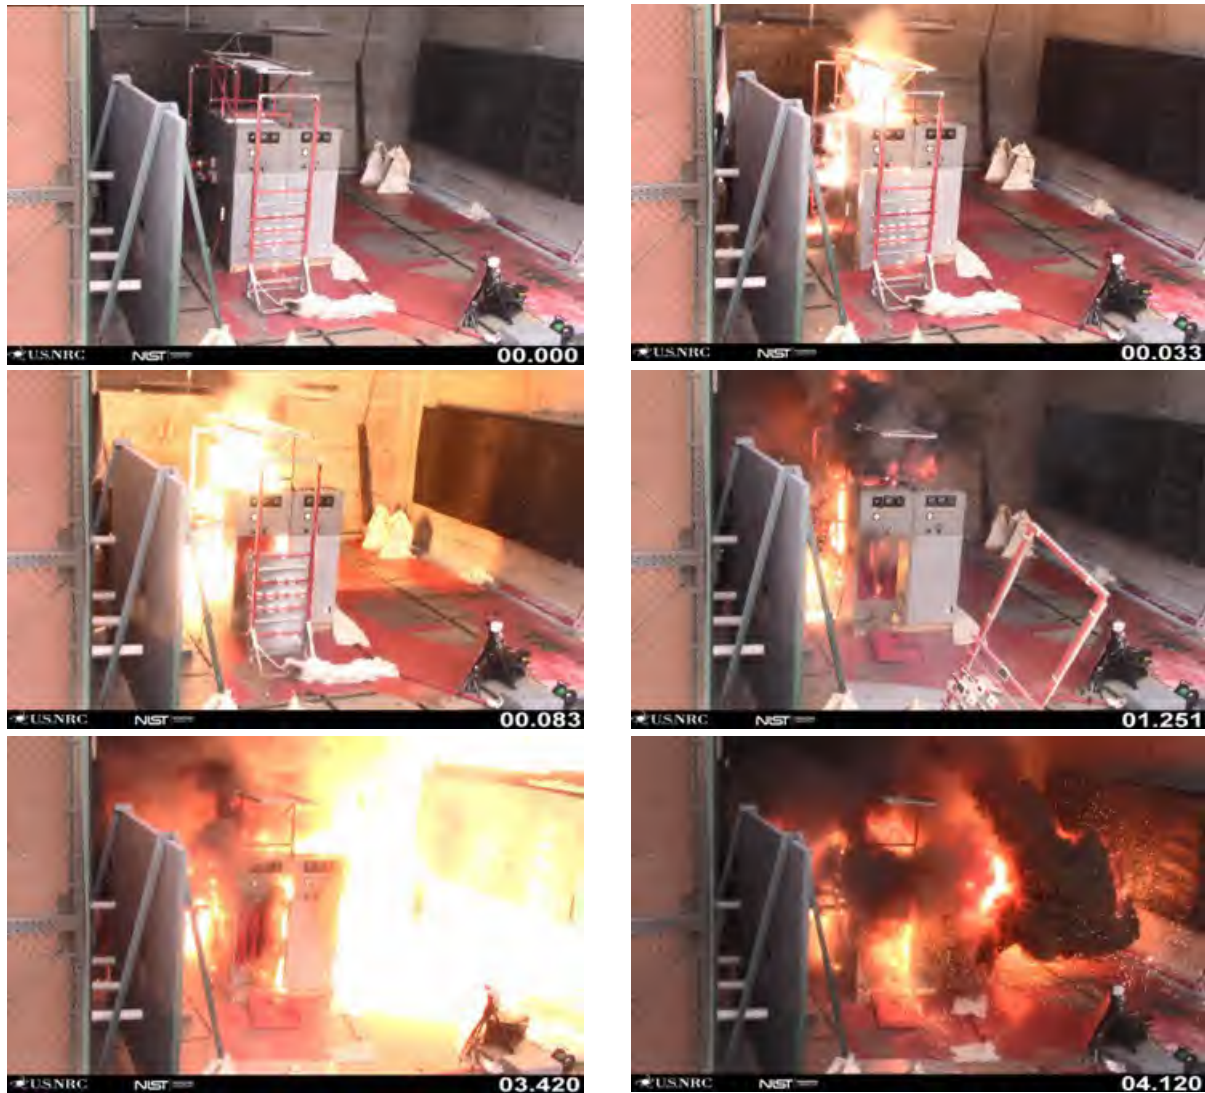
Fig. 61. Sequence of Images from Experiment 2-37 (image time stamps are in seconds).

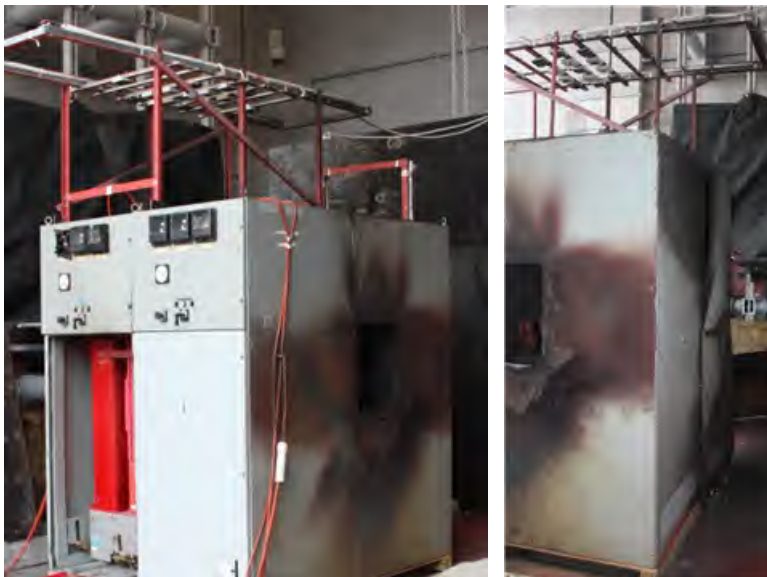
Photographs of the enclosures following the experiment is presented in Fig. 63. The enclosures did not experience a breach due to arc burn-through. However, three openings did occur: 1.) door on Enclosure “J” was blown off, 2.) side cover of Enclosure “I” near main bus compartment was blown off, and 3.) the two rear panels of Enclosure “J” bowed, and several fastener failures occurred causing a gap of no less than approximately 10 cm (4 in).

Fig. 63. Enclosure Post-Experiment 2-37. Door of Enclosure “J” was blown off, side panel of Enclosure “I” was blown off, and both rear panels were bowed.

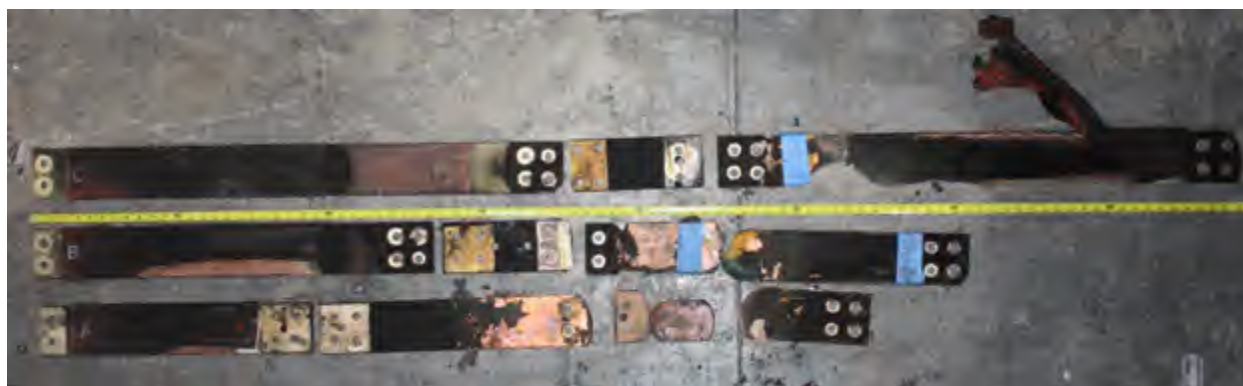
An image of the bus bars removed from the enclosure after the experiment are shown in Fig. 64. The total mass loss of the bus bars was approximately 2 804.0g. Additional details are presented in Appendix C and D.

Fig. 64. Photo of Experiment 2-37 bus bars post-experiment.
