# Understanding High Energy Arcing Faults

Course No: E05-018

*This course was adapted from the NIST U.S. Department of Commerce, Publication No. NIST TN 2290, “Report on High Energy Arcing Fault Experiments”, which is in the public domain.*

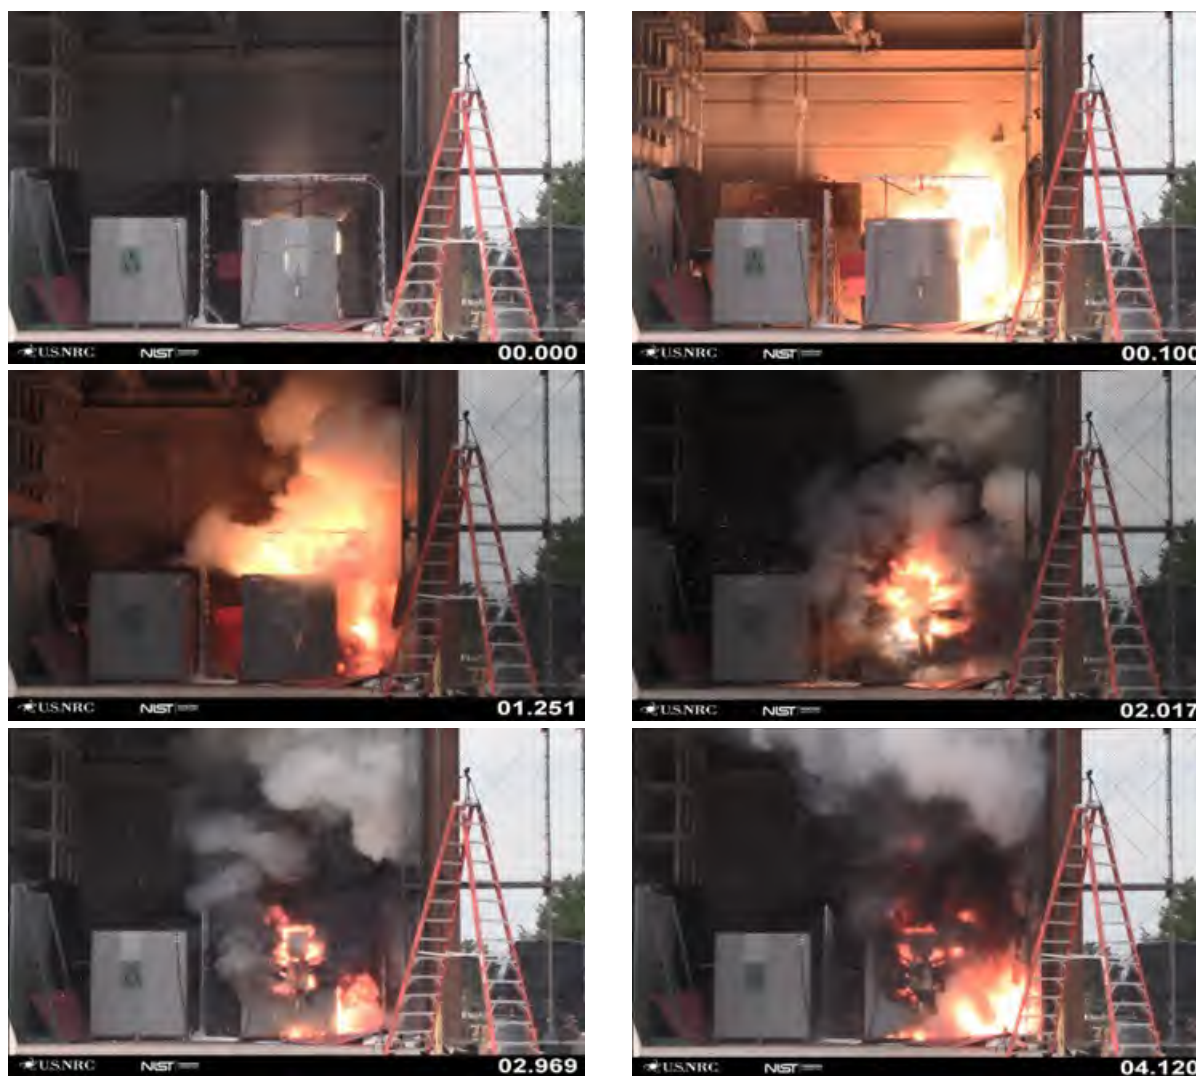
Fig. 67. Sequence of Images from Experiment 2-38 (image time stamps are in seconds).

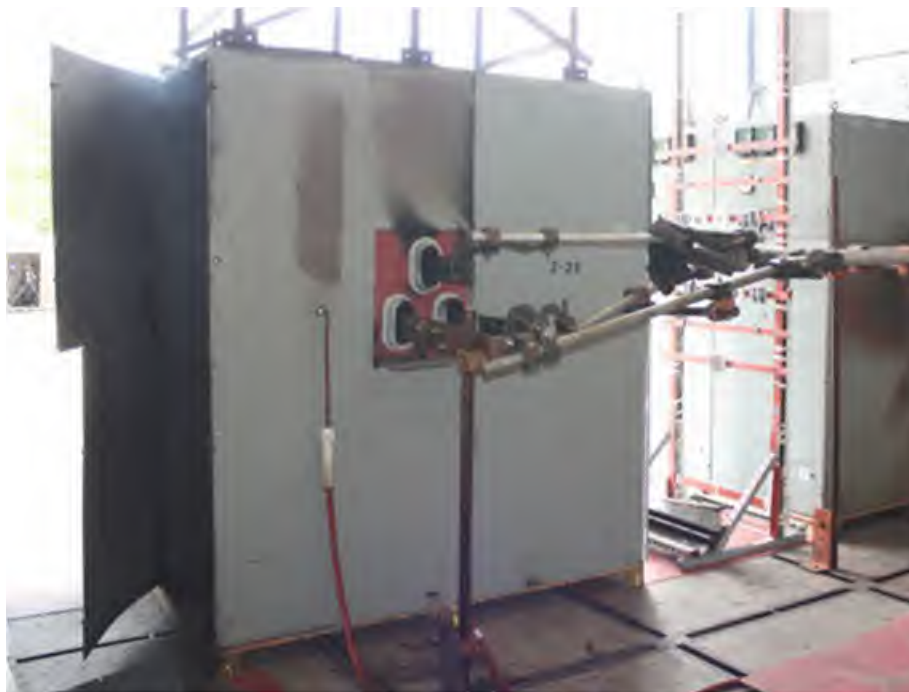
Fig. 69. Enclosure Post-Experiment 2-38. Enclosure “K” is in the foreground attached to the laboratories power supply, Enclosure “I” is across the aisle from “K”.

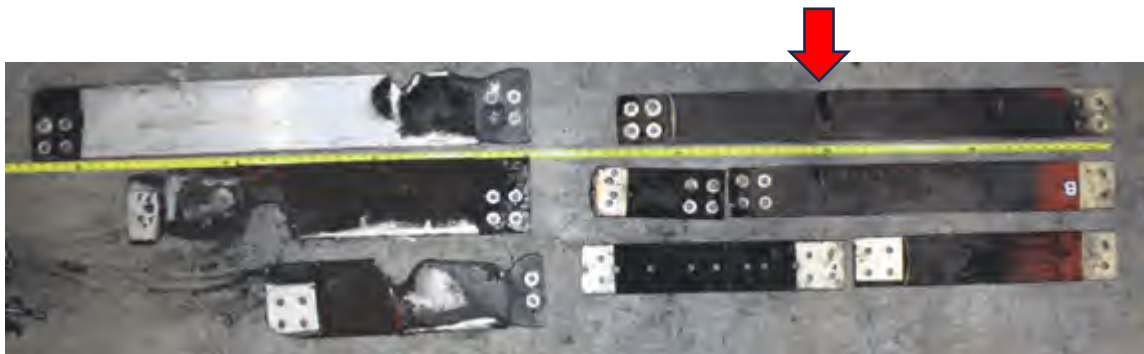
An image of the bus bars removed from the enclosure after the experiment is shown in Fig. 70. The total mass loss of the bus bars was approximately 1 797.5 g. Additional details are presented in Appendices C and D.

Fig. 70. Photo of Experiment 2-38 bus bars post-experiment (initial arc location shown by arrow).

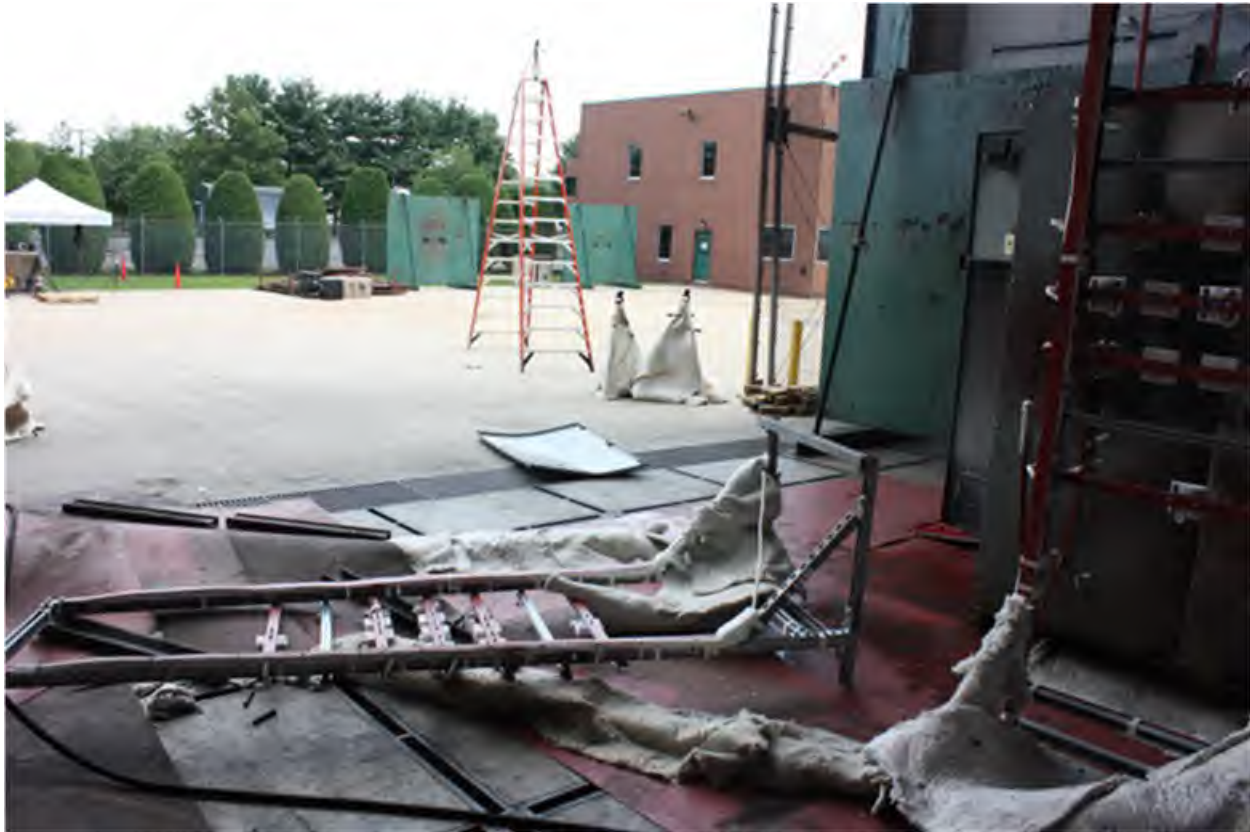
A photograph of the area surrounding the enclosures following the experiment is presented in Fig. 75.

Fig. 75. Enclosure Post-Experiment 2-39. The front door is approximately 4.9 m (16 ft) from Enclosure "M". Instrument Rack #1 is laying on ground due to impact from Enclosure "M" front door during experiment.

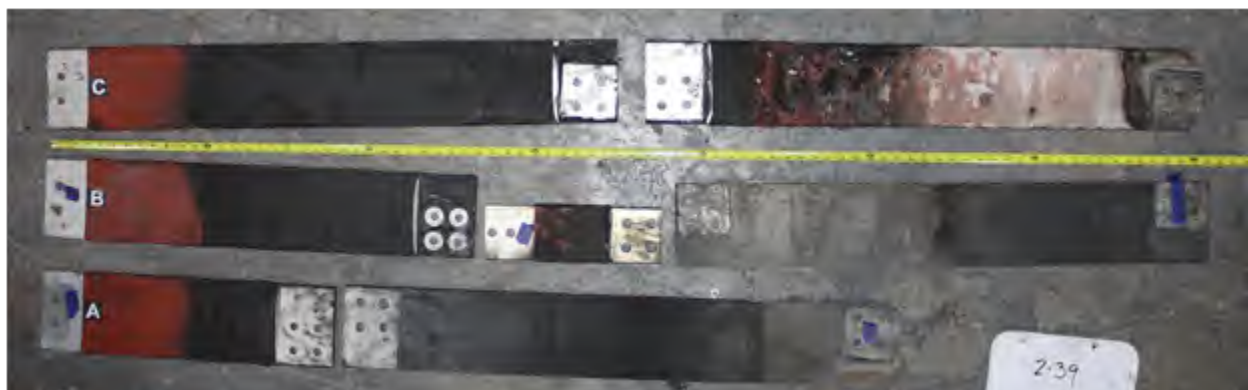
An image of the bus bars removed from the enclosure after the experiment are shown in Fig. 76. The total mass loss of the bus bars was approximately 114.5 g. Additional details are presented in Appendices C and D.

Fig. 76. Photo of Experiment 2-39 bus bars post-experiment.

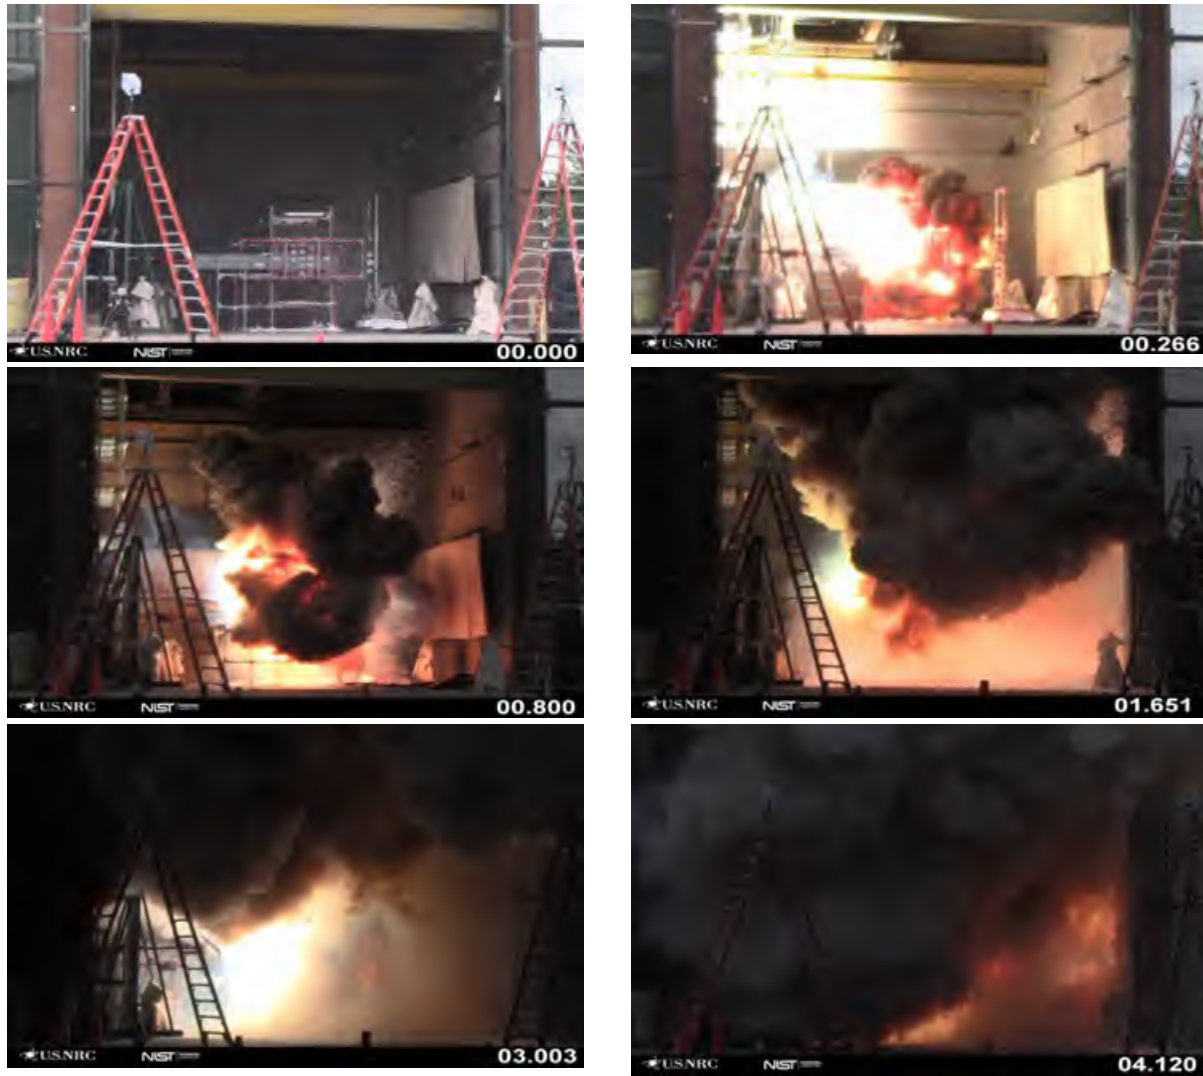
Fig. 79. Sequence of Images from Experiment 2-40 (image time stamps are in seconds).

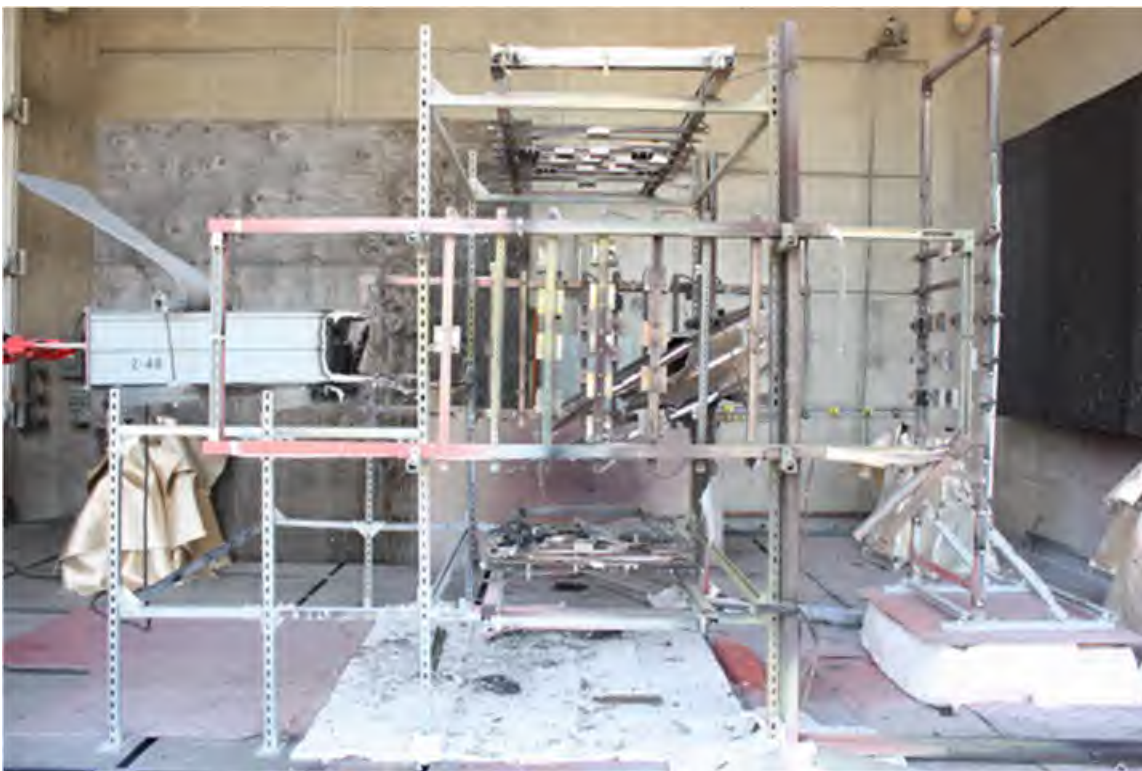
A photograph of the bus duct enclosure following the experiment is presented in Fig. 81. The enclosure was completely severed as shown below. The top cover was largely intact due to the overpressure and a large section of the bottom cover was found lying on instrumentation Rack #5.

Fig. 81. Enclosure Post-Experiment 2-40.

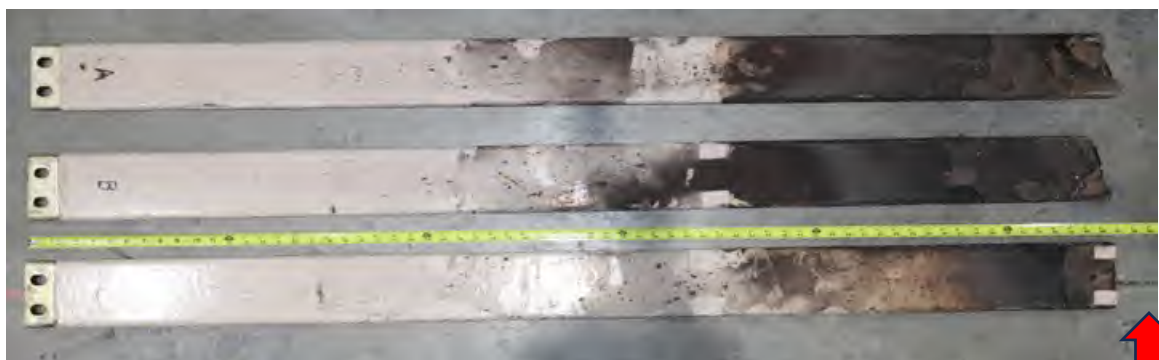
An image of the bus bars removed from the enclosure after the experiment are shown in Fig. 82. The total mass loss of the bus bars was approximately 5 125.0 g. The mass loss from the aluminum enclosure was estimated at approximately 16 088 g. Additional details are presented in Appendix C and D.

Fig. 82. Photo of Experiment 2-40 bus bars post-experiment (arc location at arrow).

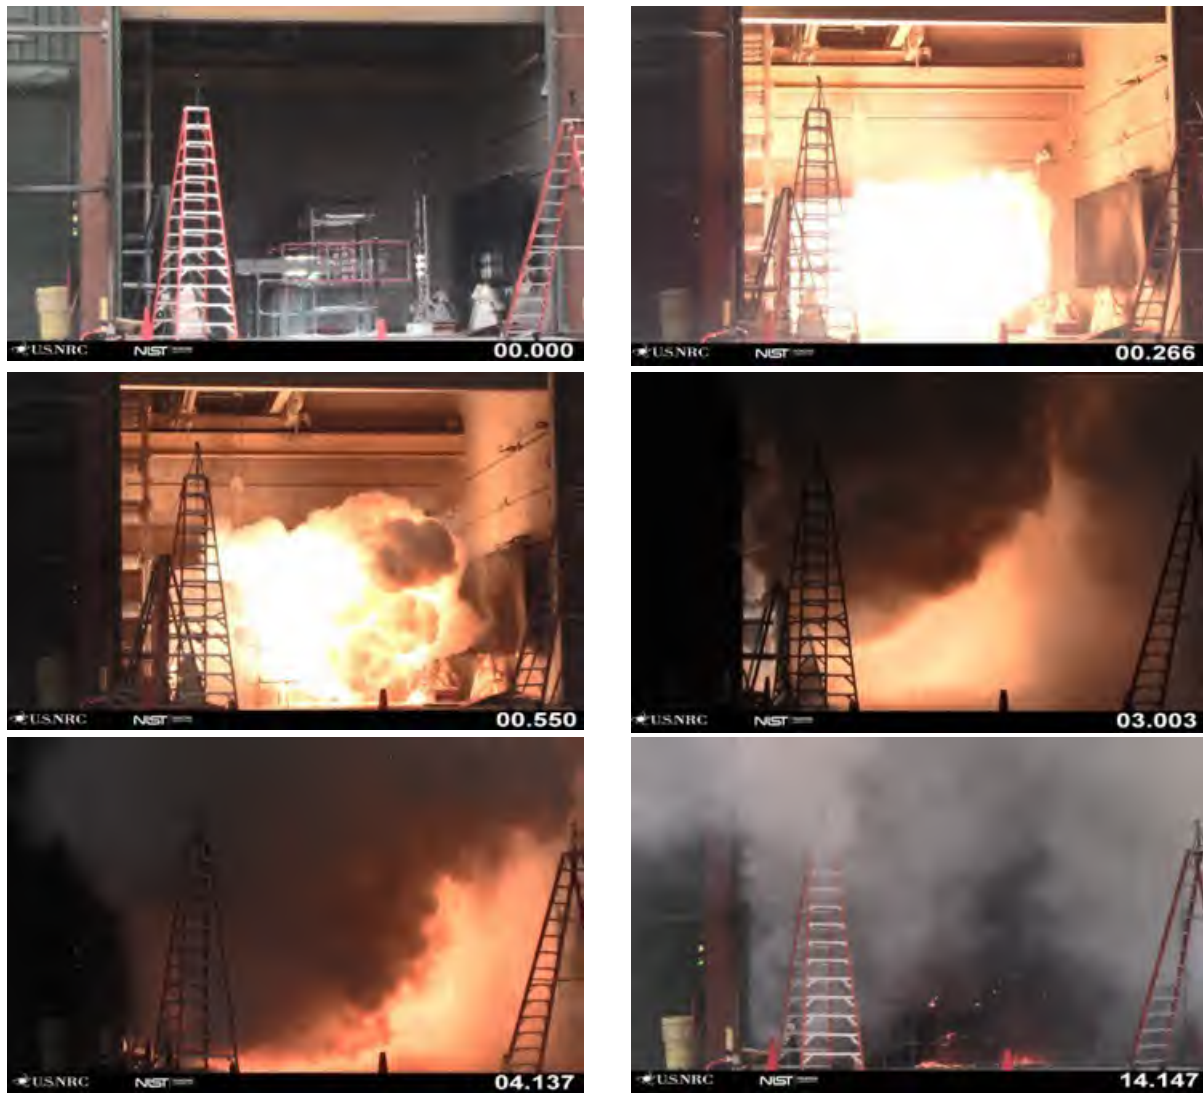
Fig. 84. Sequence of Images from Experiment 2-41 (image time stamps are in seconds).

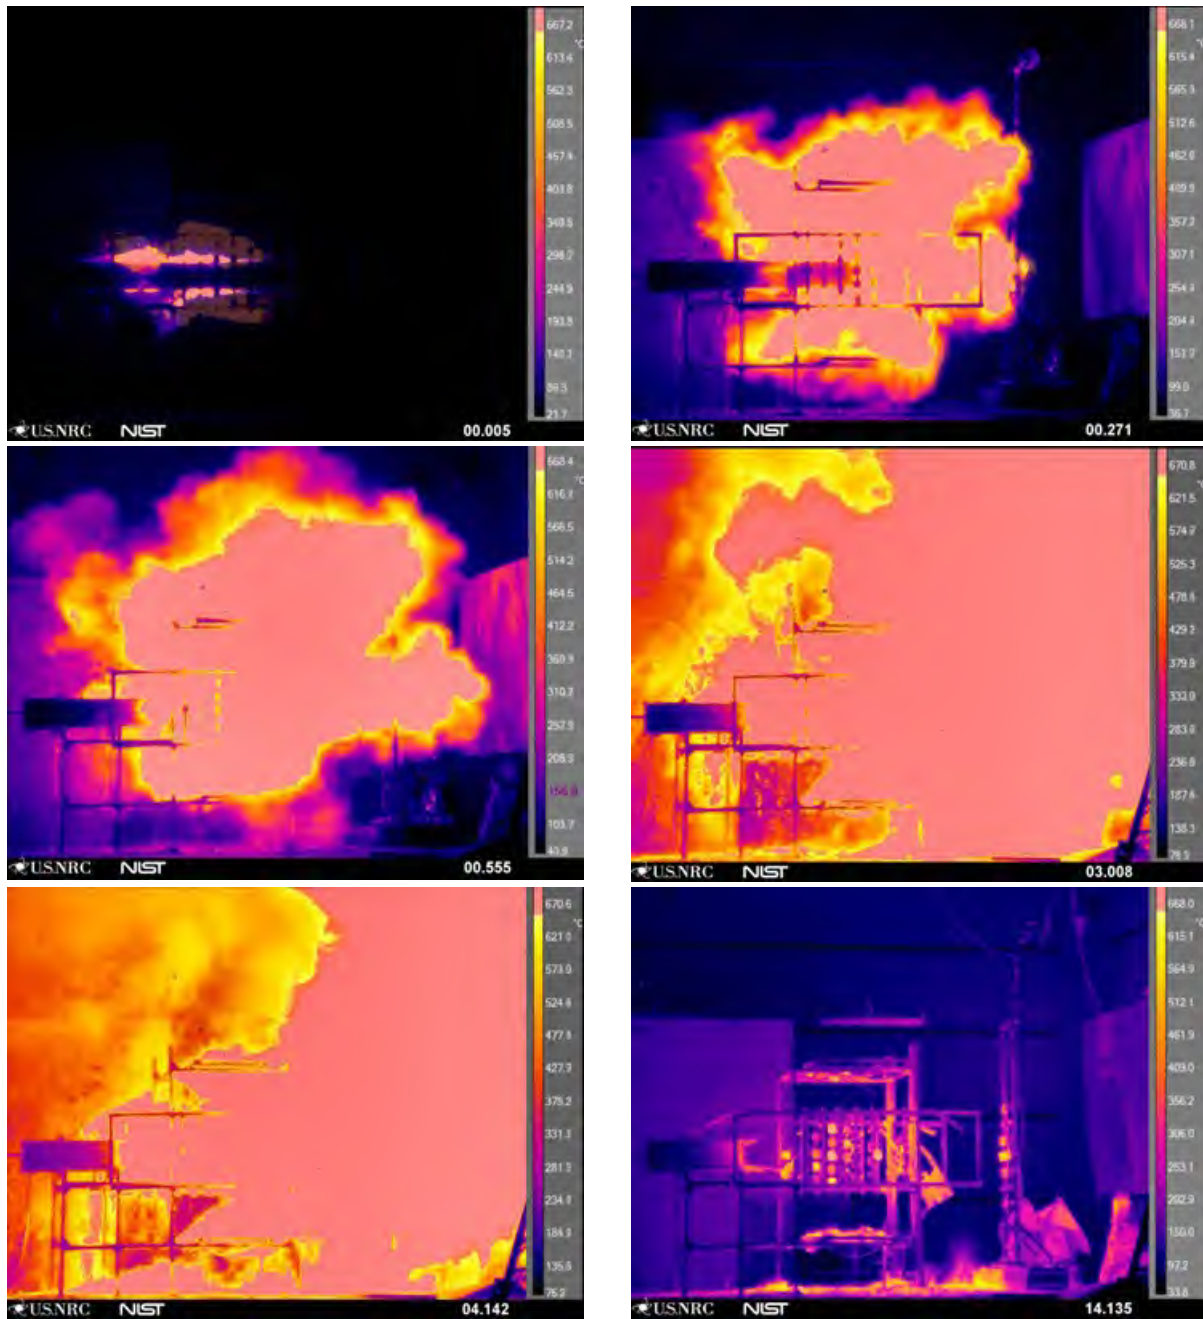
Fig. 85. Sequence of Thermal Images from Experiment 2-41 (image time stamp in seconds).

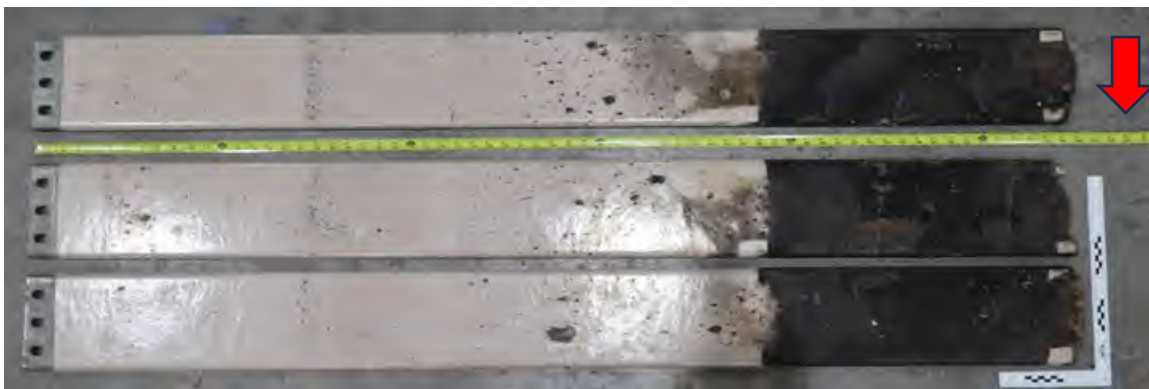
An image of the bus bars removed from the enclosure after the experiment are shown in Fig. 87. The total mass loss of the bus bars was approximately 3 489.5 g. The mass loss from the aluminum enclosure was estimated at approximately 23 849 g. Additional details are presented in Appendices C and D.

Fig. 87. Photo of Experiment 2-41 bus bars post-experiment (arc location at arrow).

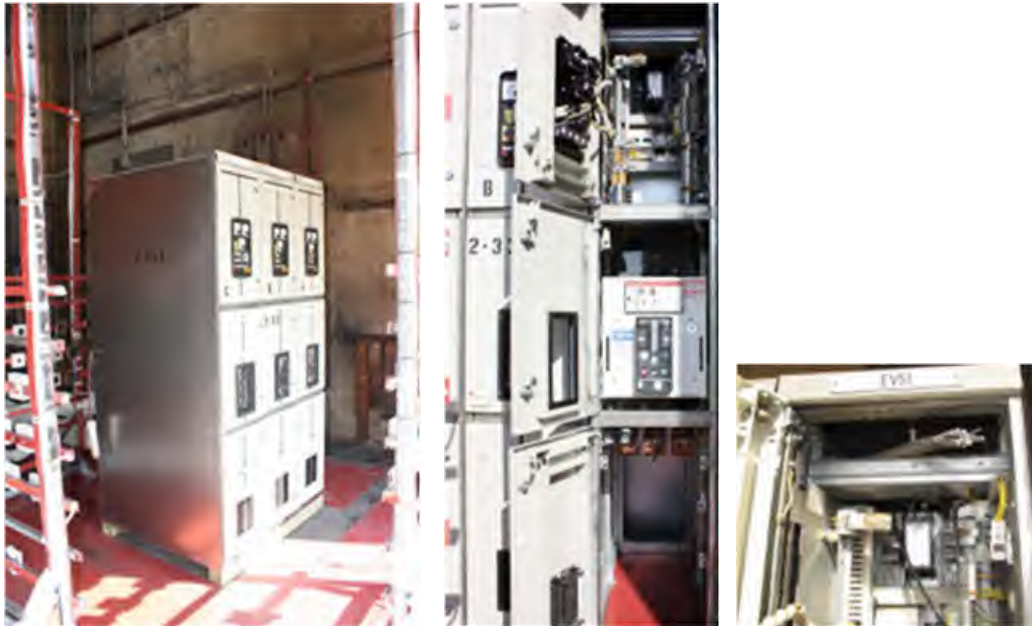
Fig. 160. Pre-Experiment 2-33A with equipment placed in Test Cell #7. Left – complete lineup, Center – Section 'A' internals viewed from front with doors open, Right – SIS wire pulled out to show amount installed in upper wire-way (note wire ends were pushed back into wireway prior to experiment).

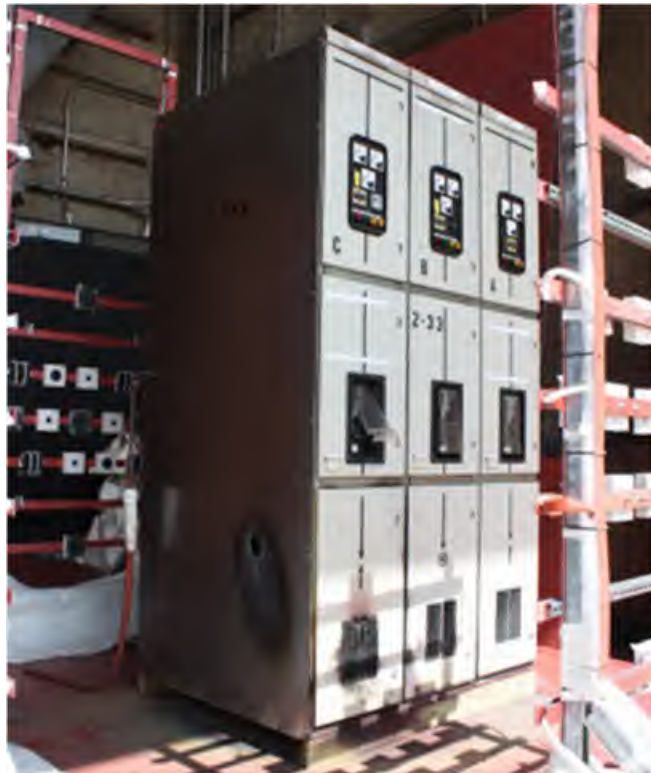
Fig. 162. Post-Experiment 2-33A. Note arc burn-through on side of Enclosure "C" (EV53), melting of vents in lower section and placement of breaker protection cover.

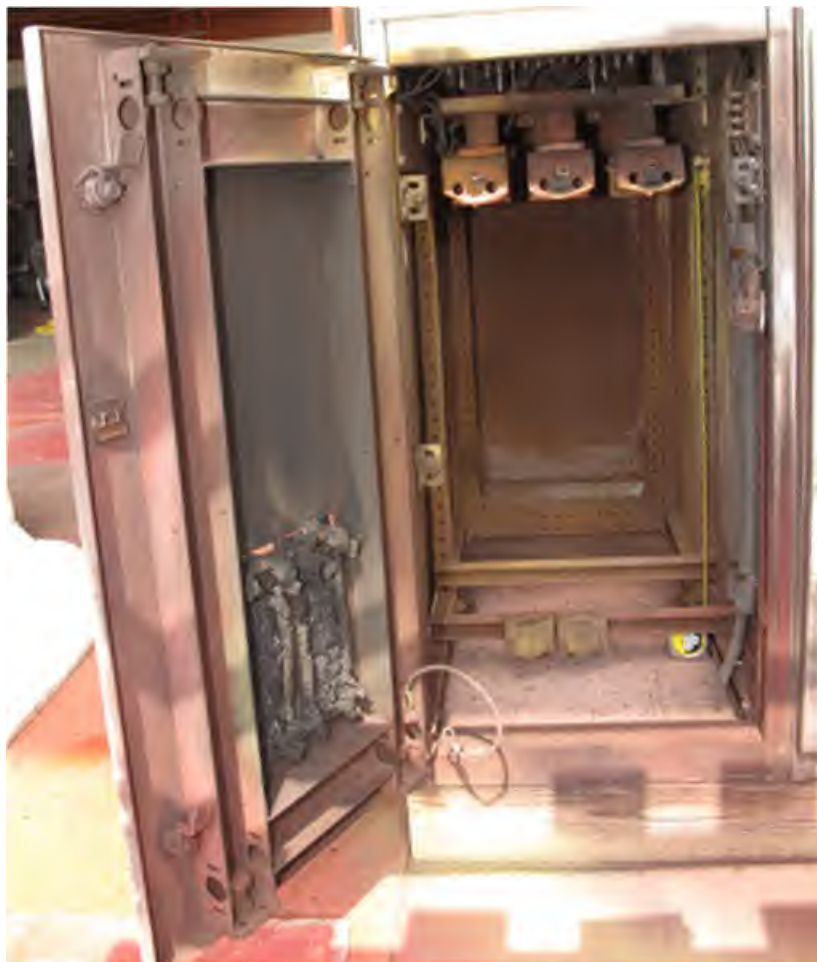
Fig. 163. Post-Experiment 2-33A Conductors. Enclosure 'C' (EV53).

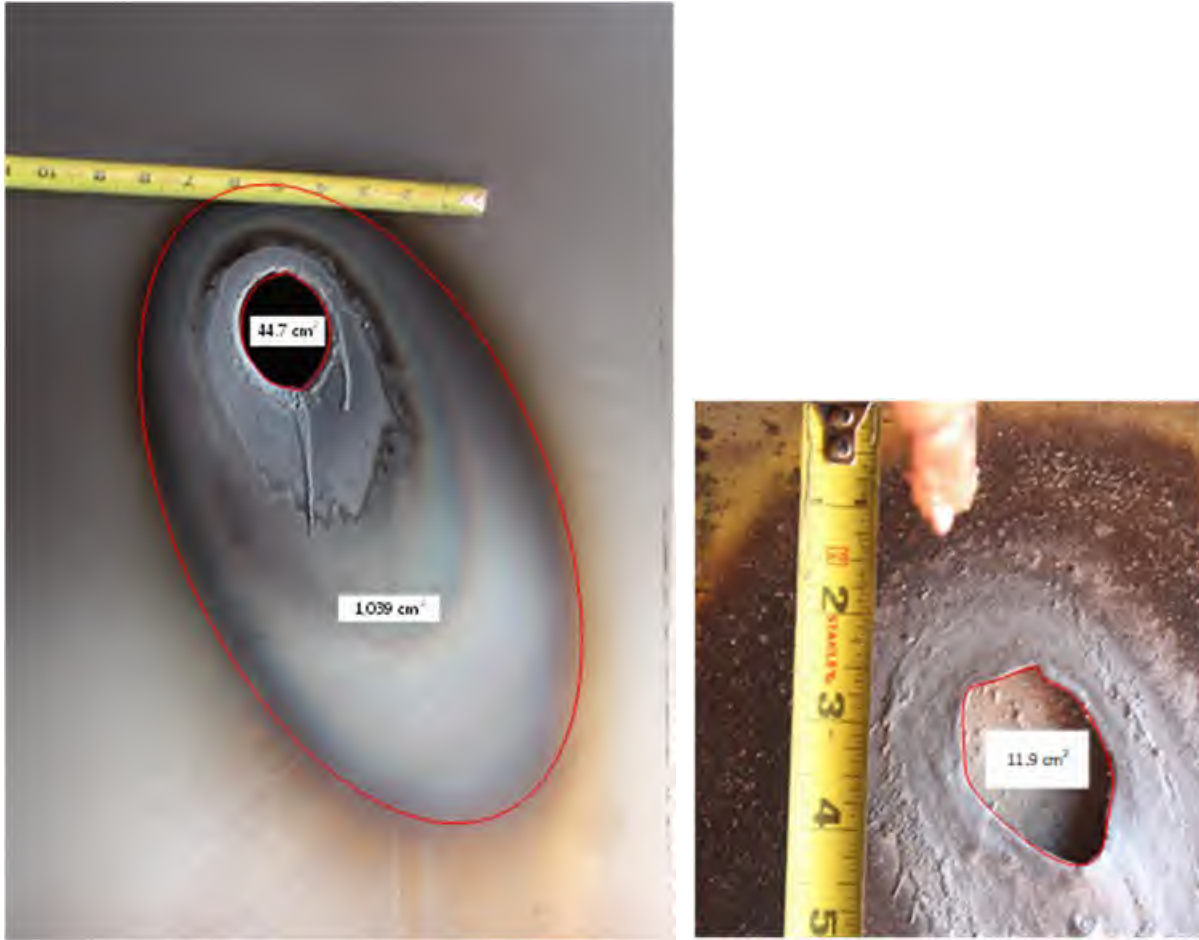
Fig. 164. Enclosure burn-through. Left – exterior panel, Right – internal panel. Total mass loss approximately 91.0 g.

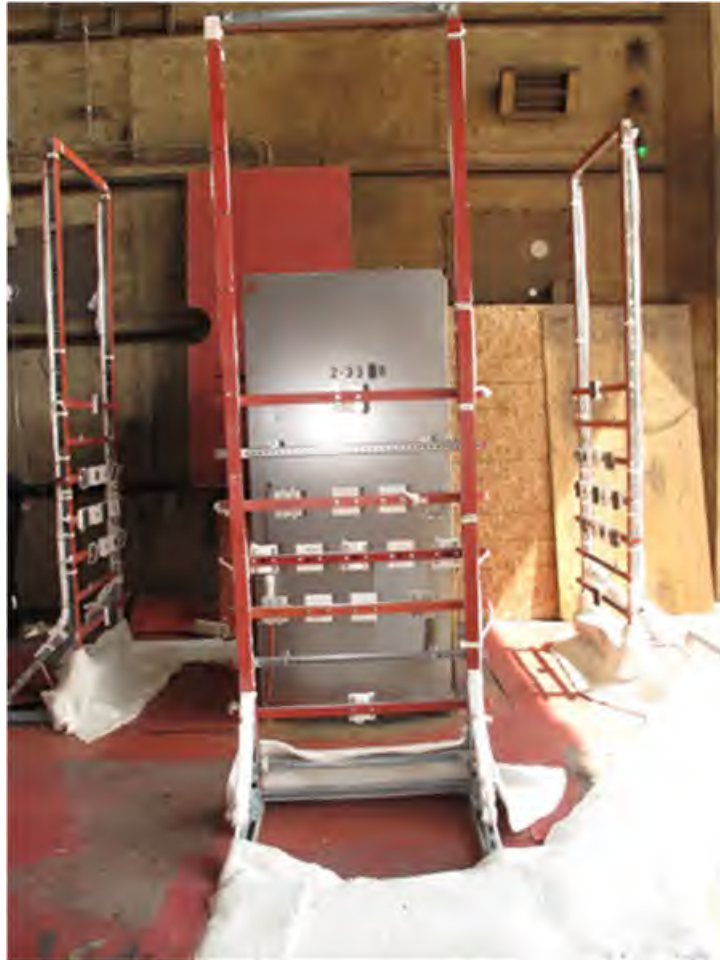
Fig. 165. Pre-Experiment 2-33B. Viewed from side opposite power supply, showing instrumentation rack arrangement surrounding enclosure.

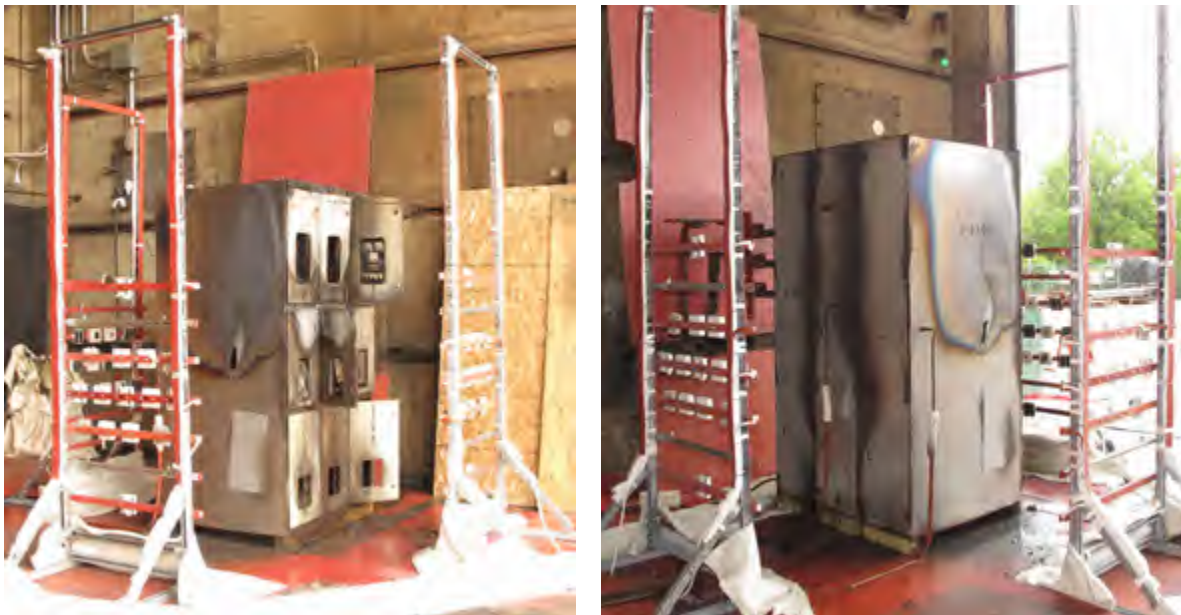
Fig. 167. Post-Experiment 2-33B Left – front corner view, Right – rear corner view.

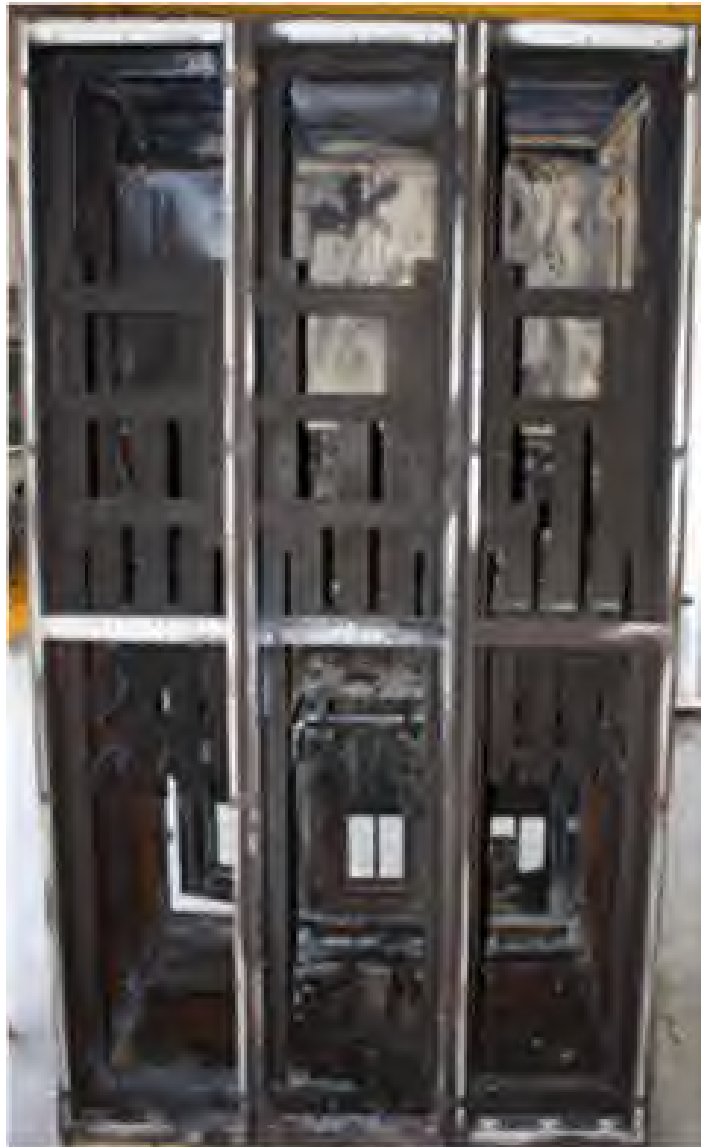
Fig. 168. Post-Experiment internal view from rear.

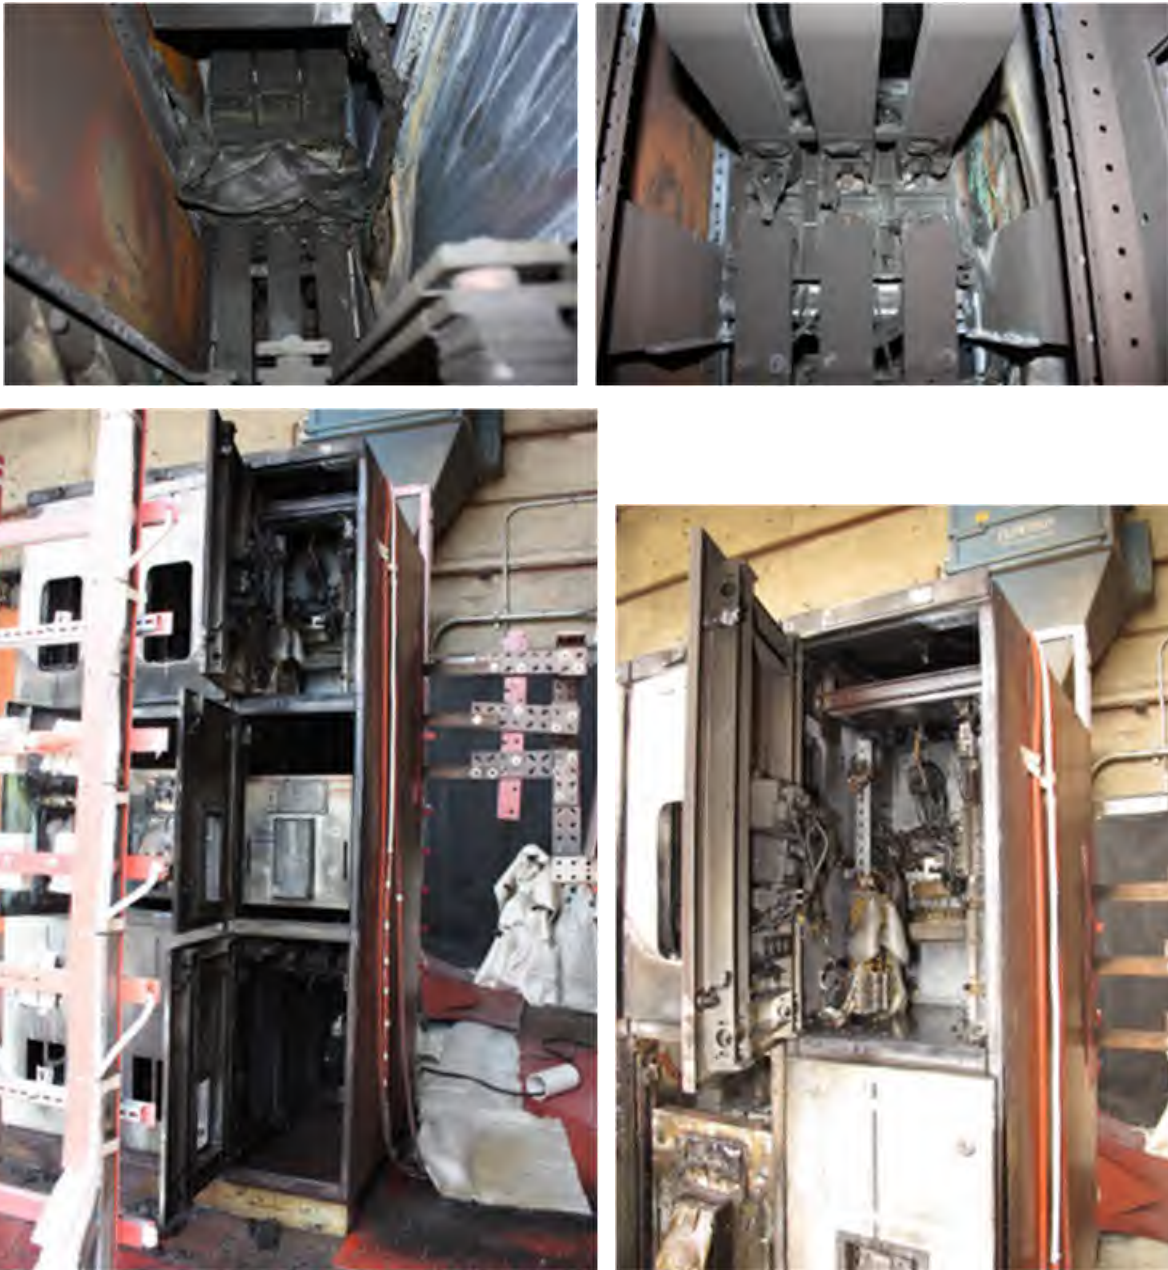
Fig. 169. Post-Experiment 2-33B Enclosure 'A' (EV51). Top left – top of breaker viewed from rear of enclosure, Top right – back of breaker, Bottom-left – Front of enclosure with all three cubicle doors open, Bottom-right – top enclosure close-up view.

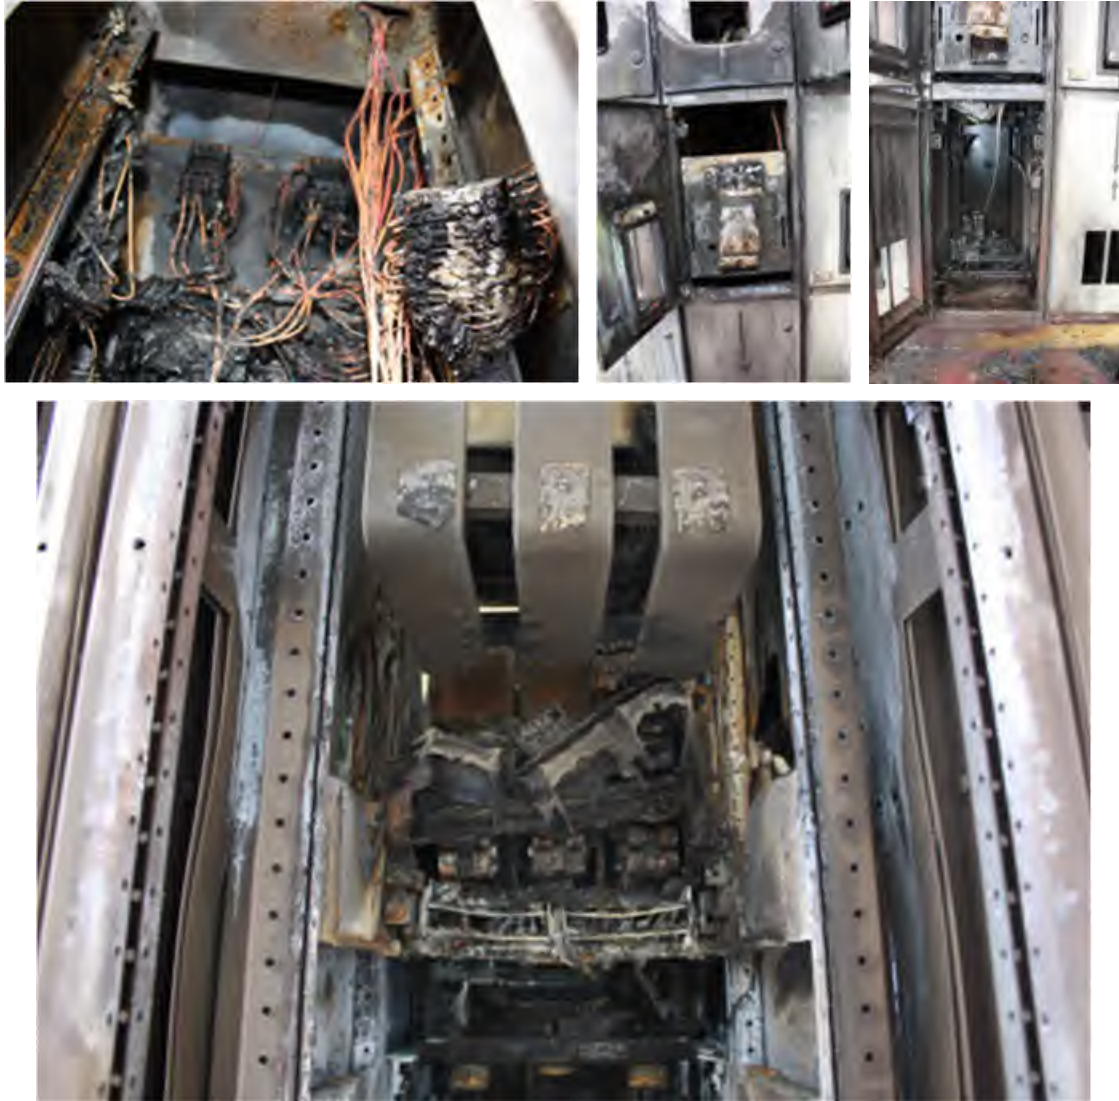
Fig. 170. Post-Experiment 2-33B Enclosure 'B' (EV52). Top left – upper cubicle internals showing remanence of panel wiring, Top center – middle cubicle with door open showing face of breaker, Top right – lower cubicle showing lower bus bars (all three phases) laying on floor of enclosure, Bottom – view of breaker from rear (note lower breaker stabs showing and lower bus bars are missing).

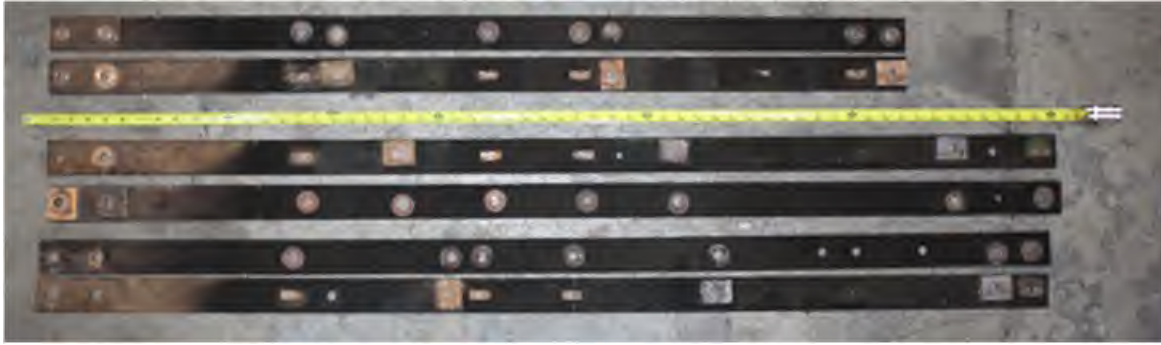
Fig. 172. Post-Experiment 2-33B Horizontal Main Bus Conductors.

Fig. 172. Post-Experiment 2-33B Horizontal Main Bus Conductors. .... 212

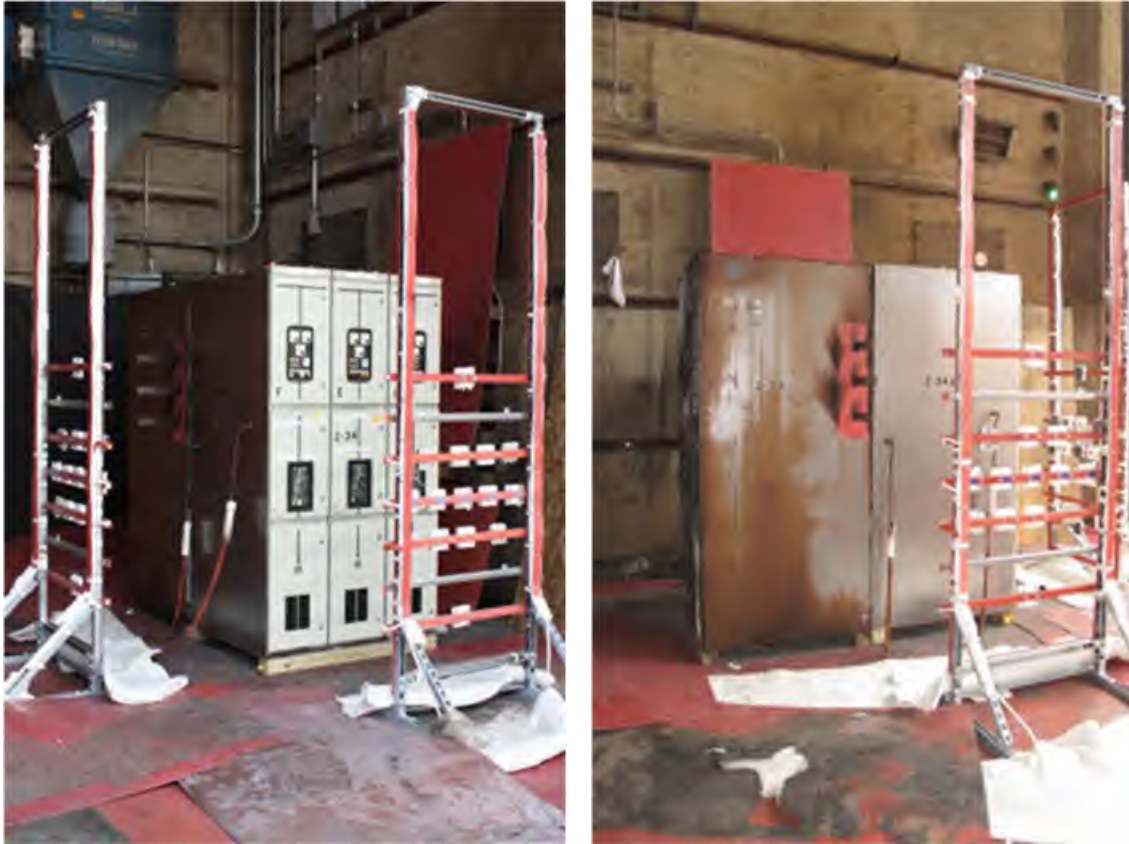
Fig. 174. Pre-Experiment 2-34 Enclosures “D”, “E”, and “F”. Left – front angle view of experimental device, Right – side view of “back-to-back” experimental configuration (note enclosure labeled 2-33 on left is not energized).

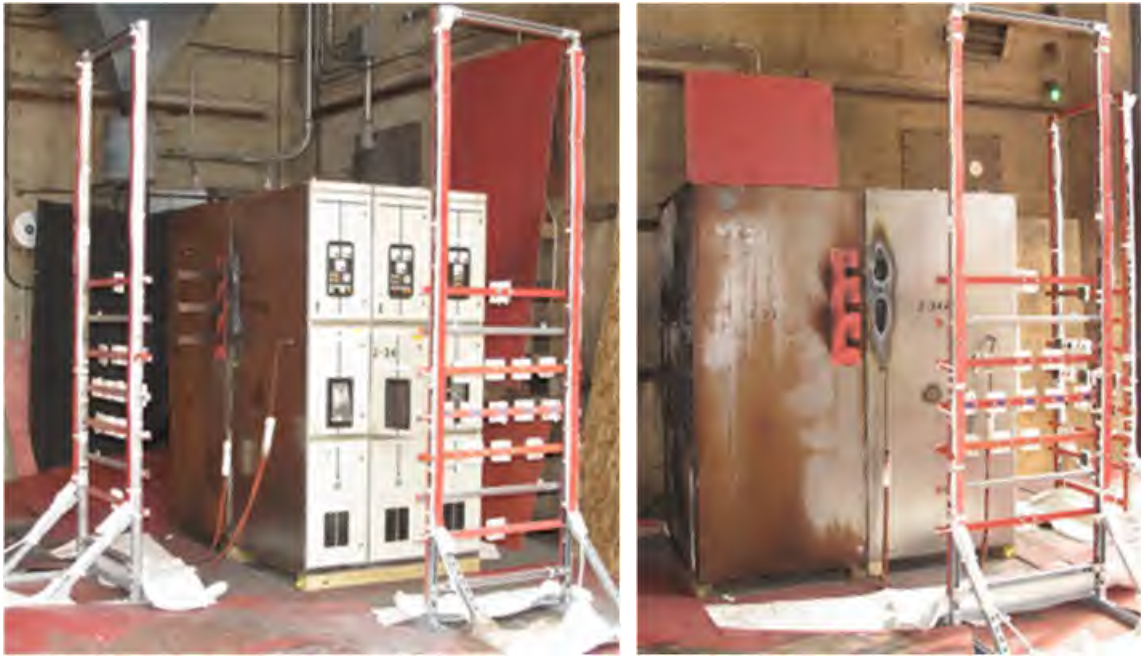
Fig. 175. Post-Experiment 2-34 Enclosures “D”, “E”, and “F”. Left – front angle view of experimental device, Right – side view of experimental device.

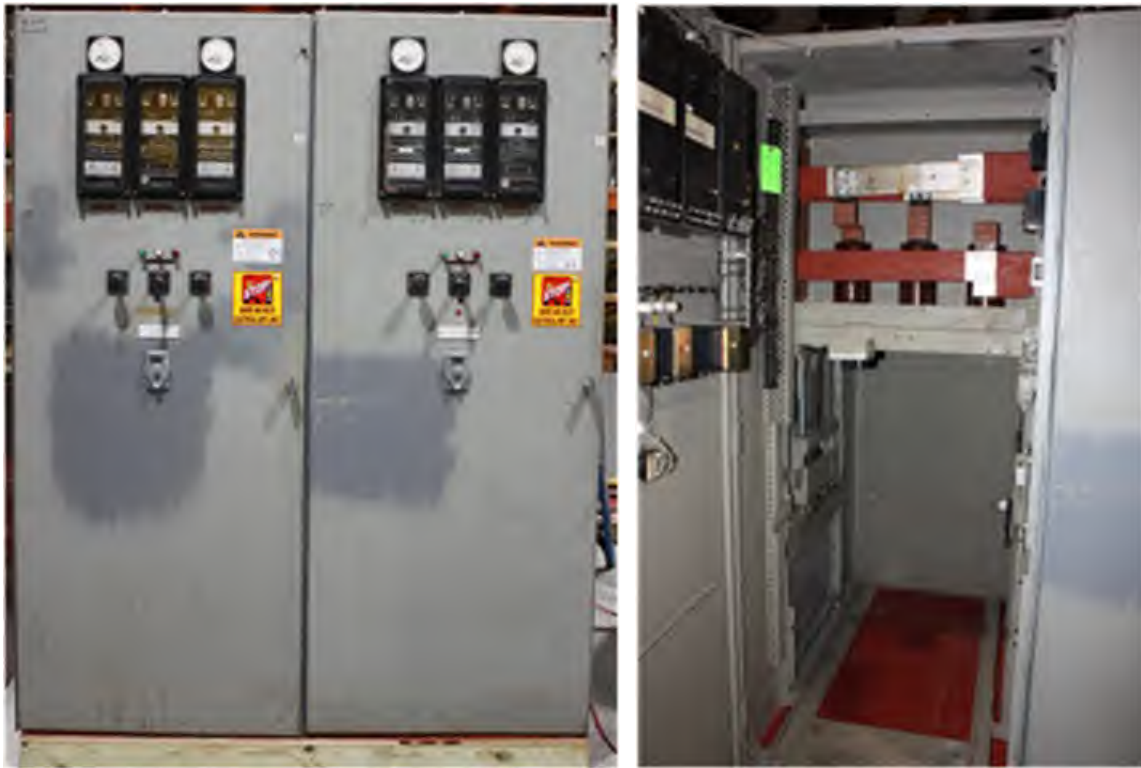
Fig. 178. Pre-Experiment 2-35 Enclosures "O" and "P". Enclosure "O" (left) and "P" (right) front panel, Right – Inside Enclosure "O" showing main bus where arc was initiated.

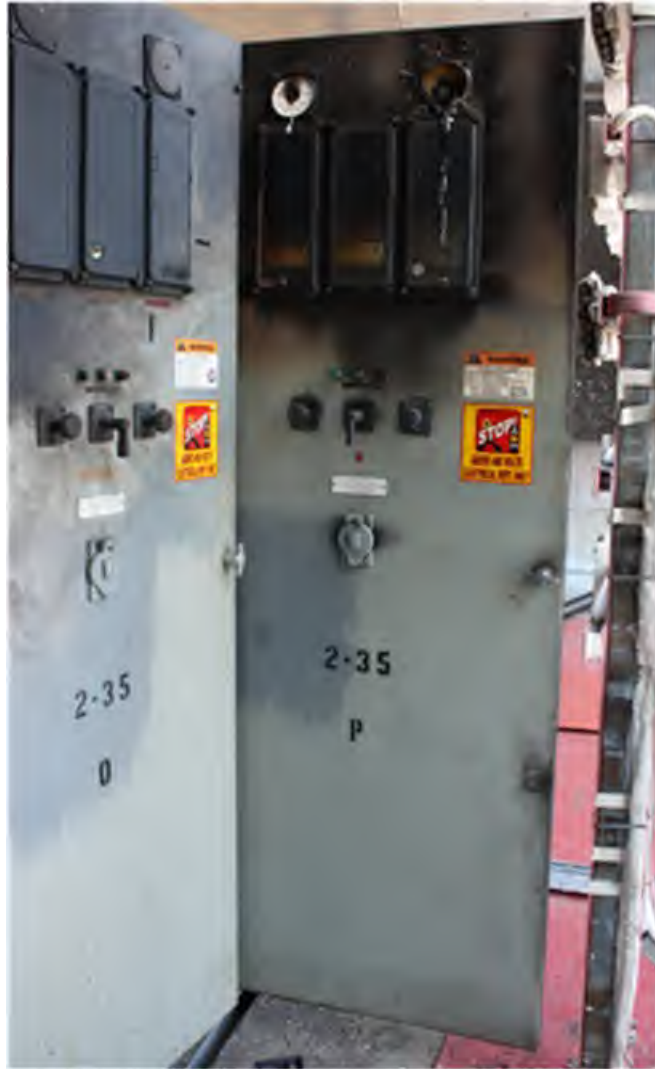
Fig. 180. Post-Experiment 2-35 Enclosures “O” and “P”. Soot and heat damage on front enclosure doors.
