# Understanding High Energy Arcing Faults

Course No: E05-018

*This course was adapted from the NIST U.S. Department of Commerce, Publication No. NIST TN 2290, “Report on High Energy Arcing Fault Experiments”, which is in the public domain.*

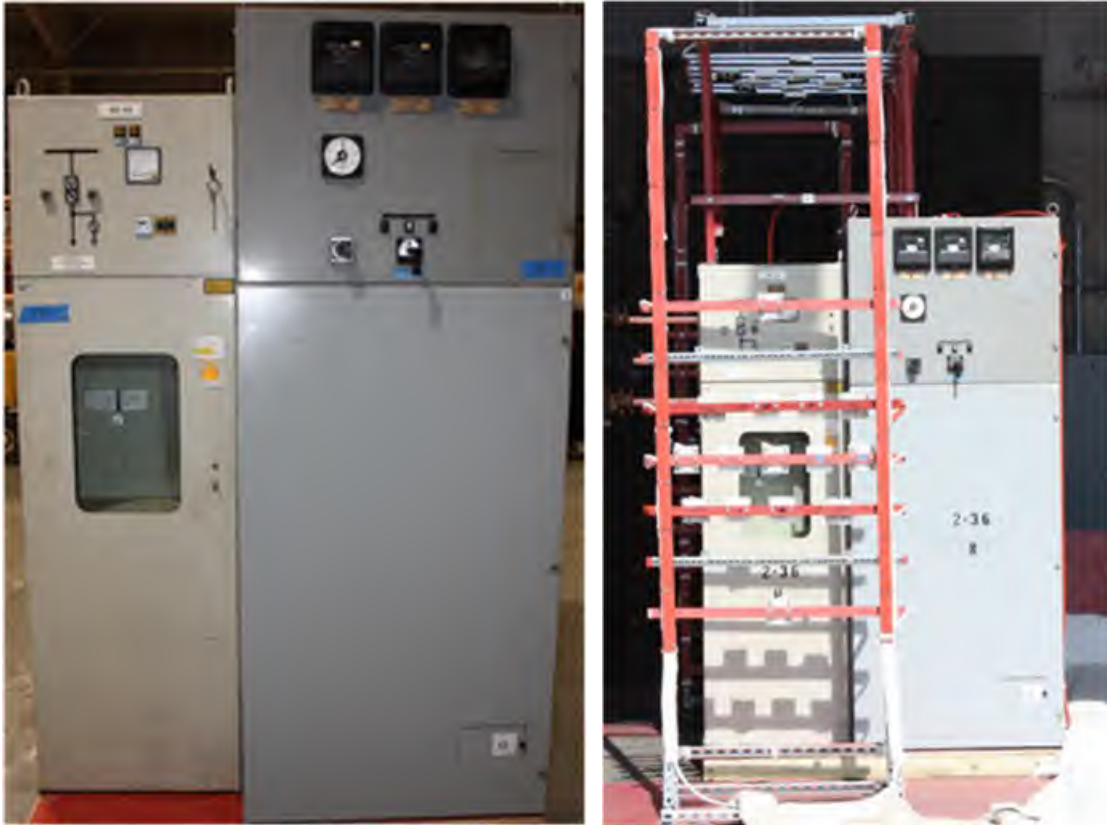
Fig. 182. Pre-Experiment 2-36 Enclosures “H” and “N”. Left – switchgear mockup at storage warehouse, Right – enclosures prior to experiment showing instrumentation rack locations.

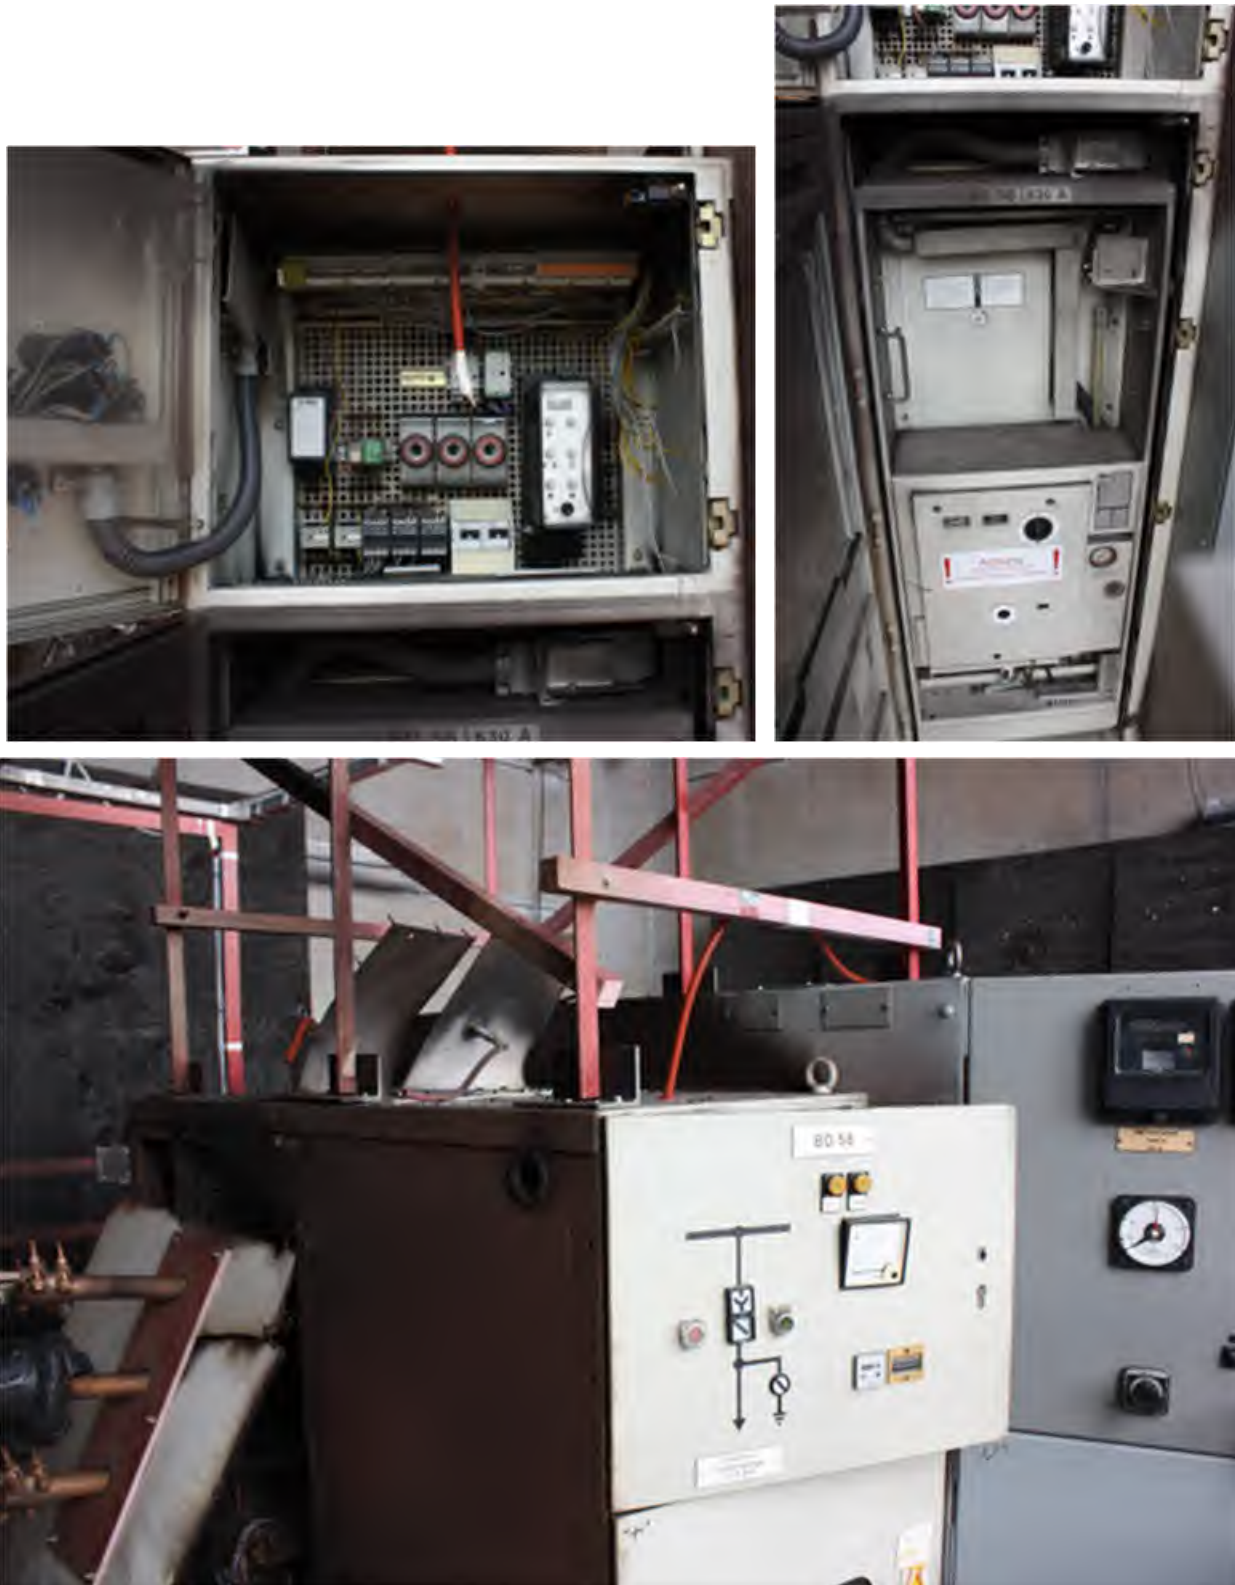
Fig. 183. Post-Experiment 2-36, Enclosure "H". Top-left – front instrument cubicle, Top-right – lower breaker cubicle, Bottom – exterior showing two panels re-oriented on top of enclosure, one panel on side completely disconnected from enclosure.

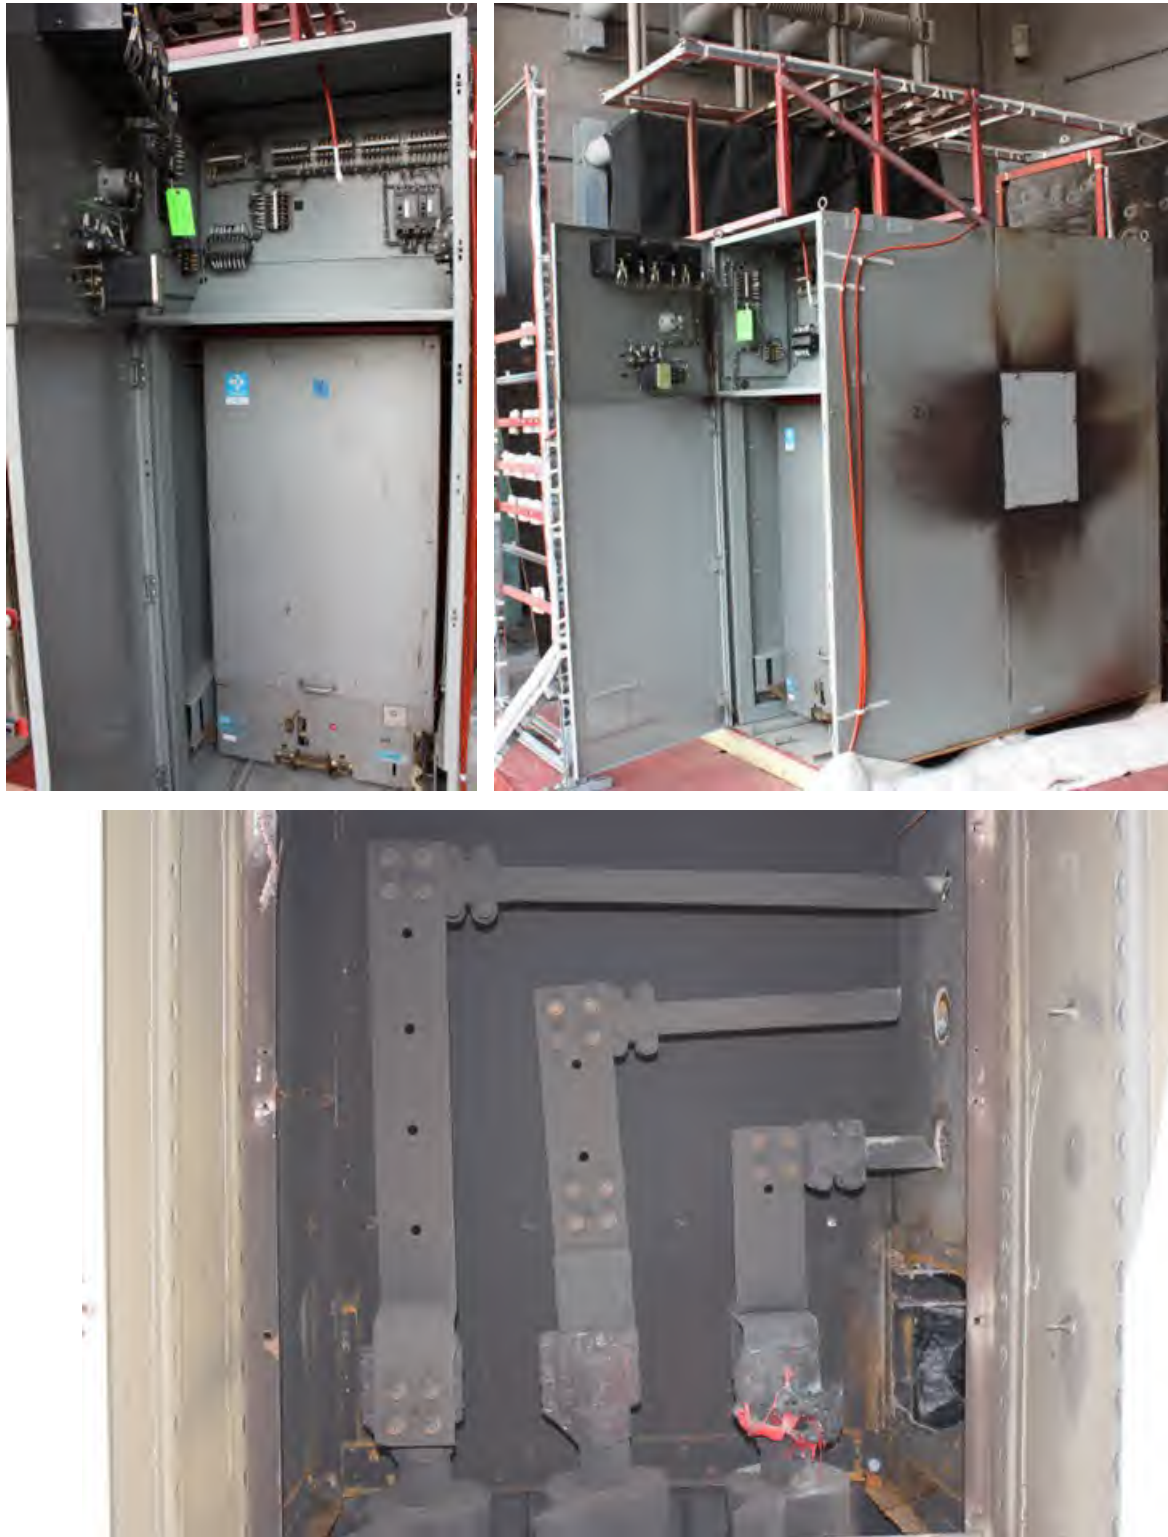
Fig. 184. Post-Experiment Enclosure "N". Top-left – front instrumentation and breaker cubicle, Top-right – side showing soot deposit near cover over main bus section of switchgear, Bottom – main bus section showing damage to horizontal copper bus.

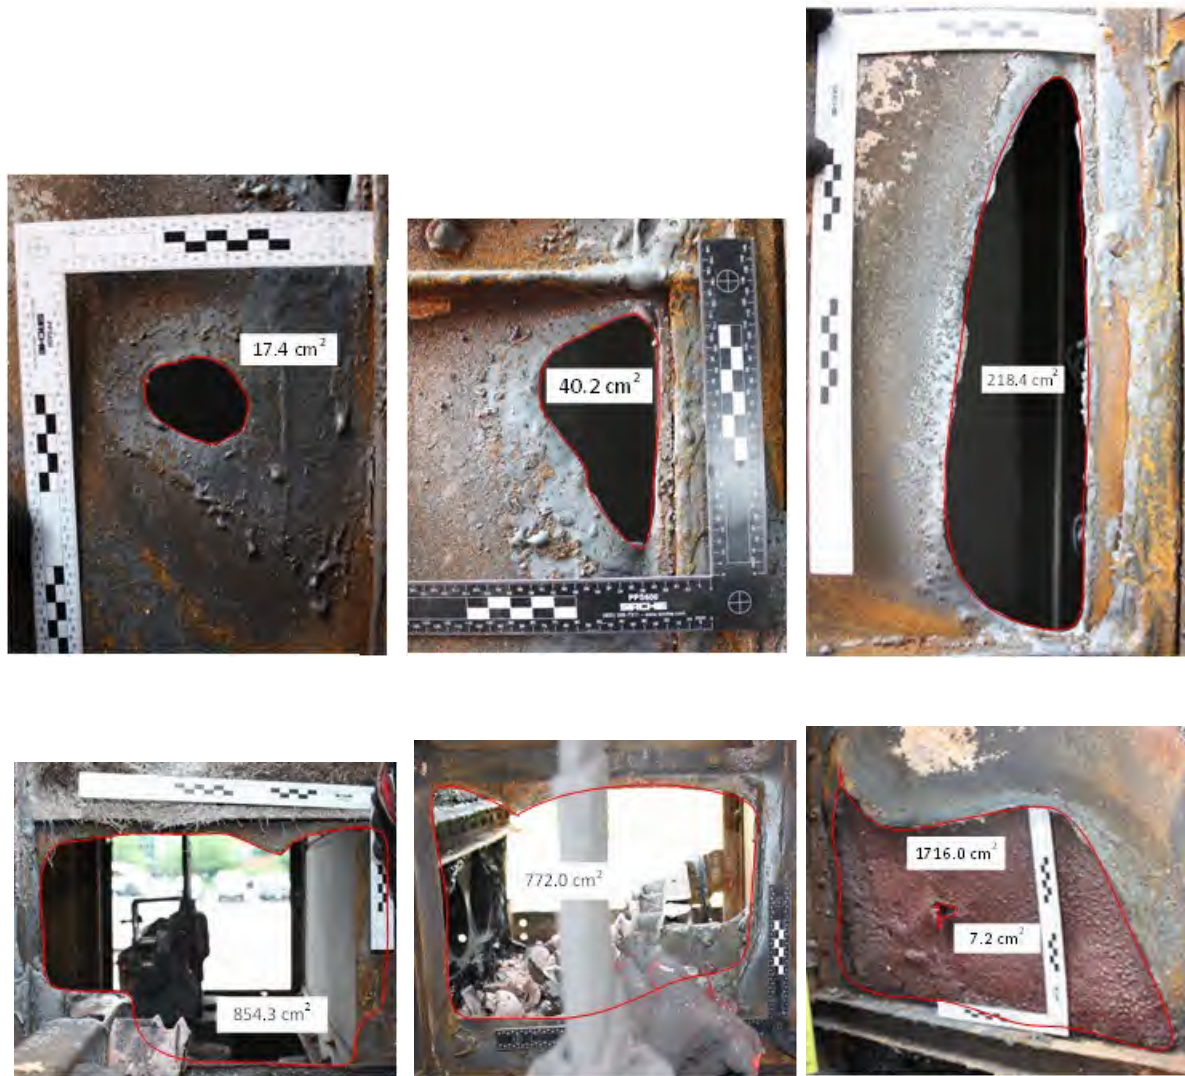
Fig. 185. Post-Experiment 2-36, Enclosure "H" breaches.

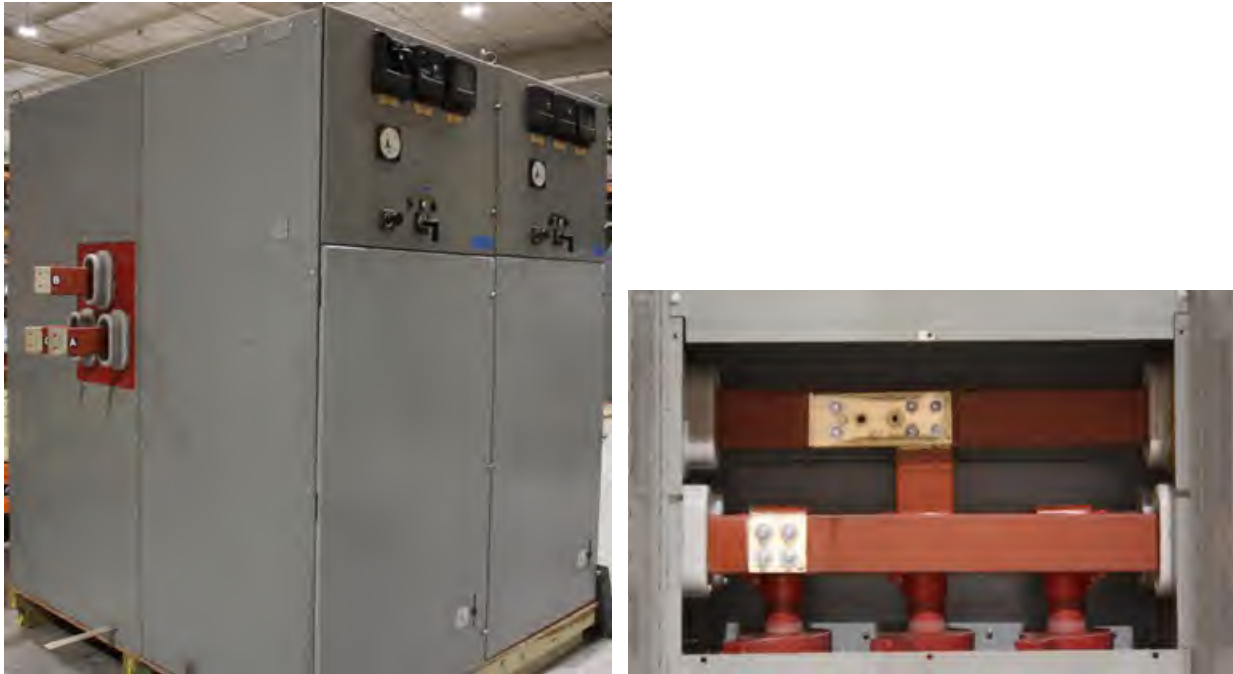
Fig. 186. Pre-Experiment 2-37 Enclosures “J” and “I”. Left – off angle view of Enclosure “J” (left) and “I” (right), Right – arc location main bus.

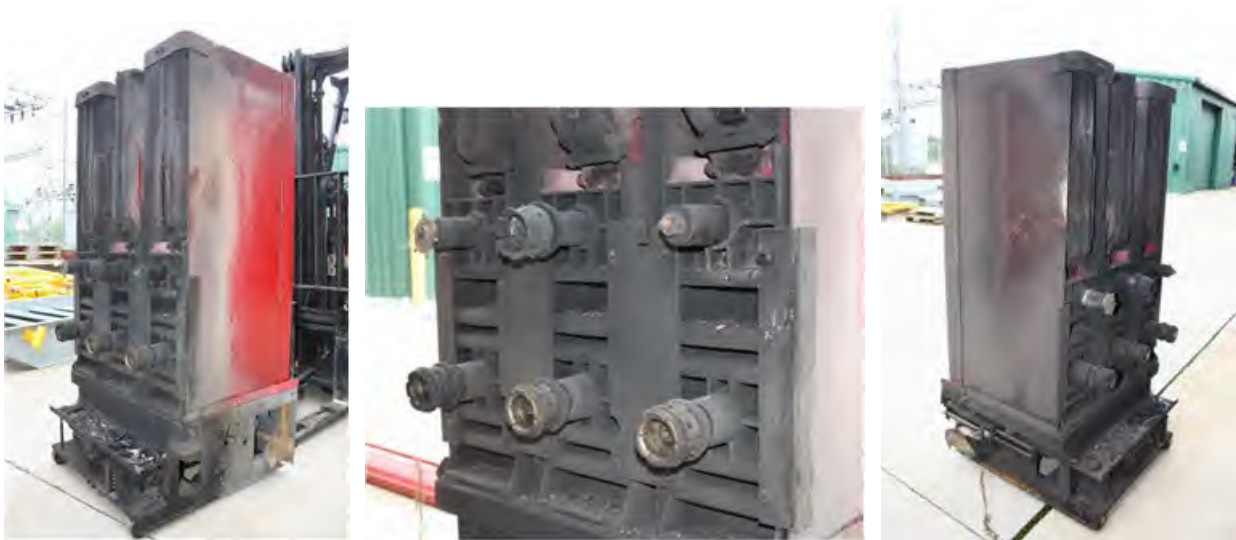
Fig. 187. Post-Experiment 2-37 Breaker. Left - rear angle view, Center – stab close-up, Right - rear angle view.

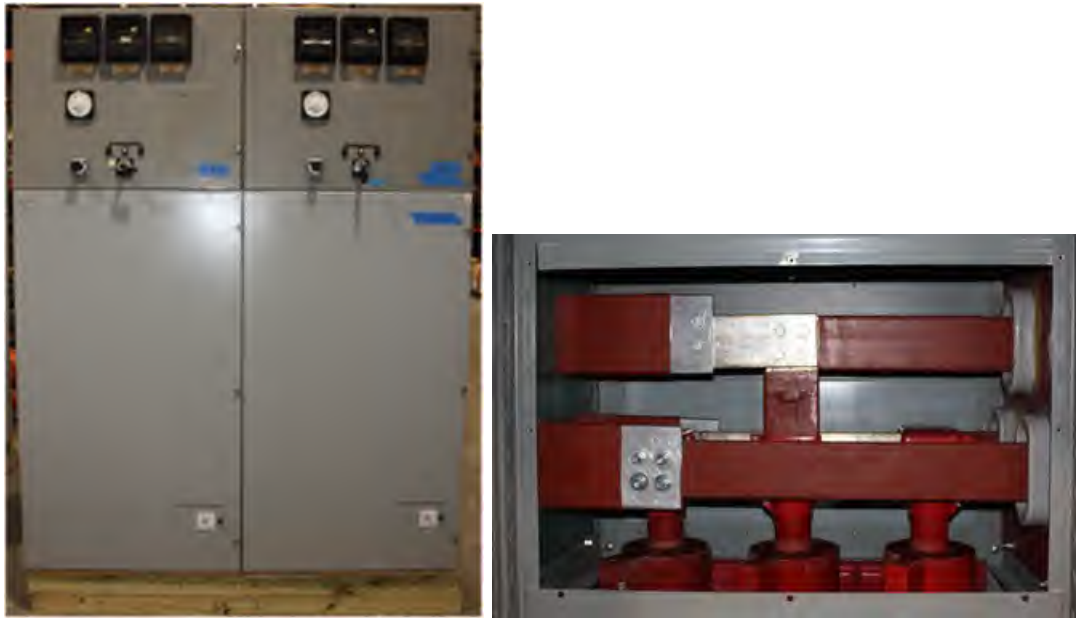
Fig. 189. Pre-Experiment 2-38 Enclosure “K” and “L”. Left - Enclosure “K” (left) and “L” (right), Right - arc location on main bus Enclosure “K”.

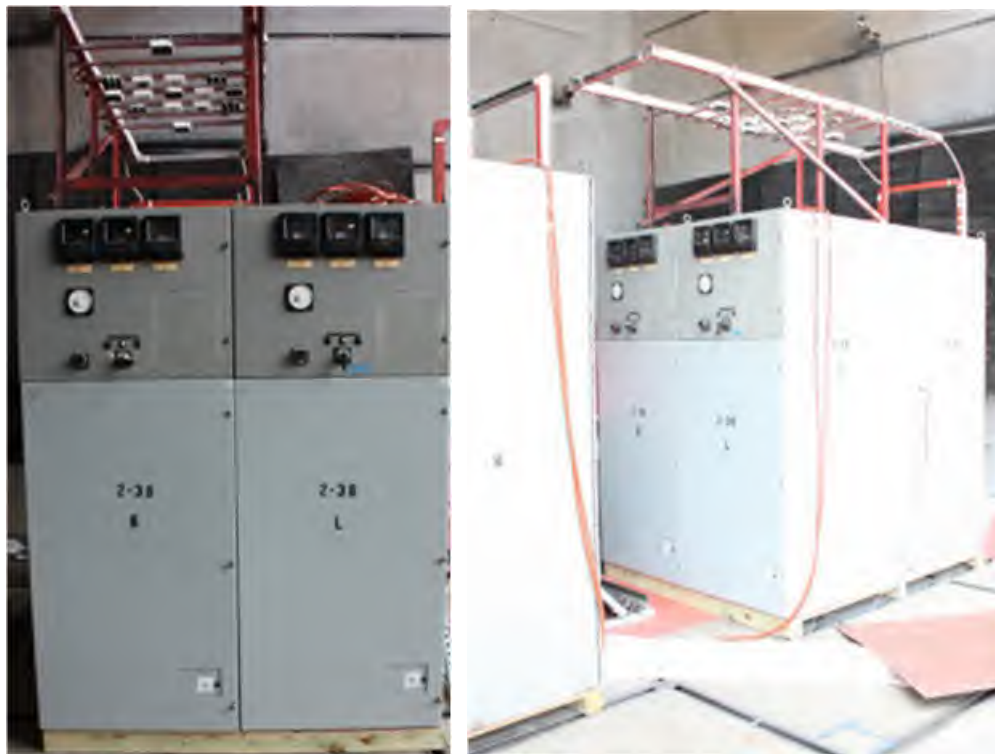
Fig. 190. Pre-Experiment 2-38 Enclosure “K” and “L”. Left – Enclosure “K” (left) and “L” (right). Right – general cross-aisle configuration with Enclosure “M” across from “L” and Enclosure “I” across from “K”.

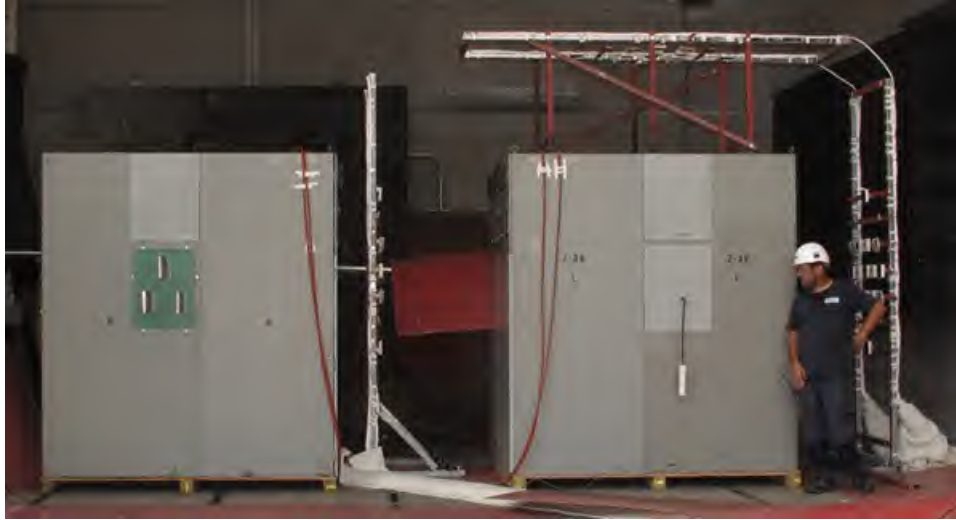
Fig. 191. Pre-experiment 2-38 Enclosure “M” and “L”. Front view of “cross-aisle” configuration. Arc initiated in Enclosure “K” located behind Enclosure “L”.

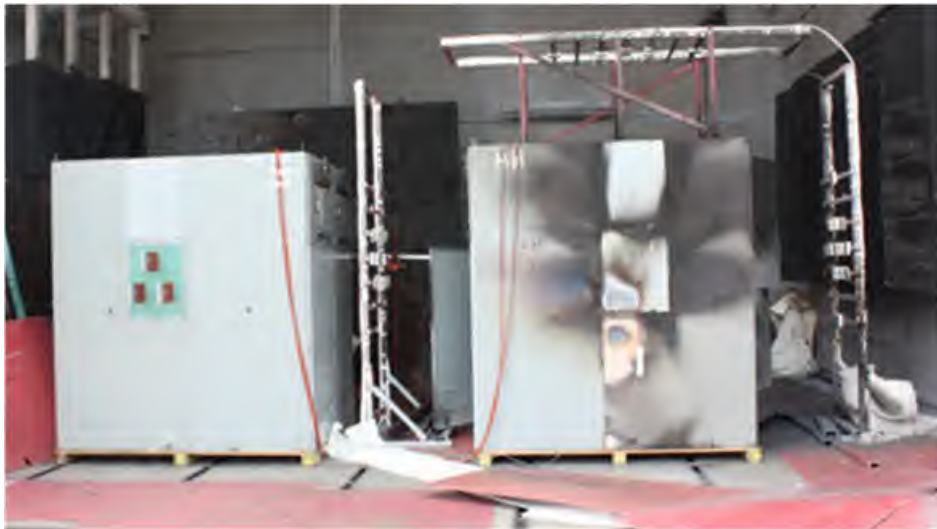
Fig. 192. Post-Experiment 2-38 Enclosure “M” and “L”. Front view of Enclosure “M” (left) with Enclosure “I” behind, and Enclosure “L” (right) with Enclosure “K” behind (where arc initiated).

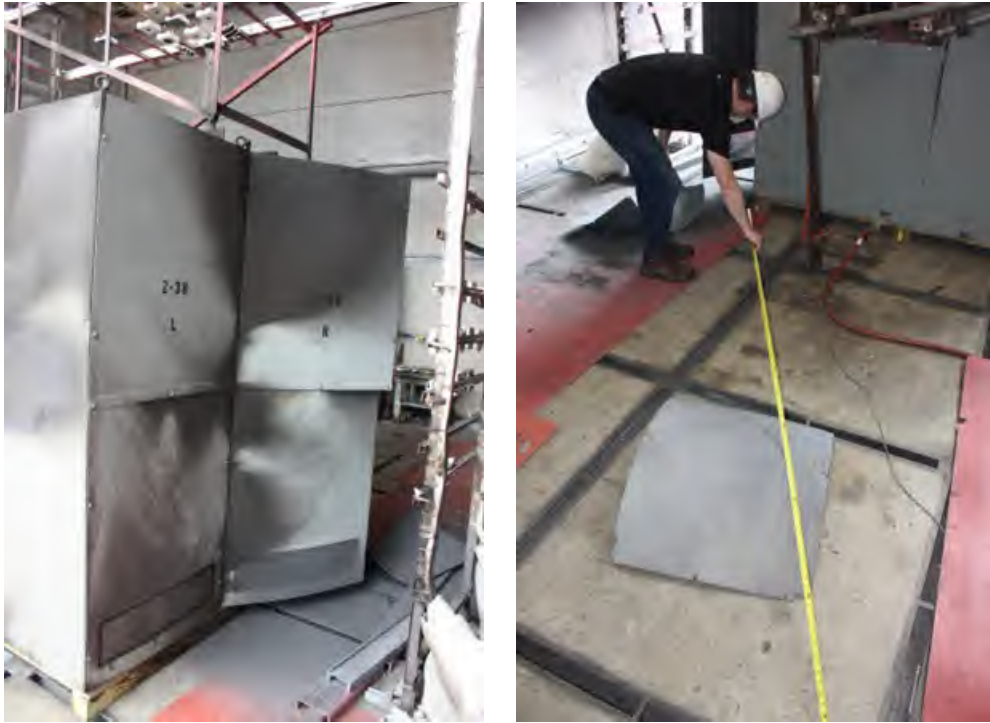
Fig. 193. Post-experiment 2-38 Enclosures “L” and “K”. Left - Enclosure "K" rear panel breach due to pressure, Right – measurement of rear internal panel distance from Enclosure “K” corner. Note that both internal panels surrounding main bus were ejected during experiment and located on floor. Farthest panel was approximately 3 m (10 ft) from enclosure, while nearest panel was approximately 0.9 m (3 ft) from enclosure.

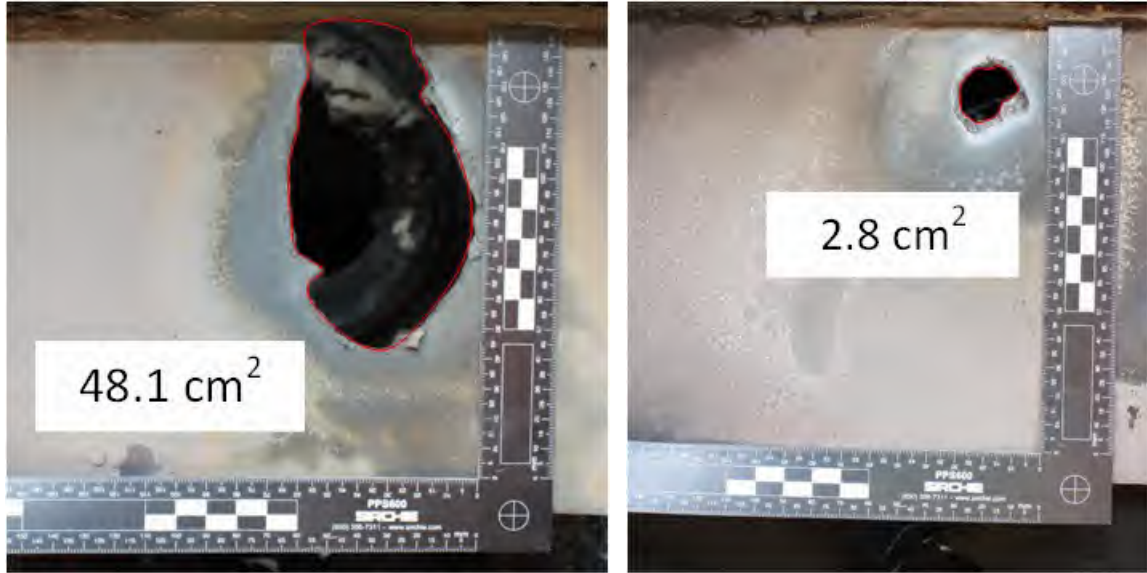
Fig. 195. Post-Experiment 2-38 Internal Breaches Enclosure "L".

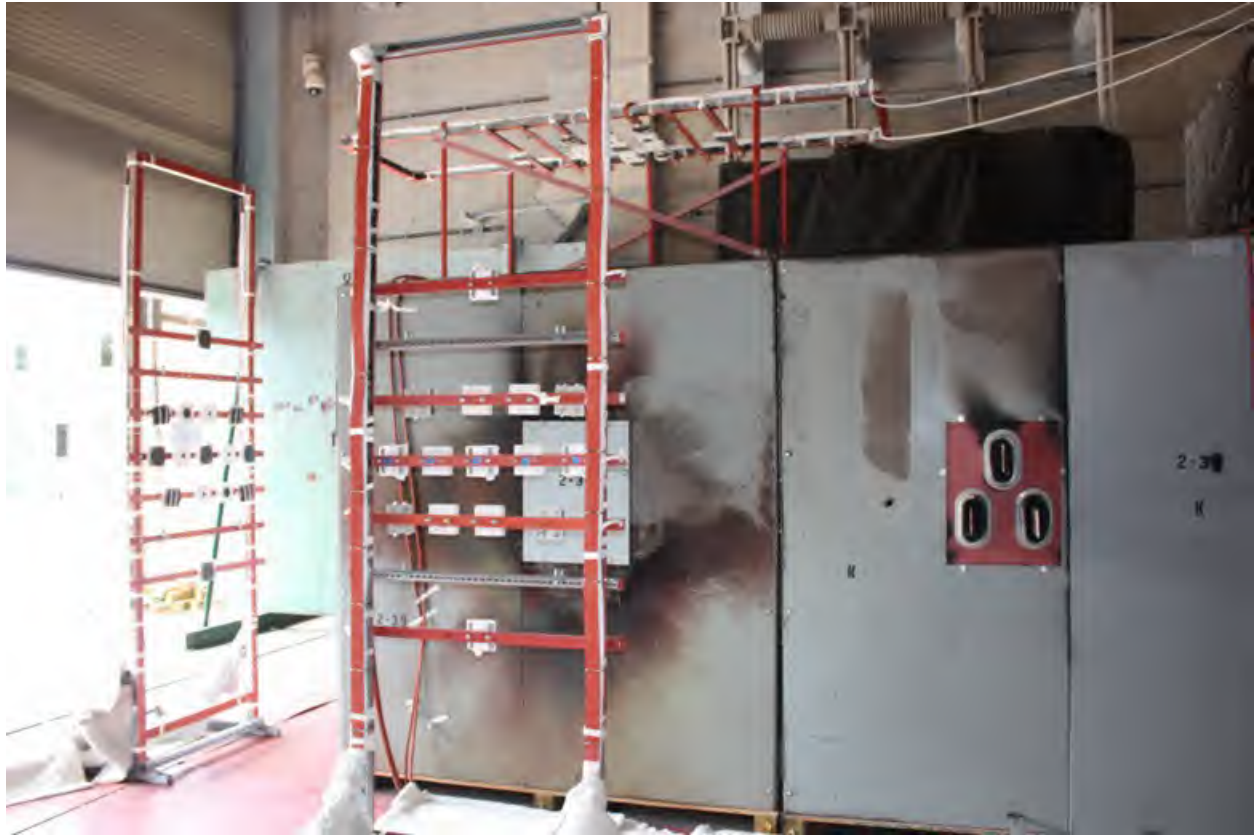
Fig. 196. Pre-Experiment 2-39 Enclosures "I" and "K". Enclosure "I" (left) and "K" (right), Enclosure "M" is next to Enclosure "I" (behind Enclosure "I" in photo) and Enclosure "L" is next to Enclosure "K" (behind Enclosure "K" in photo).

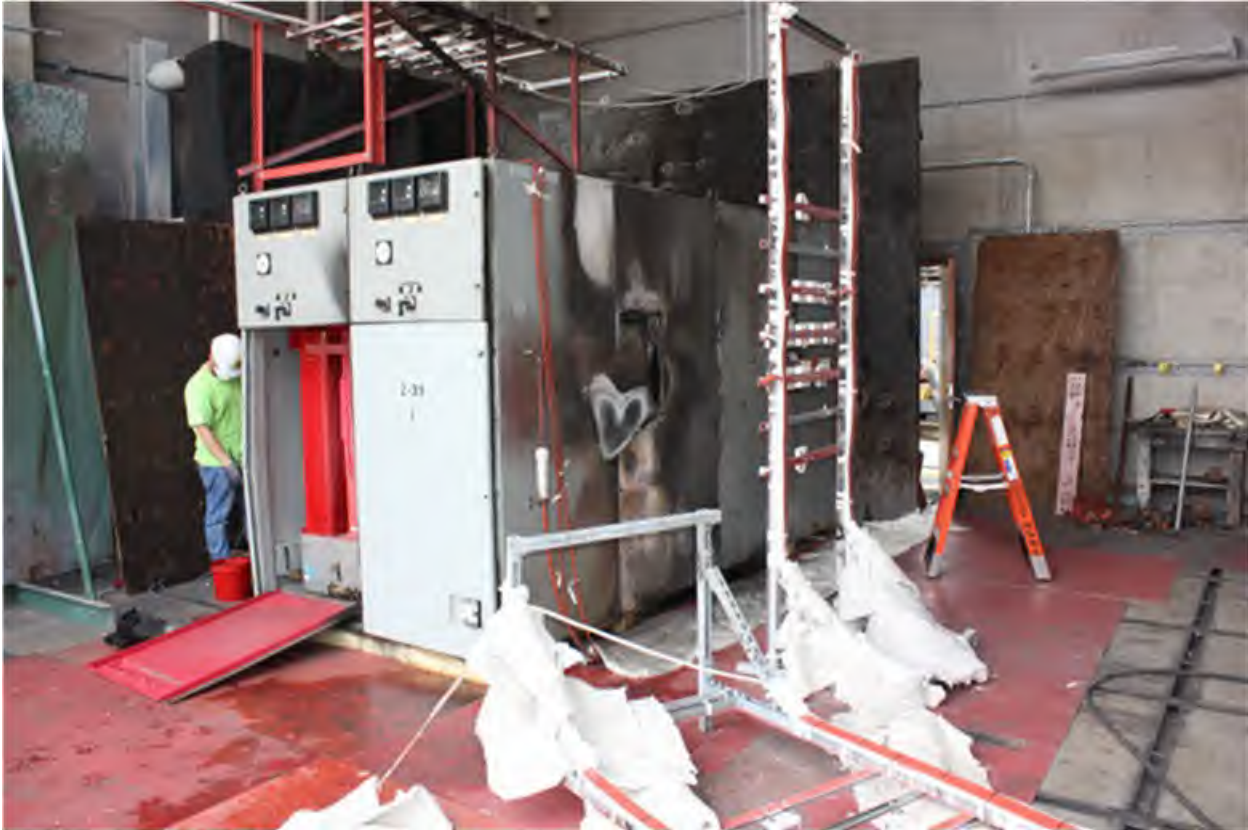
Fig. 197. Post-Experiment 2-39 Enclosures “M”, “I”, and “K”. Note door to Enclosure “M” is not in photo, instrument rack positioned in front of Enclosure “I” fell to the ground after impact from Enclosure “M” door.

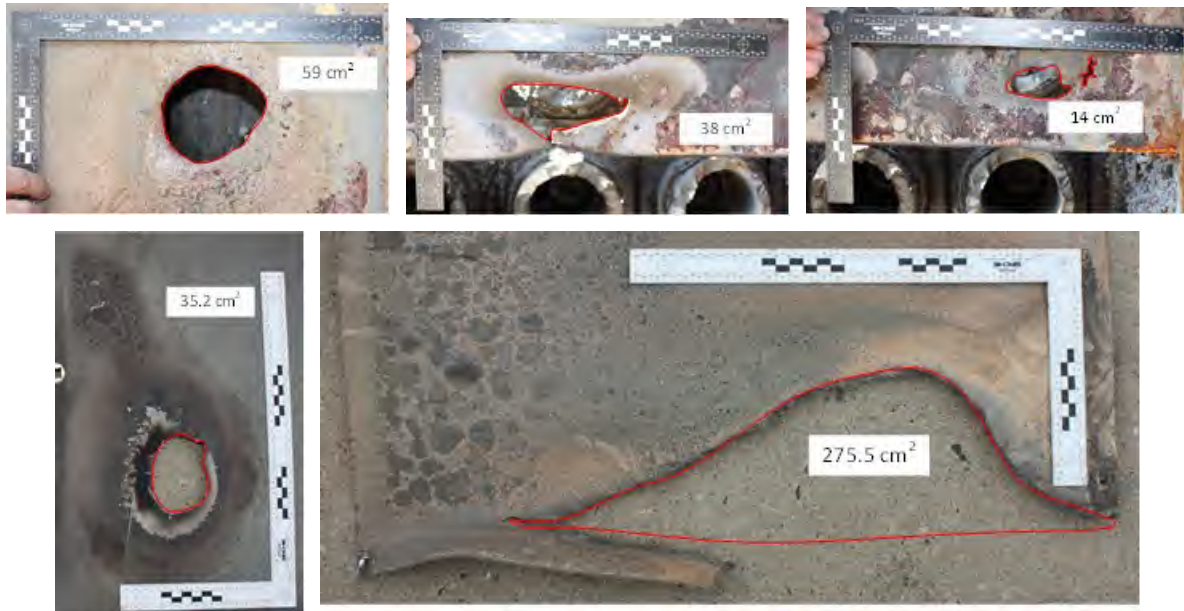
Fig. 198. Post-Experiment 2-39 Enclosure “M” Breaches. Top – internal panels near secondary run-backs, Bottom – internal bottom bus panels.

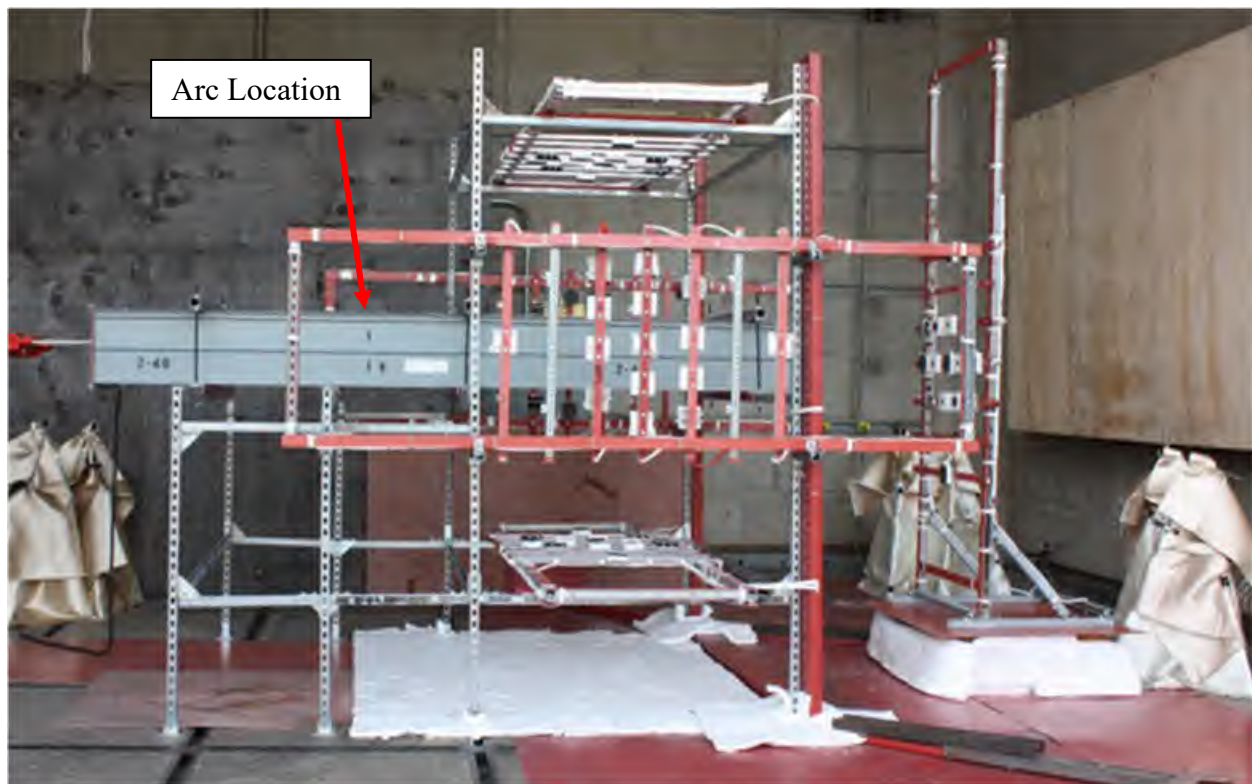
Fig. 201. Pre-Experiment 2-40 Bus Duct. Duct and instrument rack configuration prior to experiment, arc initiated at arrow.

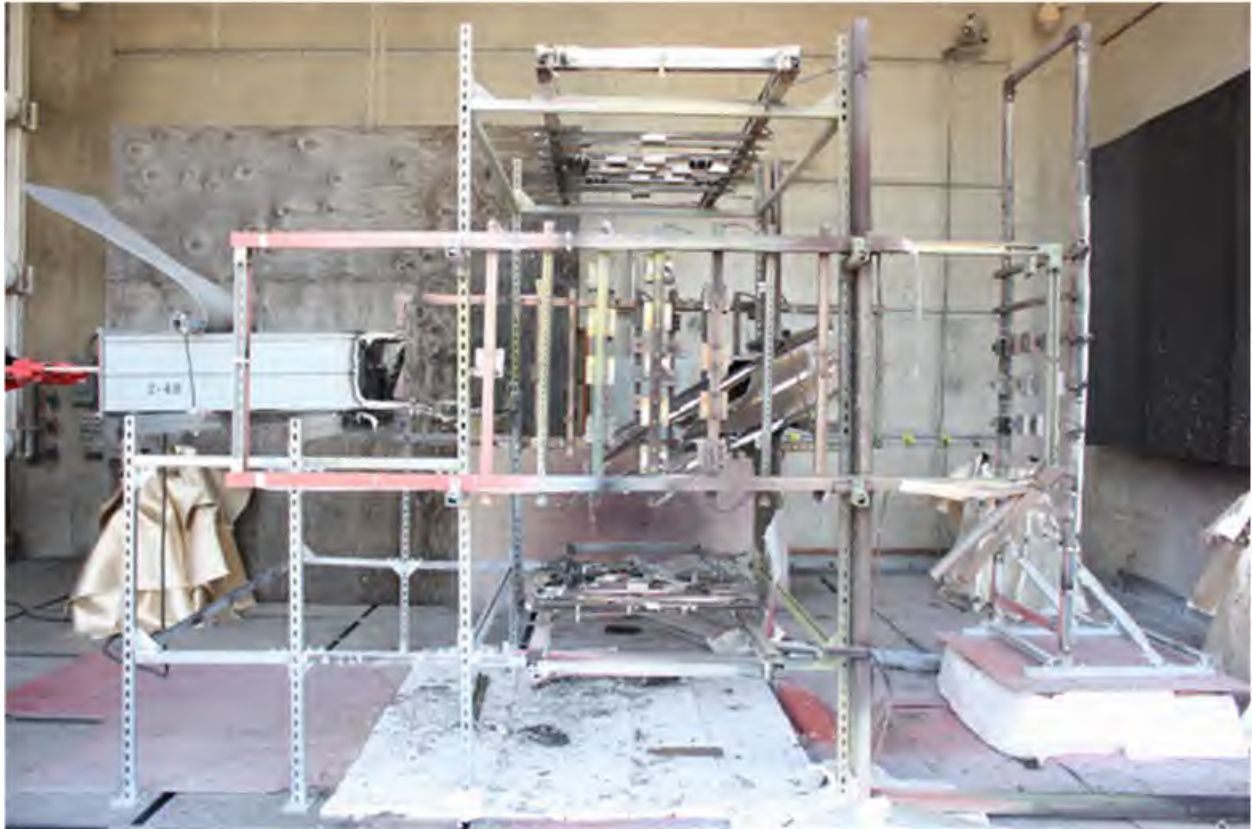
Fig. 202. Post-Experiment 2-40 Bus Duct. Duct severed with a portion resting on the support structure.

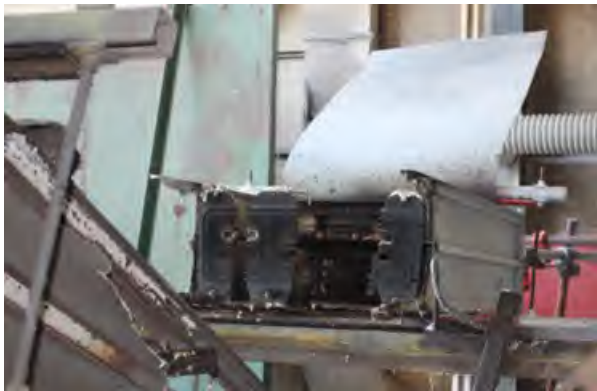
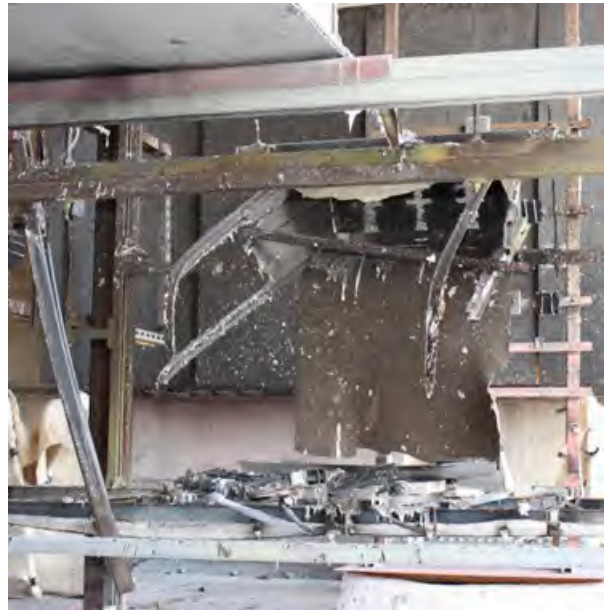
Fig. 203. Post-Experiment 2-40 Bus Duct. Left – horizontal duct with copper bars at support, Right – end of severed duct as viewed from incoming power side.

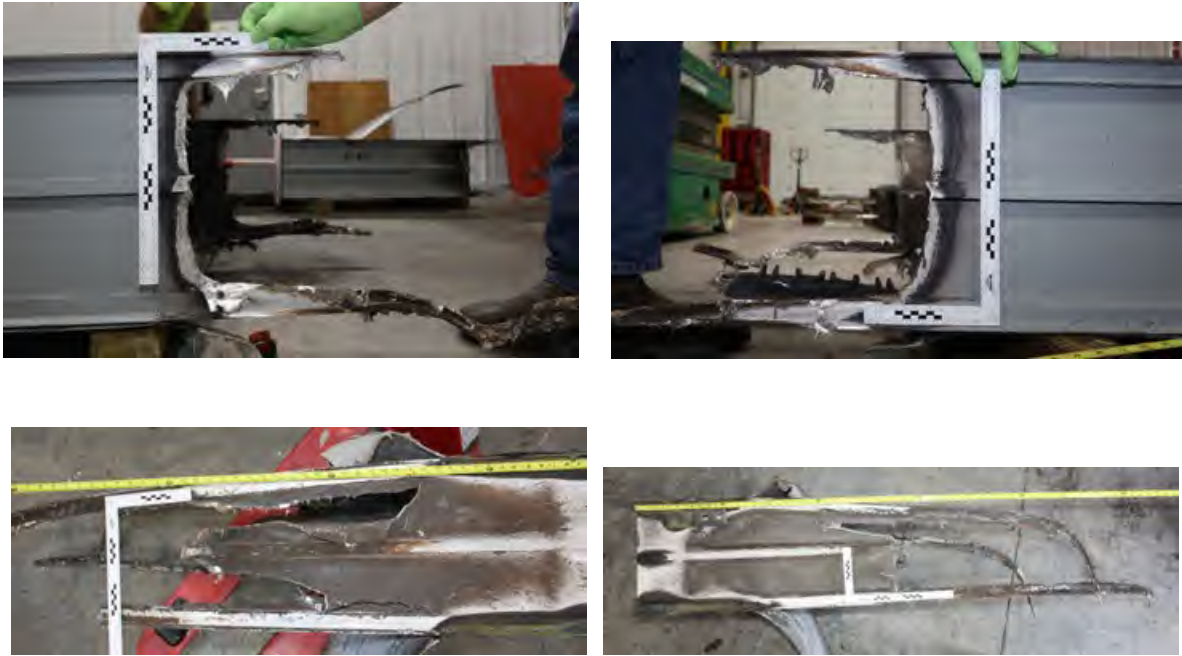
Fig. 204. Post-Experiment 2-40 Duct Enclosure Breach.

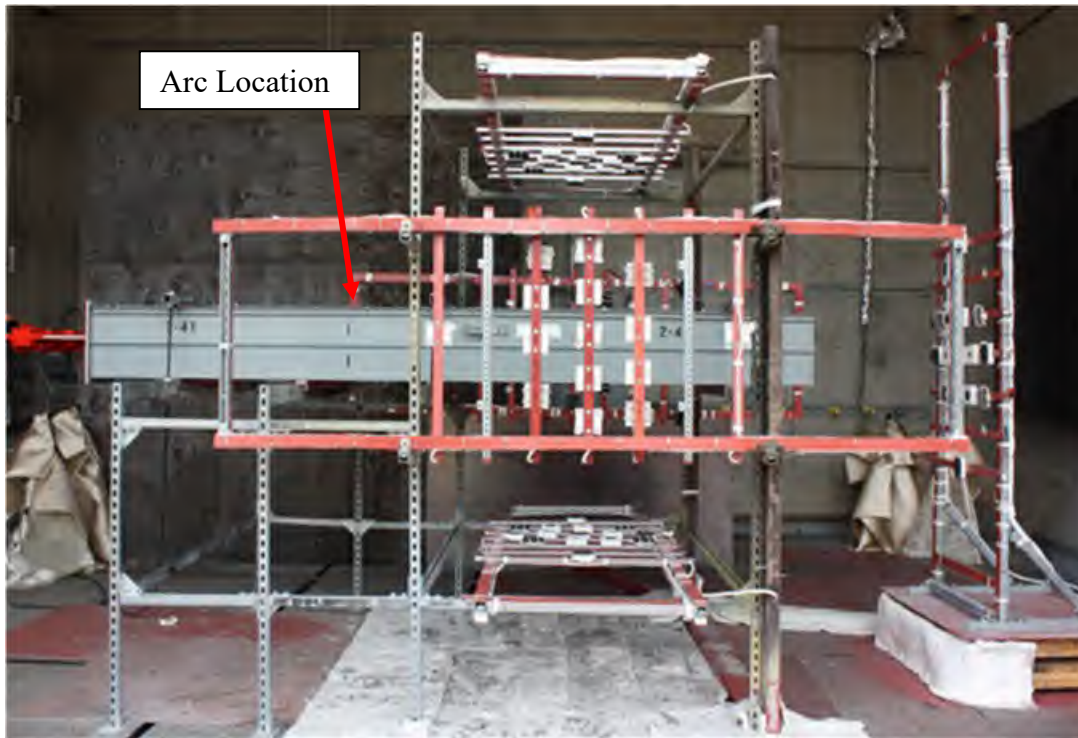
Fig. 205. Pre-Experiment 2-41 Bus Duct. Duct and instrument rack configuration prior to experiment.

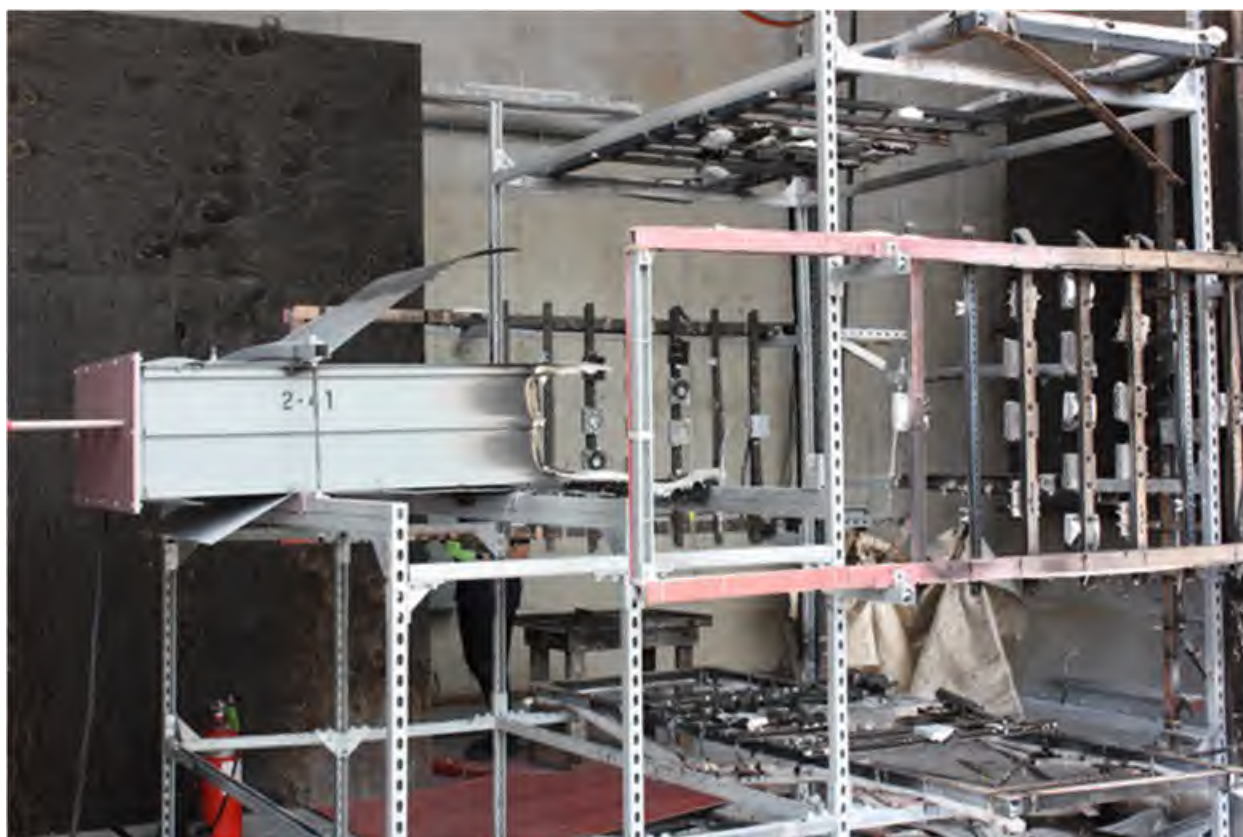
Fig. 206. Post-Experiment 2-41 Bus Duct. View of remaining duct from power side.

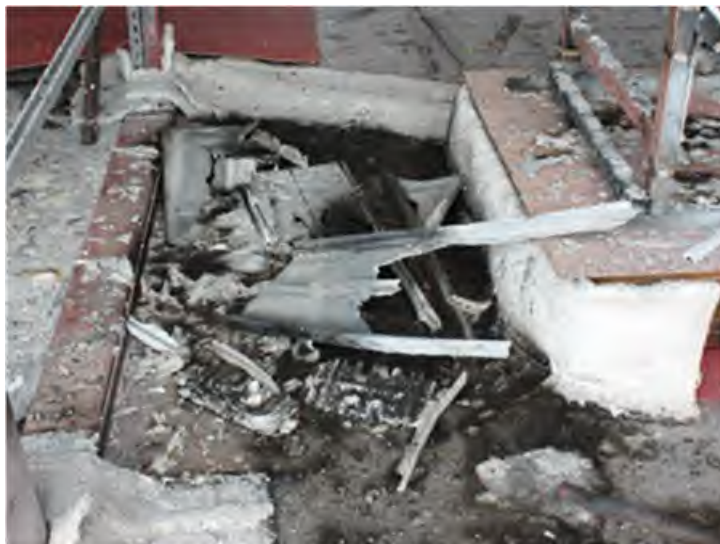
Fig. 208. Post-Experiment 2-41 Bus Duct. Remaining bus duct enclosure located on ground after experiment.

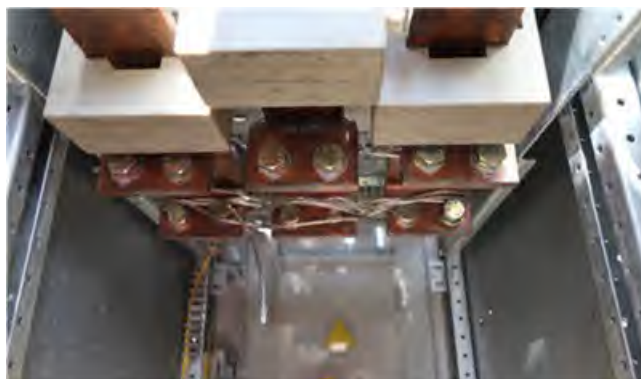
Fig. 213. Pre-Experiment 2-XXA. Arcing wire location.

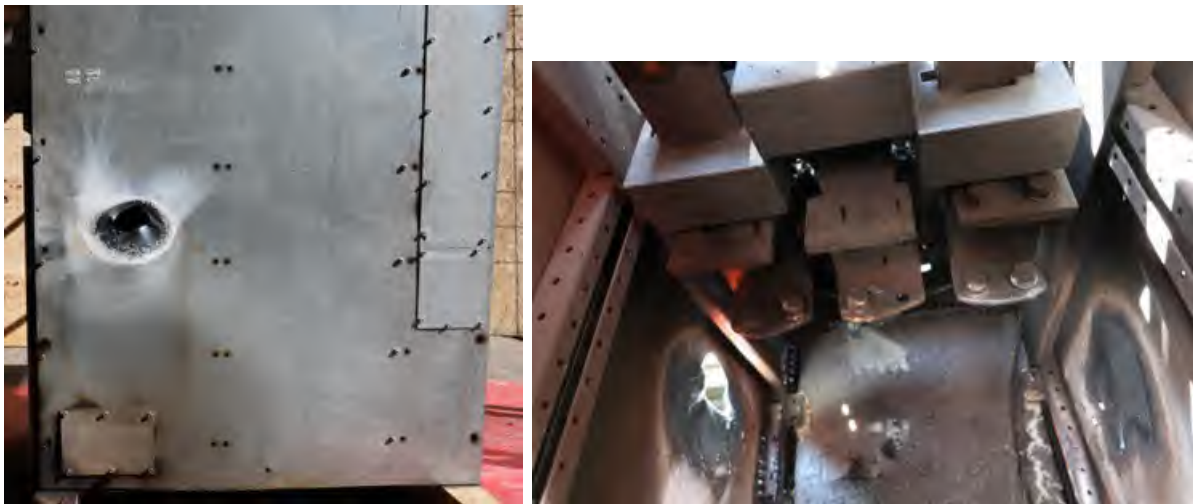
Fig. 215. Post-Experiment 2-XXA. Left – enclosure breach on right side of gear (cladding 1.5 mm [0.060 in] thick), Right – internal bus bar condition at arcing location.

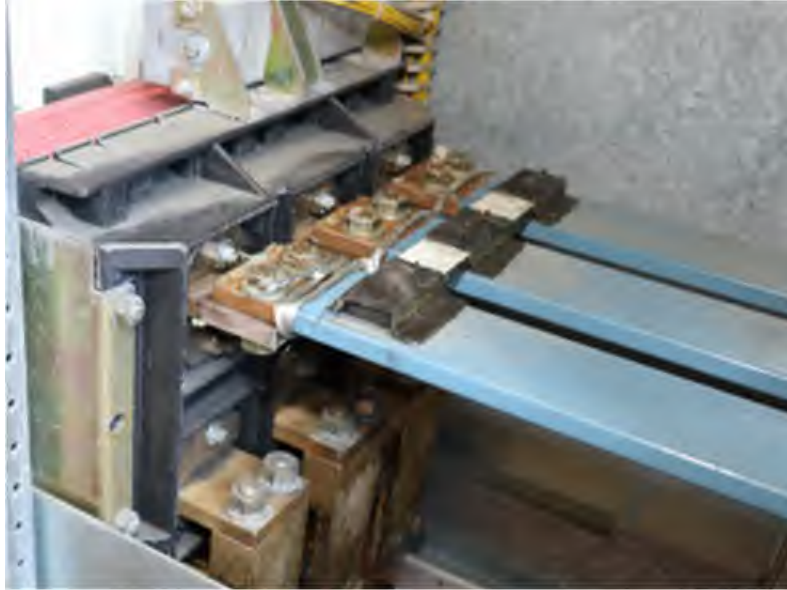
Fig. 219. Pre-Experiment 2-YYA arcing wire location.

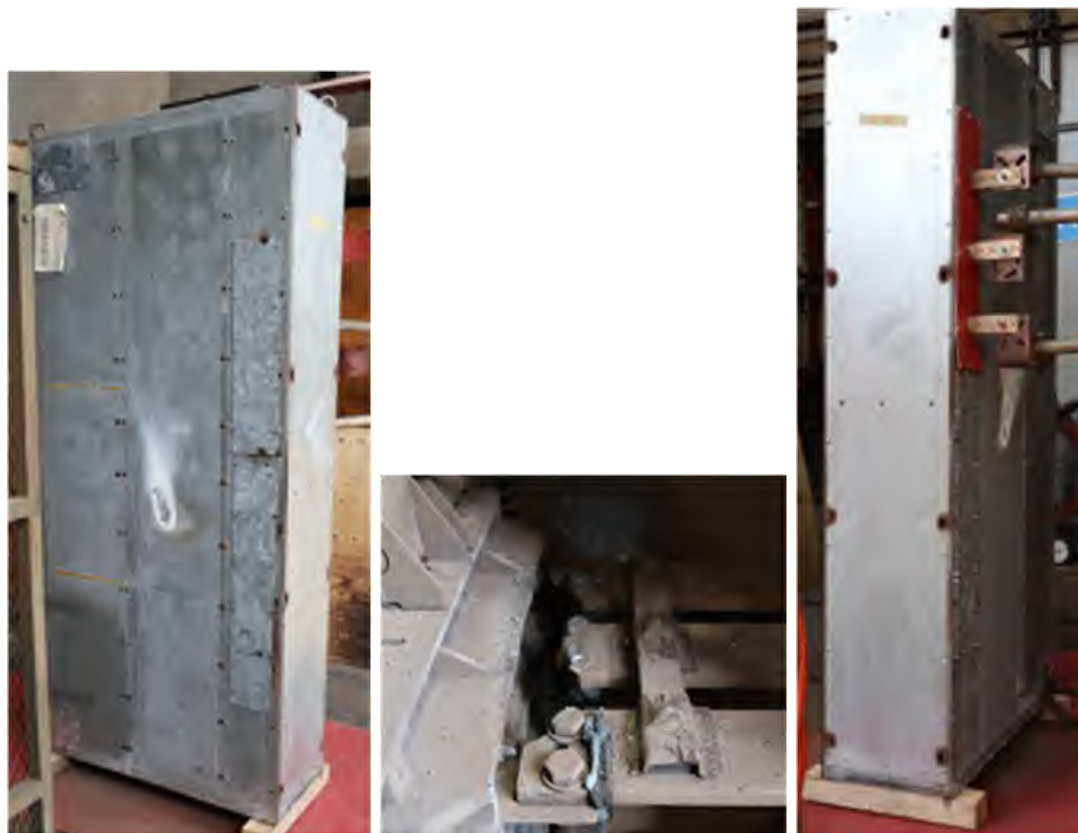
Fig. 221. Post-Experiment 2-YYA. Left – Enclosure heat damage on right side (opposite incoming power supply), Center – bus bars at arc initiation location, Right – Enclosure heat damage on left side (incoming power supply side).
