# Understanding High Energy Arcing Faults

Course No: E05-018

*This course was adapted from the NIST U.S. Department of Commerce, Publication No. NIST TN 2290, “Report on High Energy Arcing Fault Experiments”, which is in the public domain.*

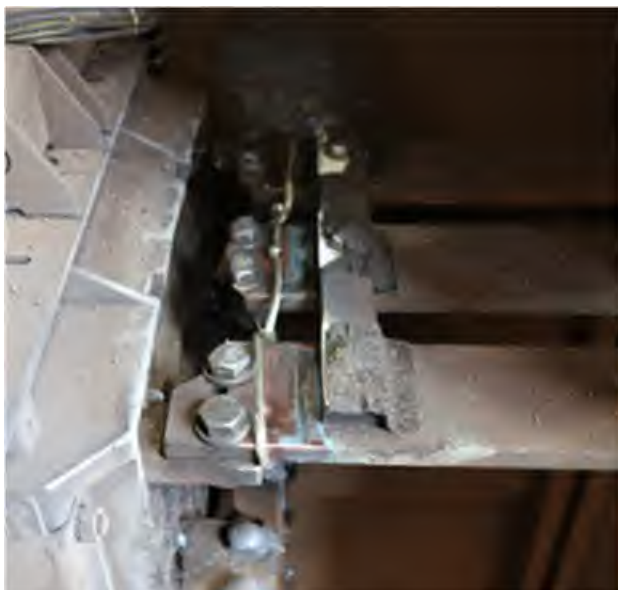
Fig. 222. Pre-Experiment 2-YYA. Arcing wire location.

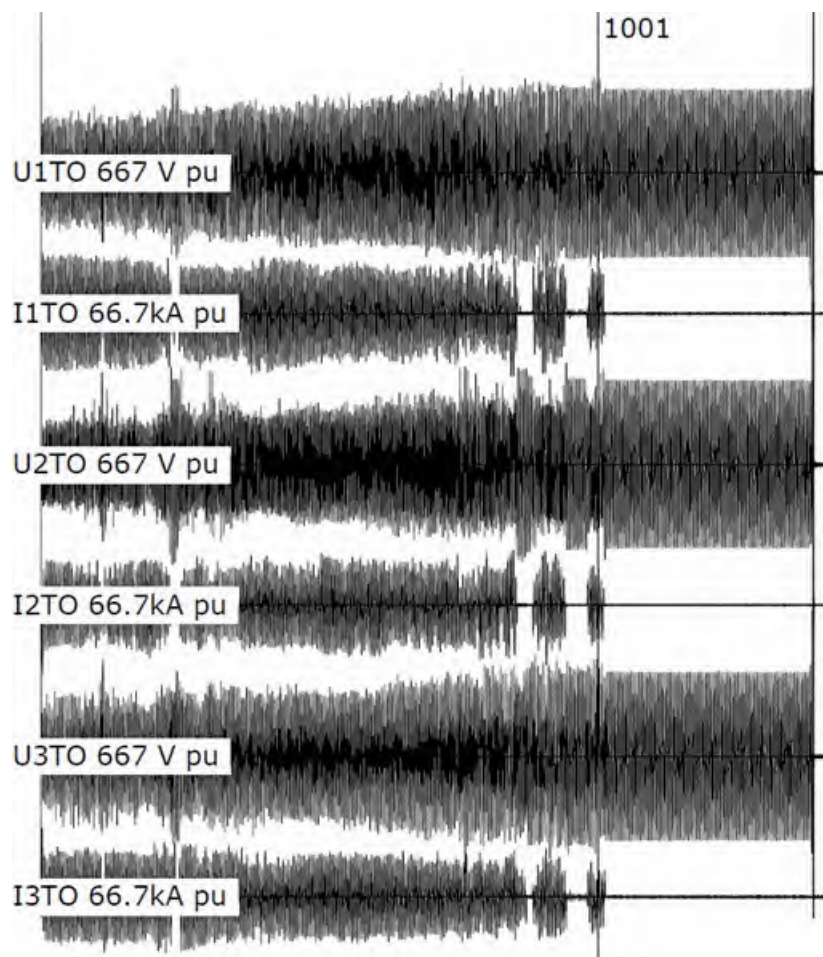
Fig. 223. Experiment 2-YYB. Electrical data readout.

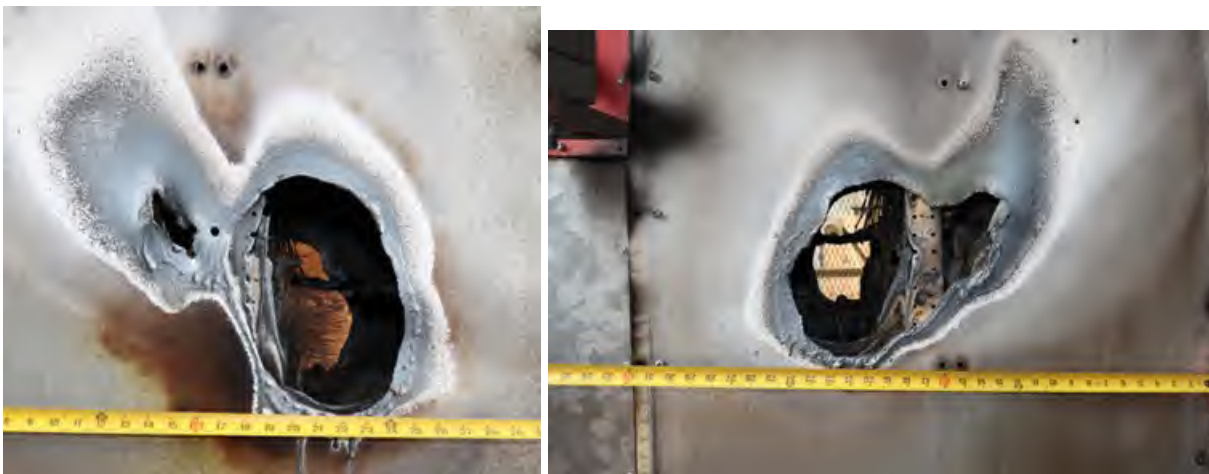
Fig. 224. Post-Experiment 2-YYB Enclosure Breaches. Left - enclosure breach on right side of enclosure (opposite incoming power supply), Right – enclosure breach on left side of enclosure (incoming power supply side). (cladding 1.5 mm [0.060 in] thick).

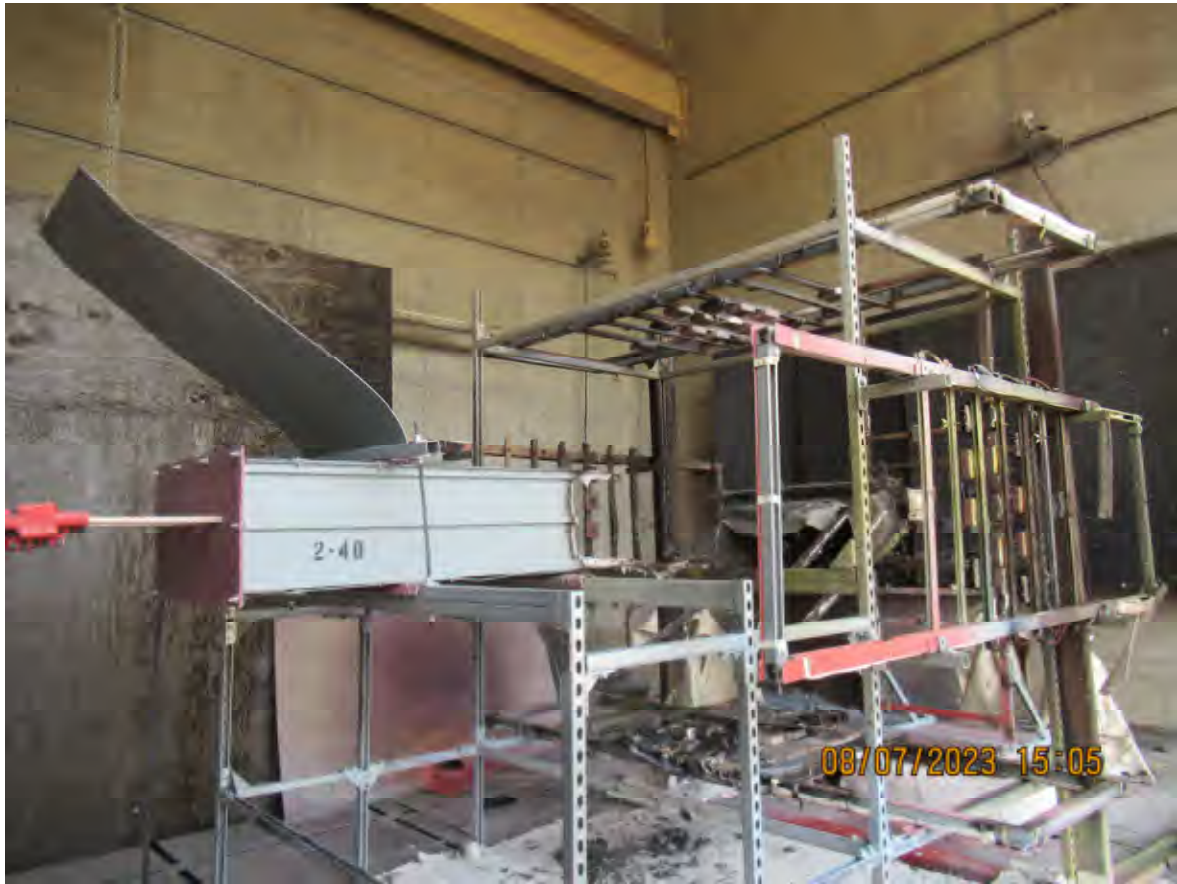
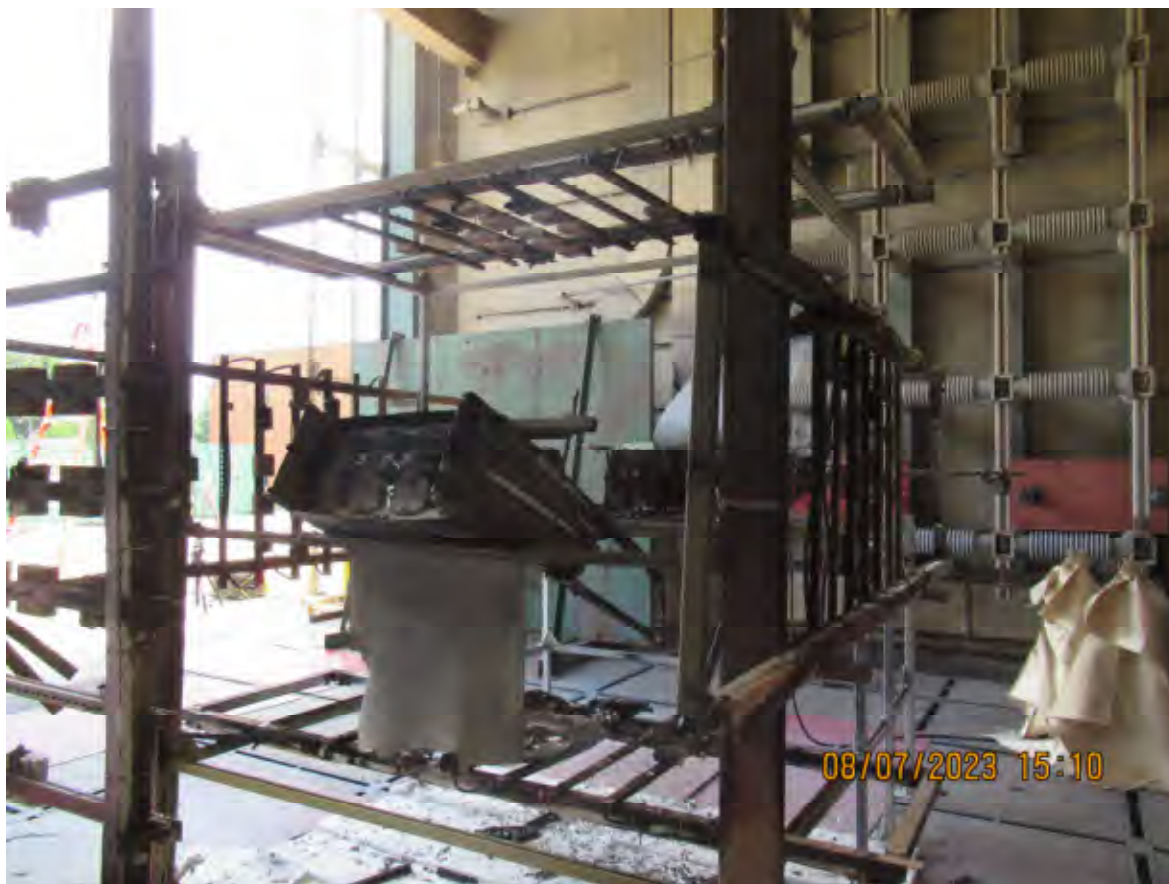
**5.6 Photograph after test**

Heavy damage to the bus duct. Majority of enclosure vaporized.

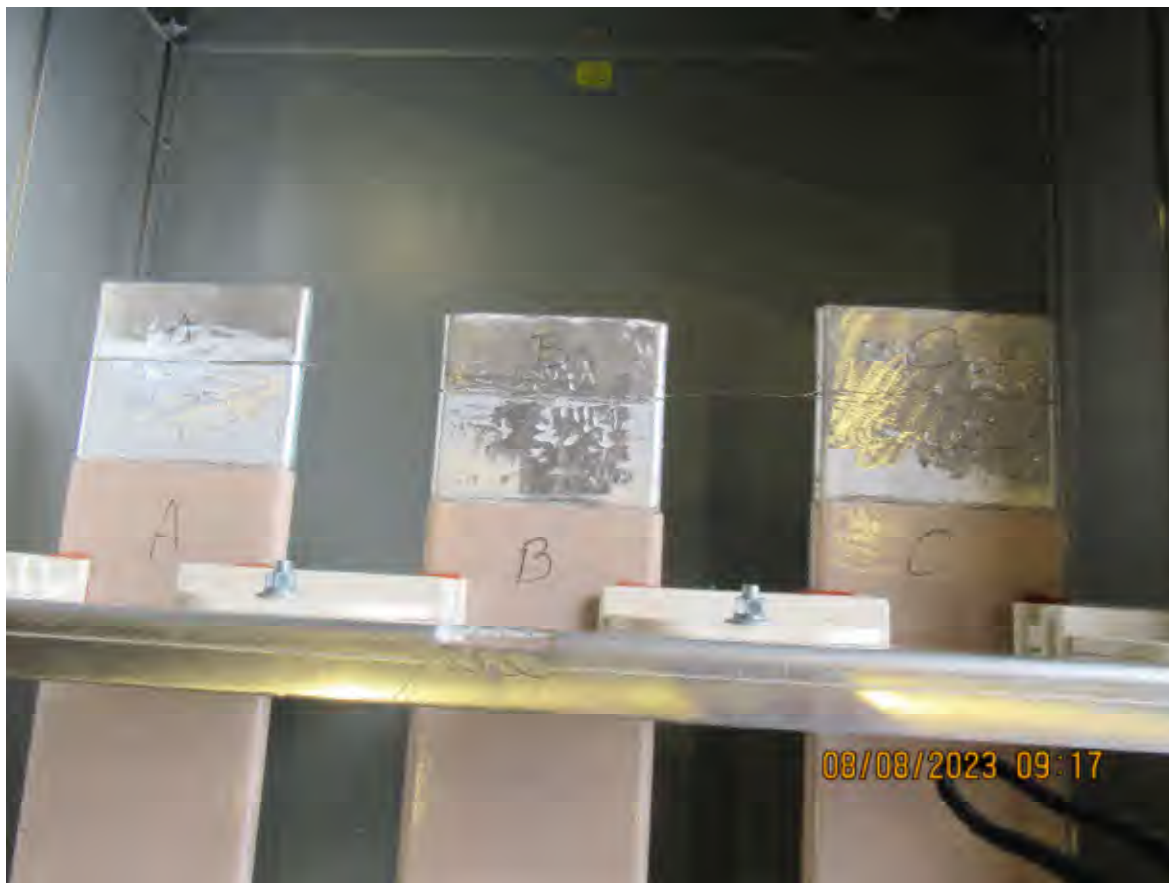
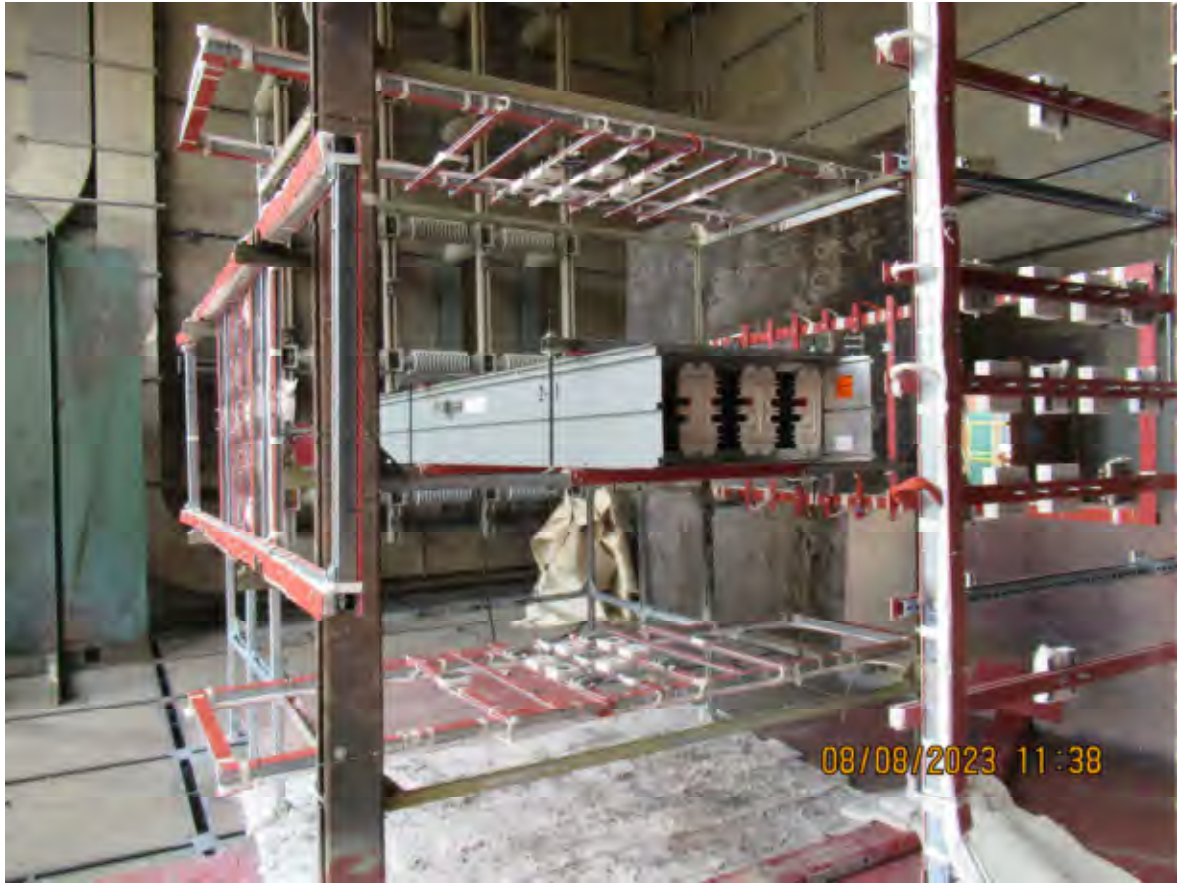
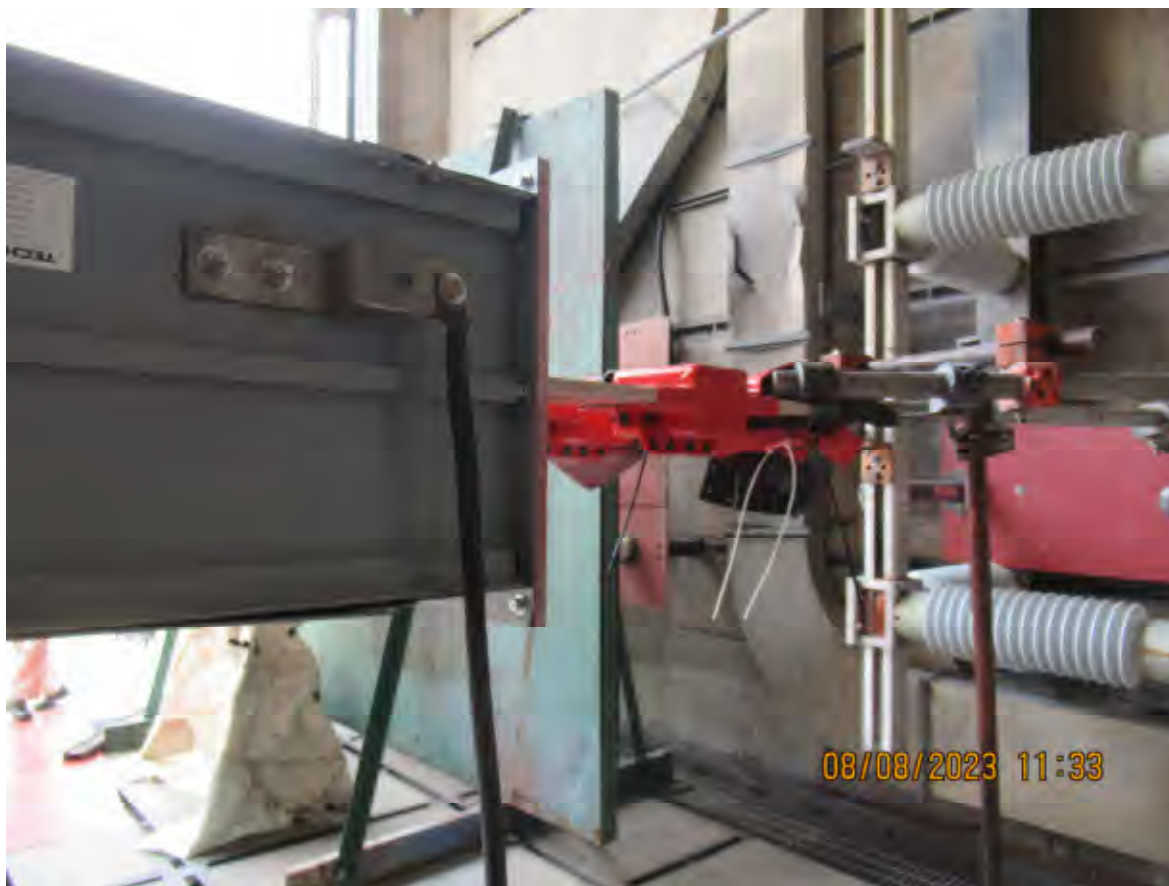
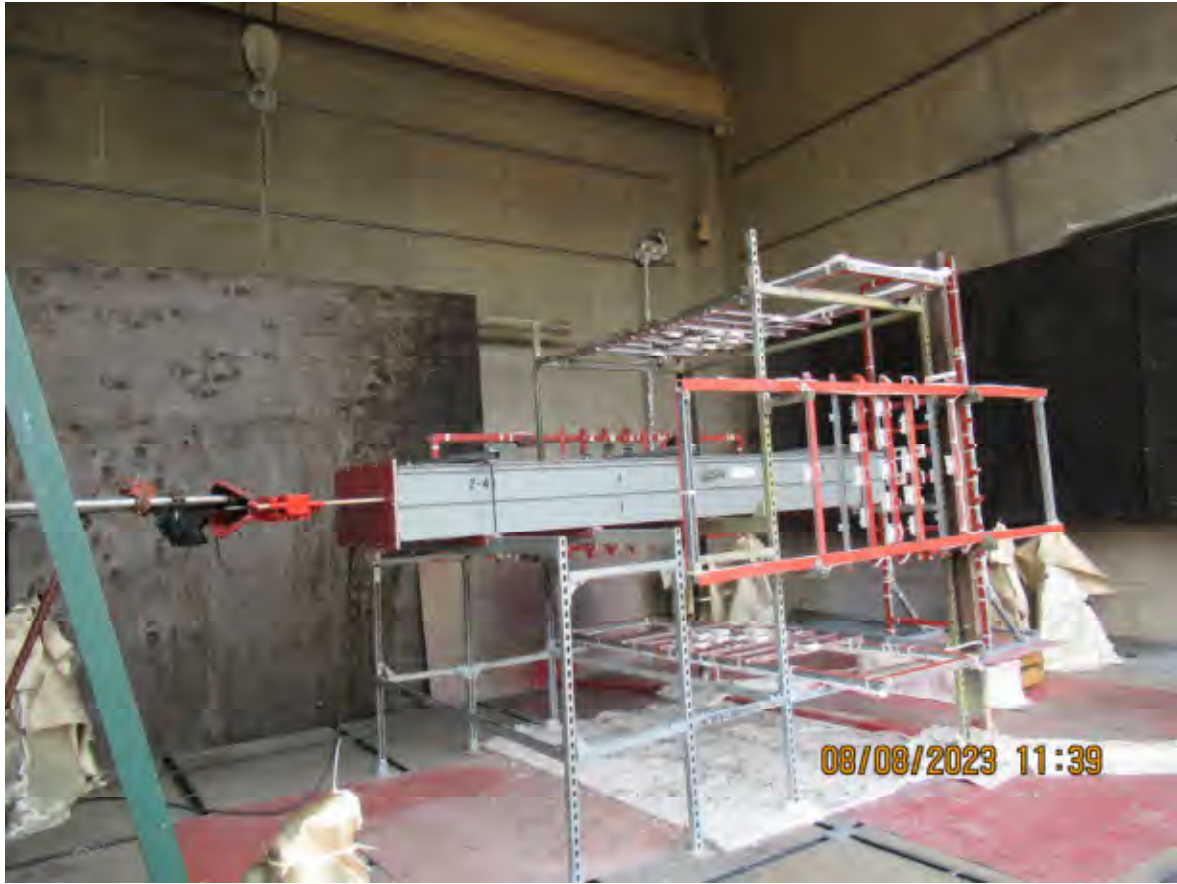
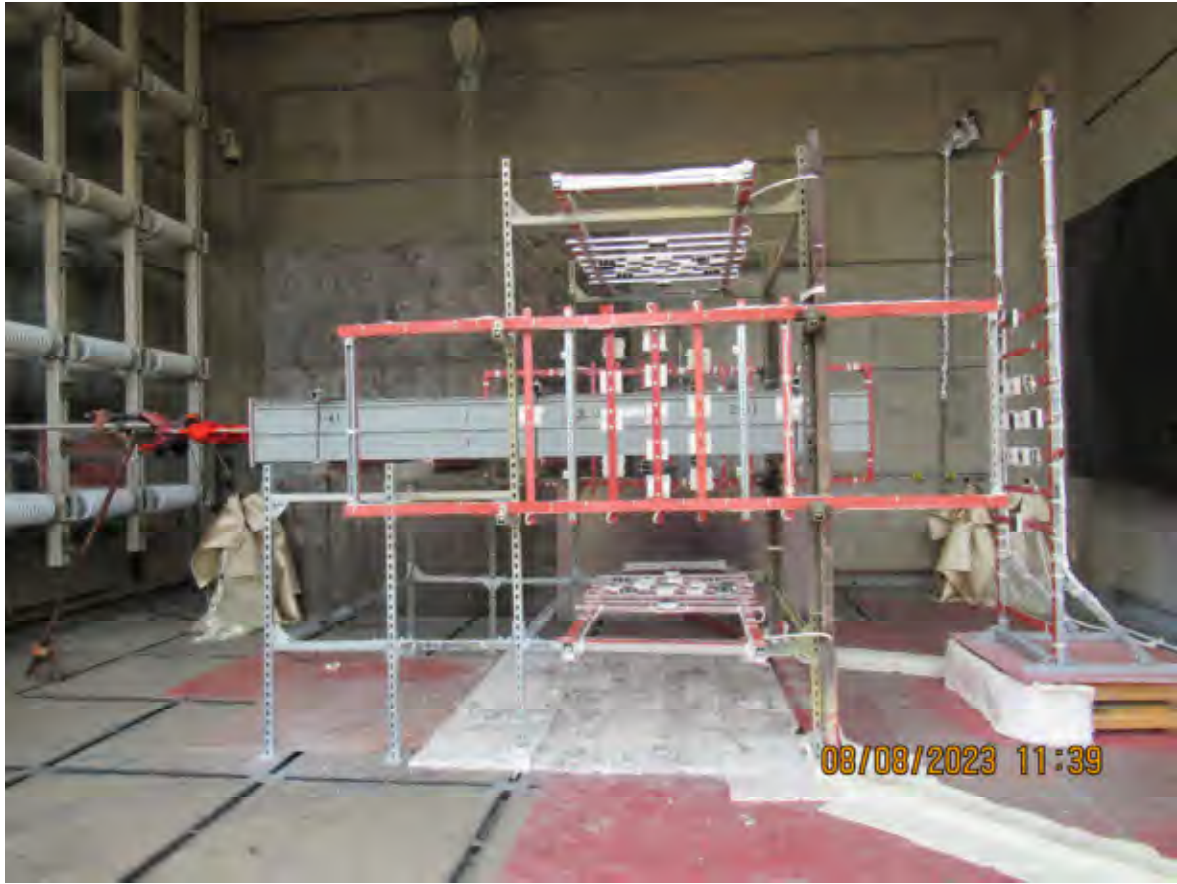
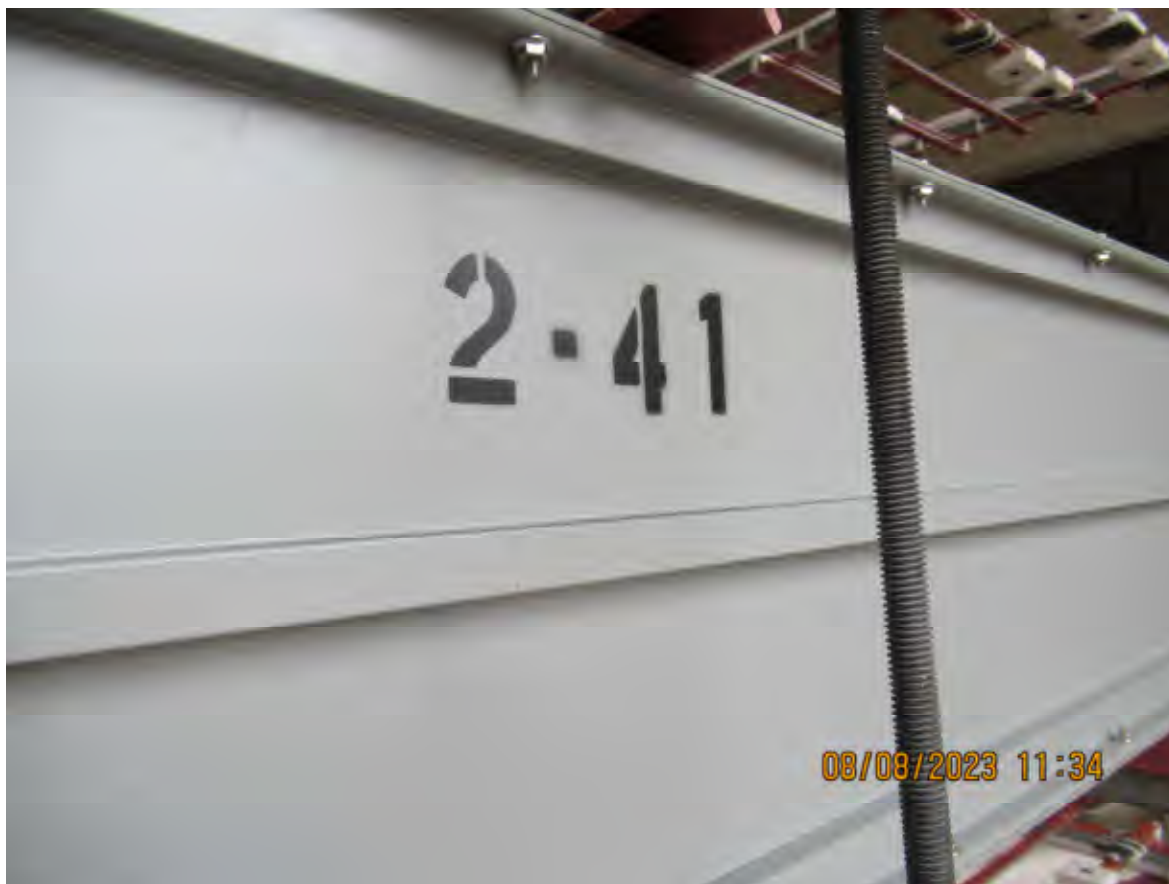
**6.3 Photograph before test**

Supply		
Power	MVA	216
Frequency	Hz	60
Phase(s)		3
Voltage	kV	4.19
Current	kA	30
Impedance	$\Omega$	0.0801
Power factor		< 0.1
Neutral		not earthed

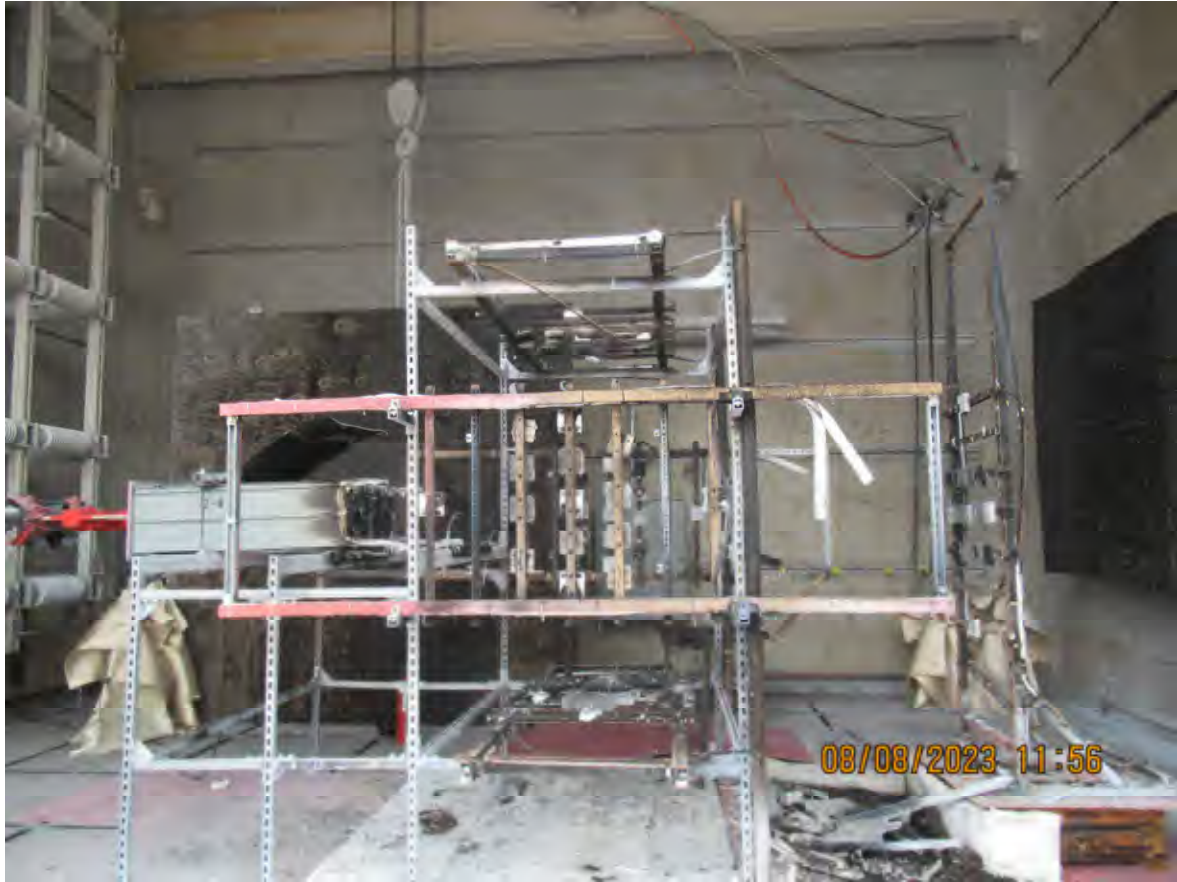
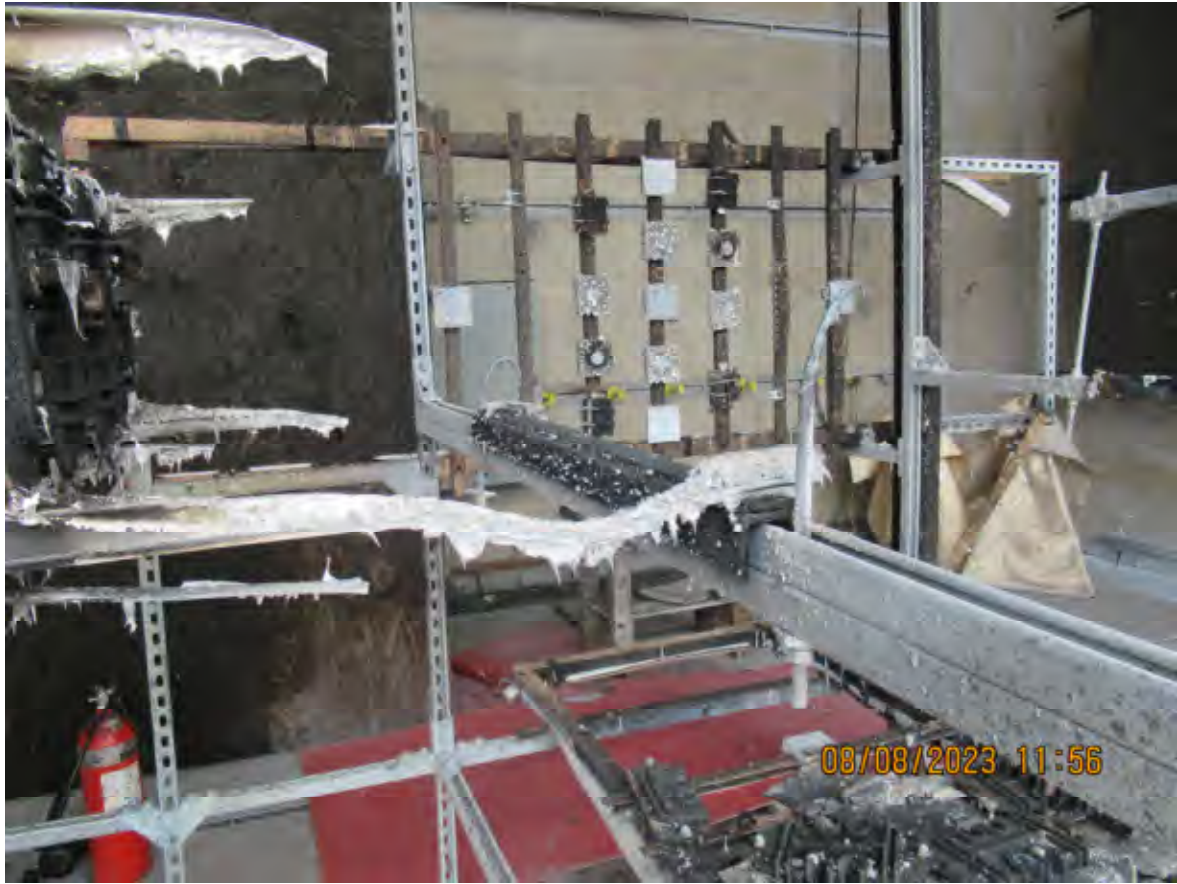
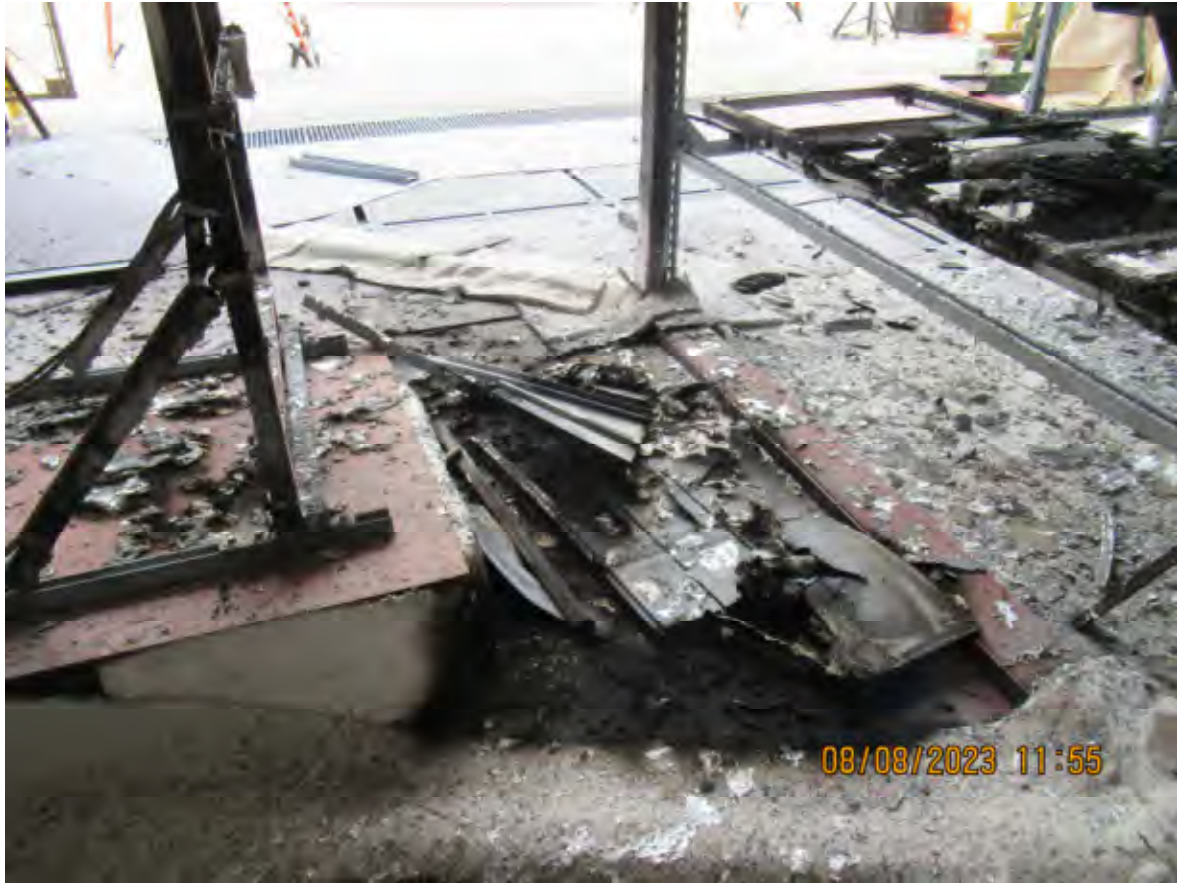
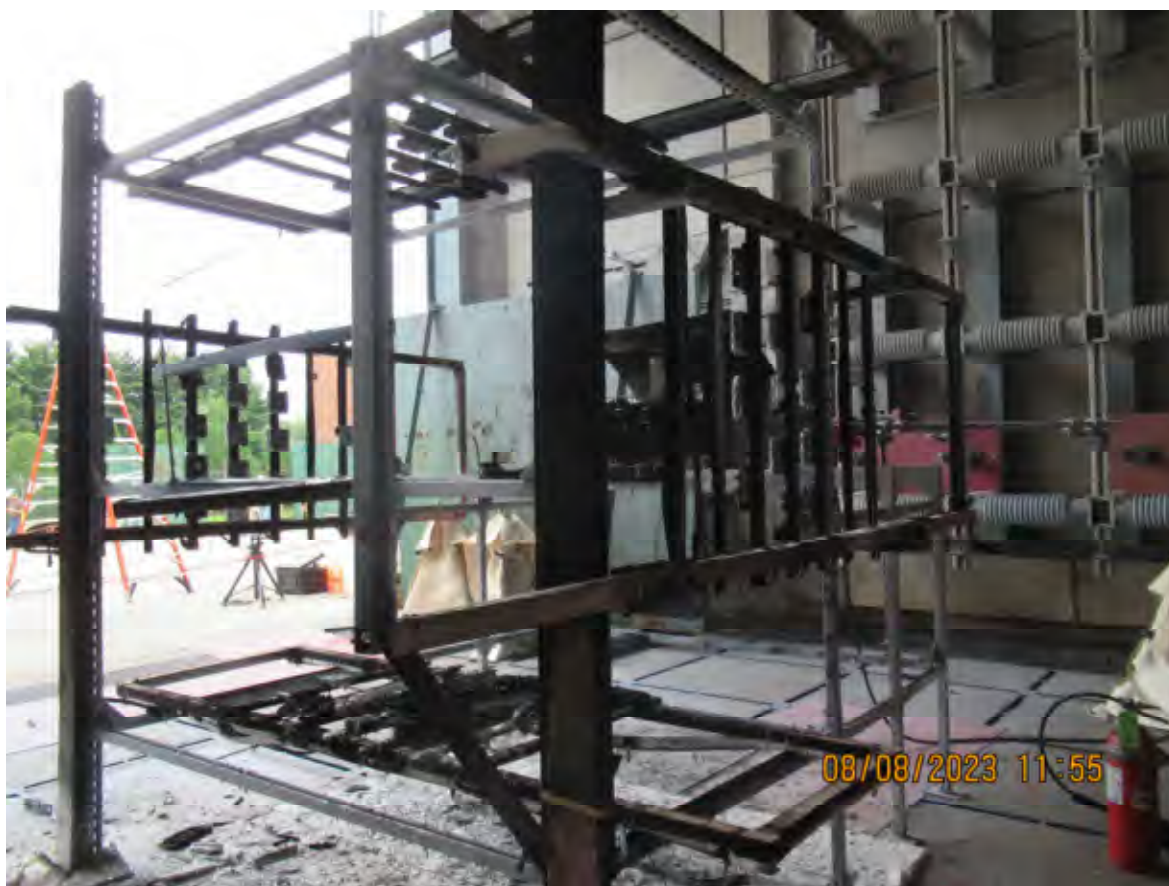
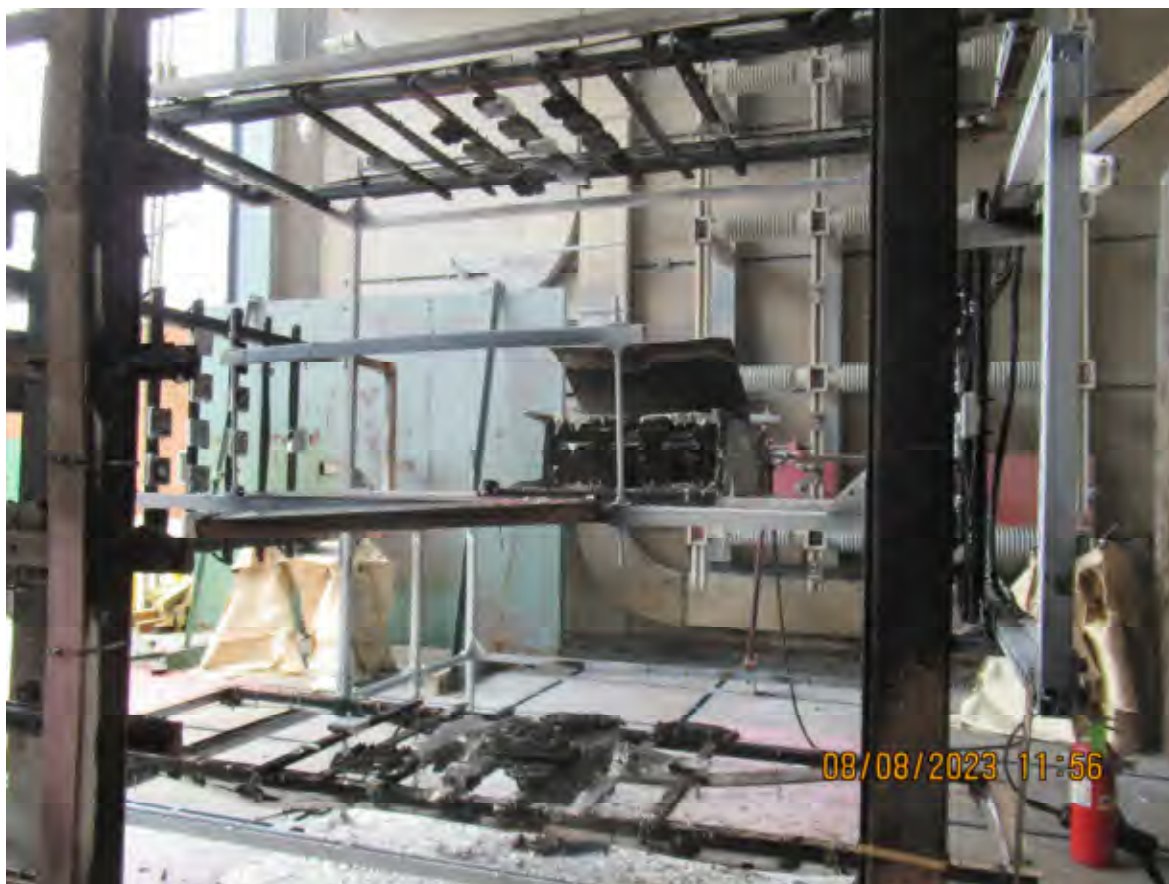
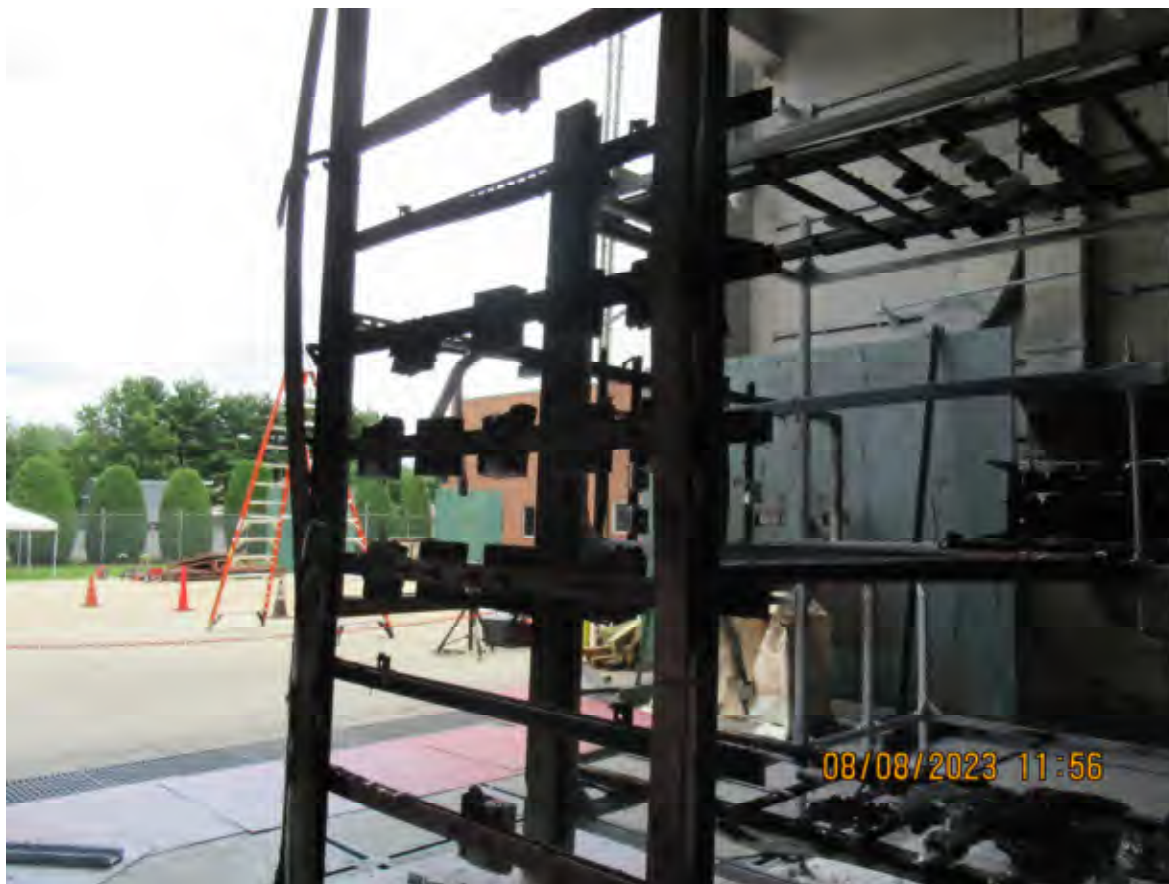
**6.6 Photograph after test**

Observations: Emission of flames and gas observed.

Heavy damage to the bus duct. Majority of enclosure vaporized.

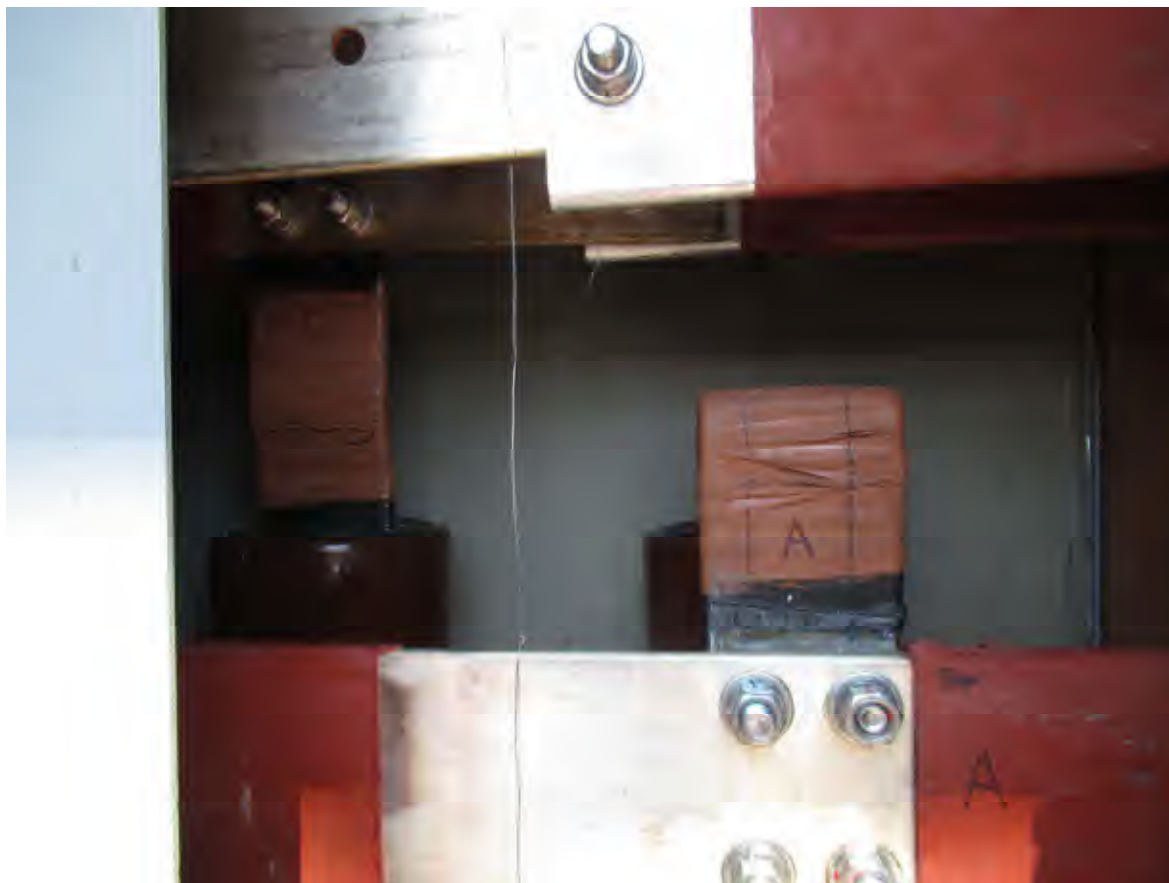
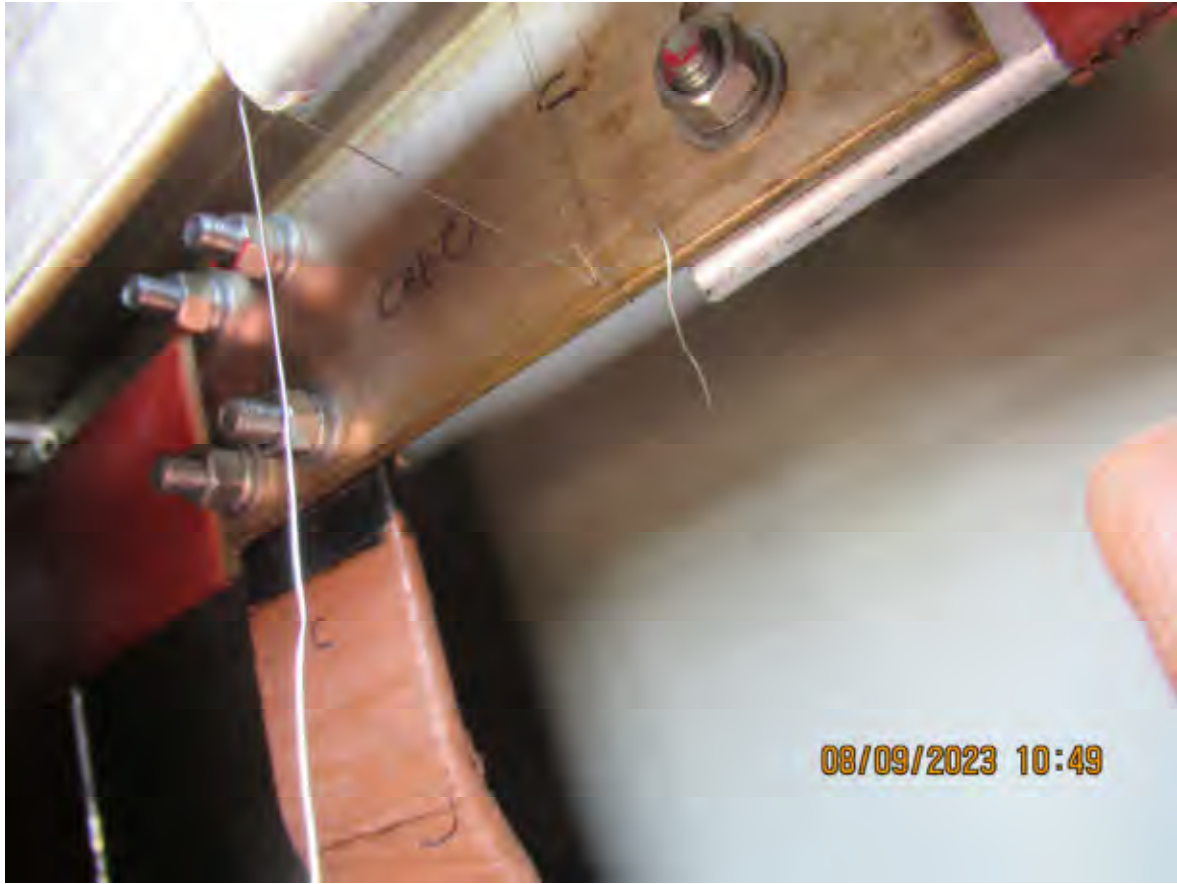
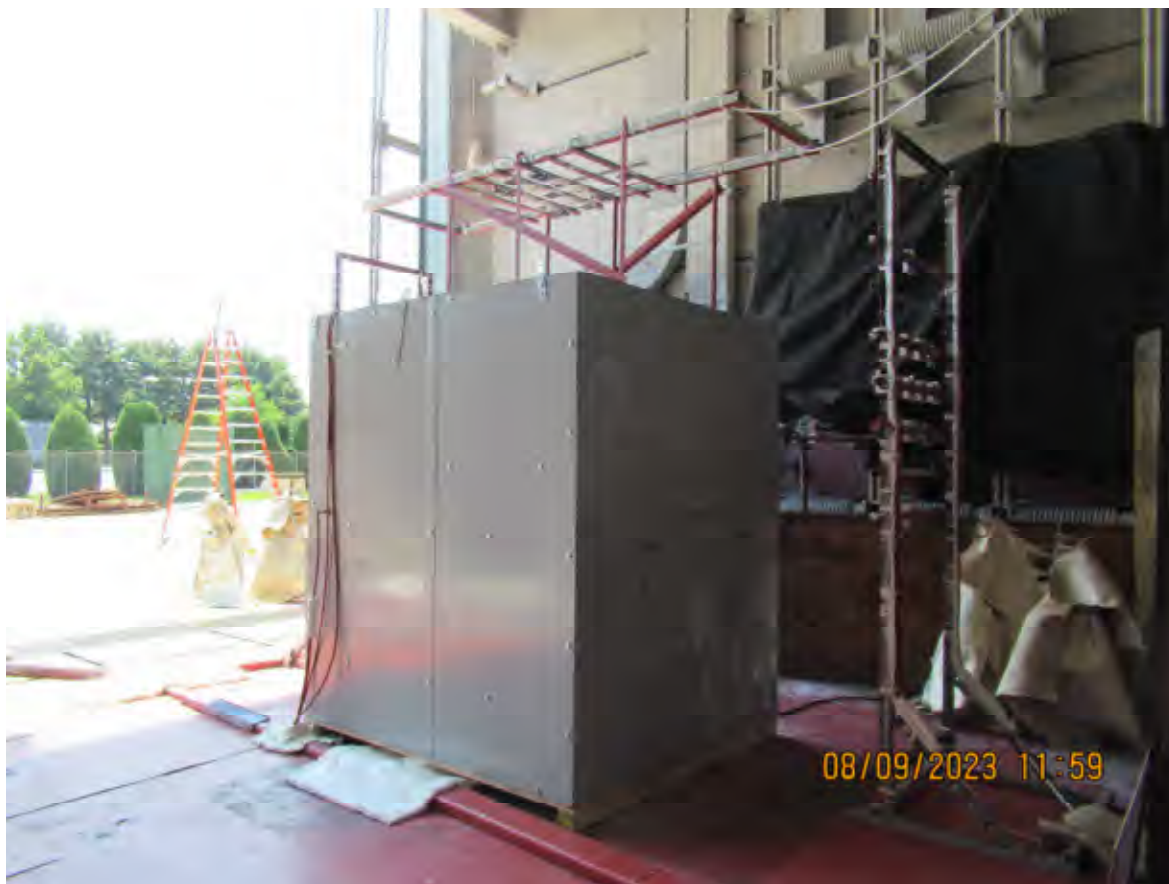
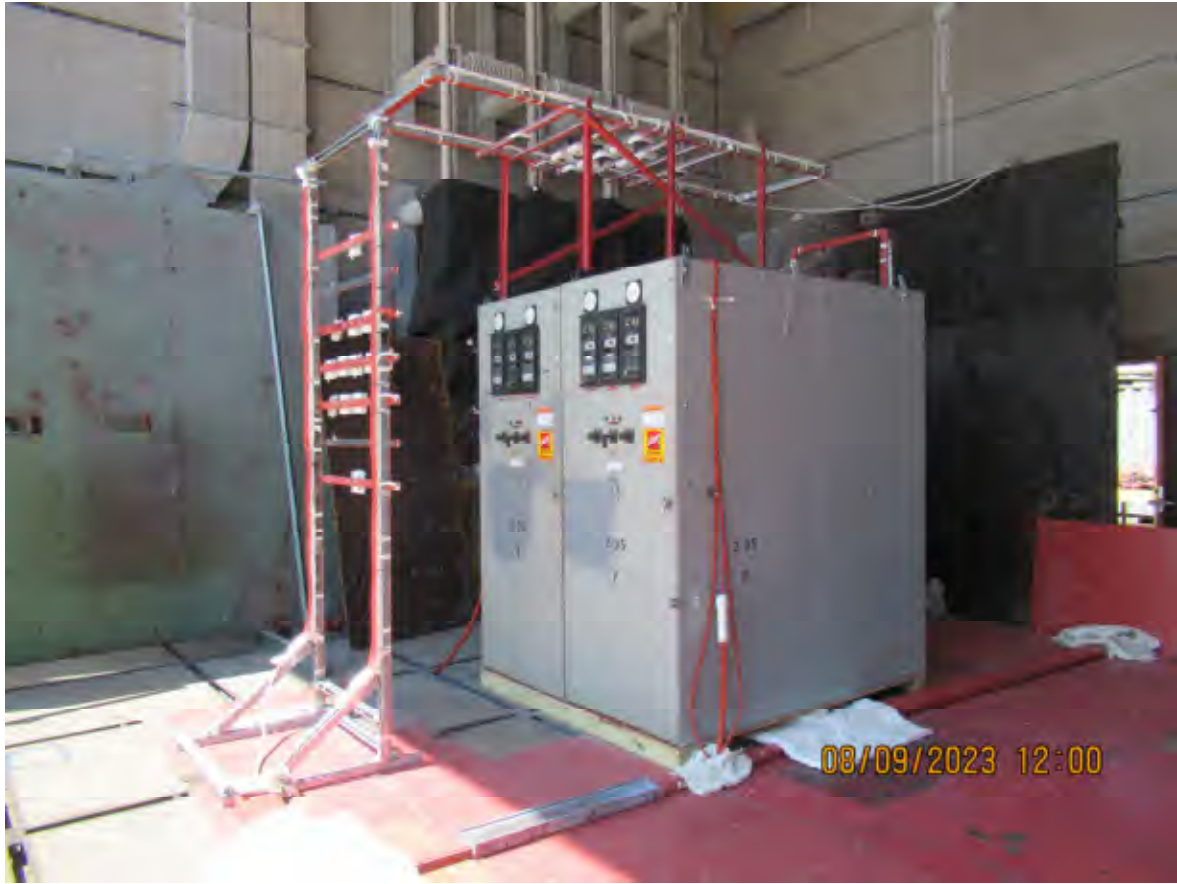
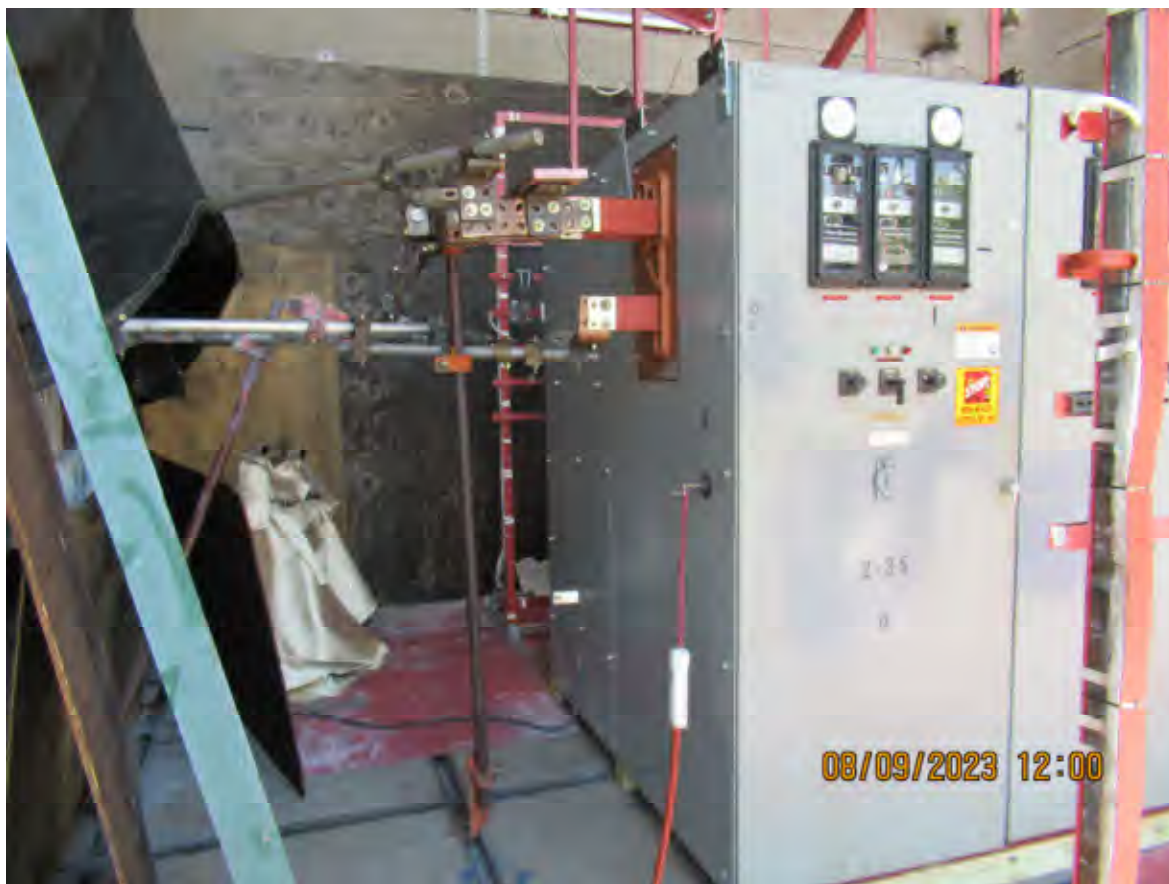
**8.3 Photograph before test**

Supply		
Power	MVA	302
Frequency	Hz	60
Phase(s)		3
Voltage	kV	6.97
Current	kA	25
Impedance	Ω	0.161
Power factor		< 0.1
Neutral		not earthed
