# Understanding High Energy Arcing Faults

Course No: E05-018

*This course was adapted from the NIST U.S. Department of Commerce, Publication No. NIST TN 2290, “Report on High Energy Arcing Fault Experiments”, which is in the public domain.*

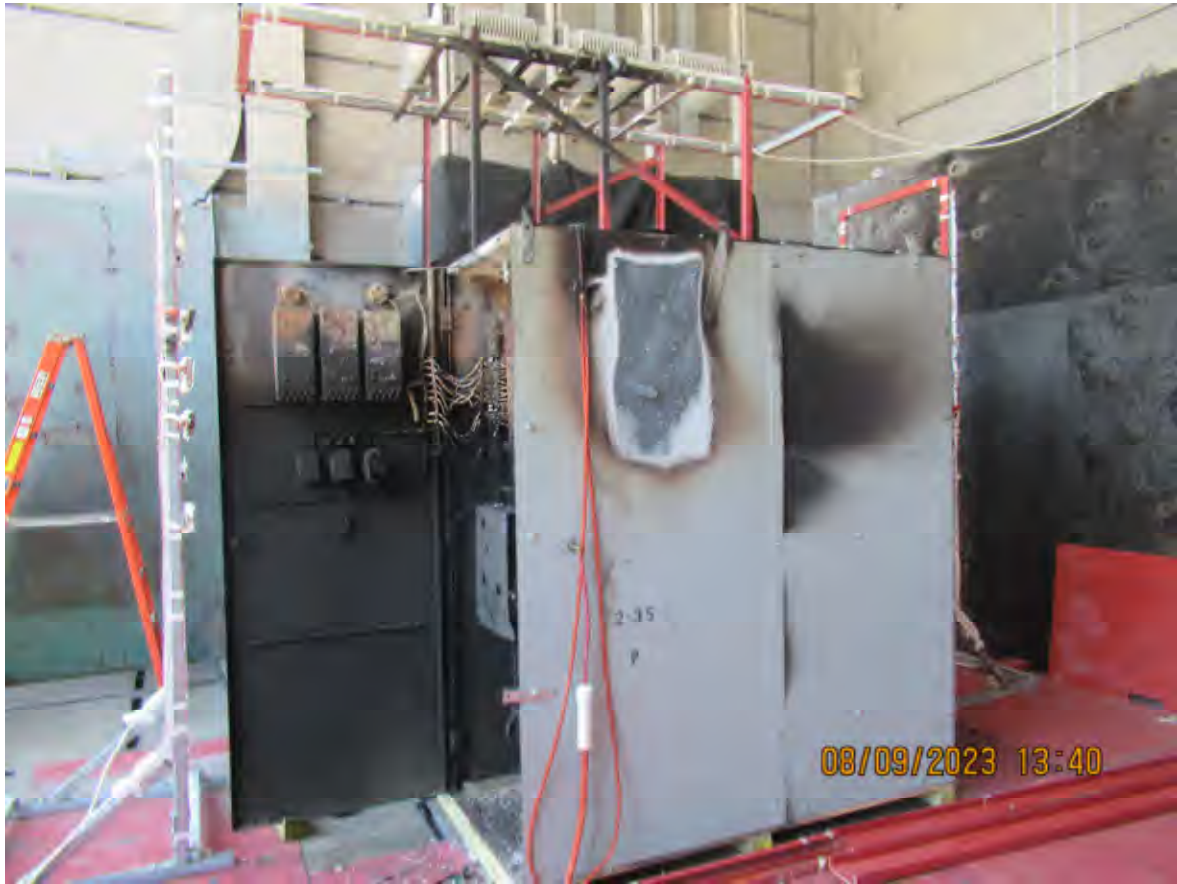
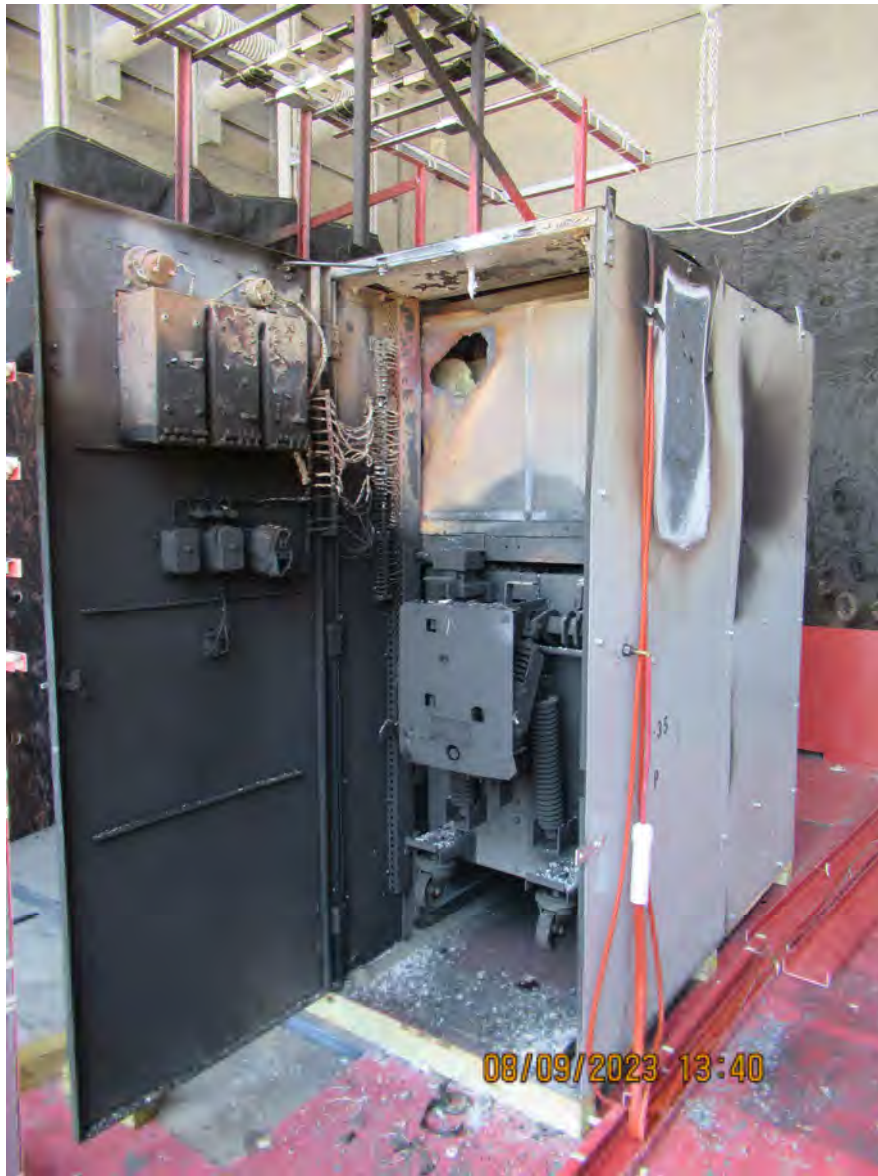
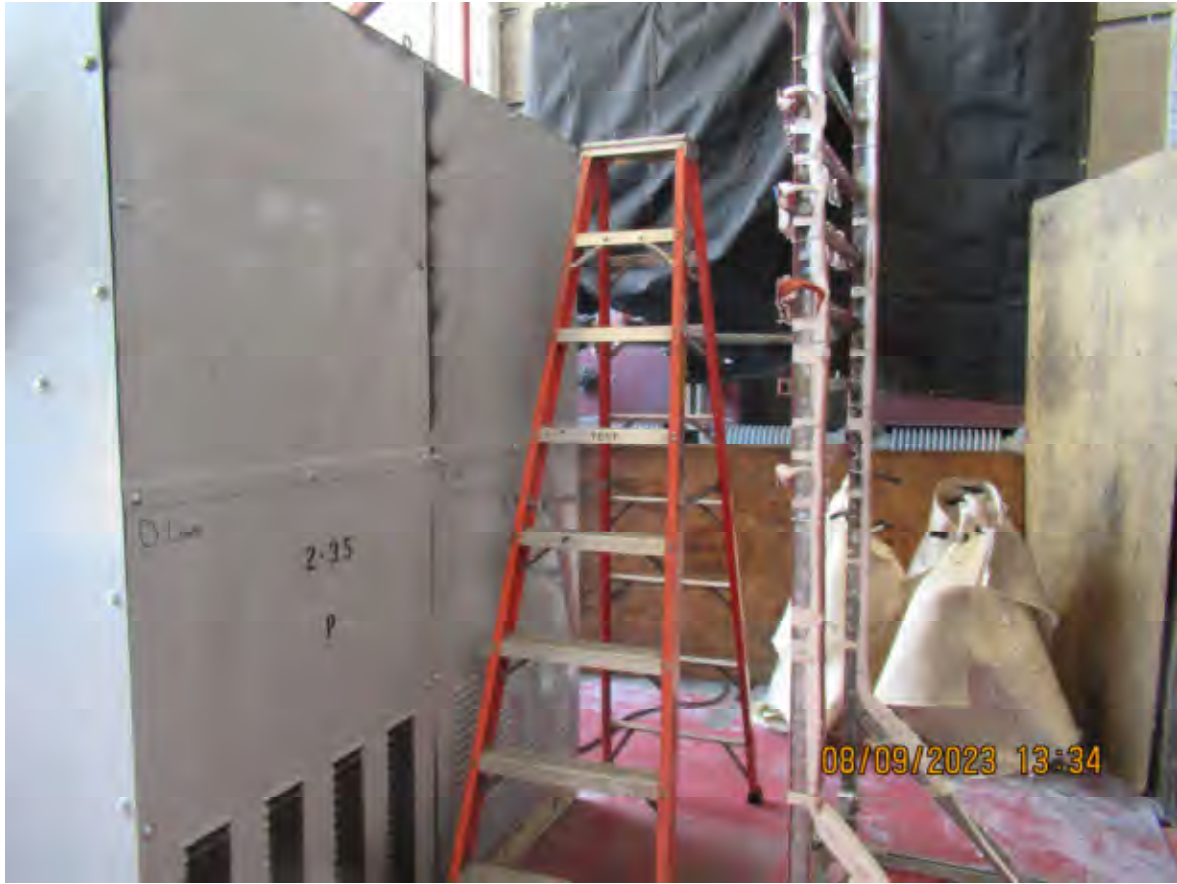
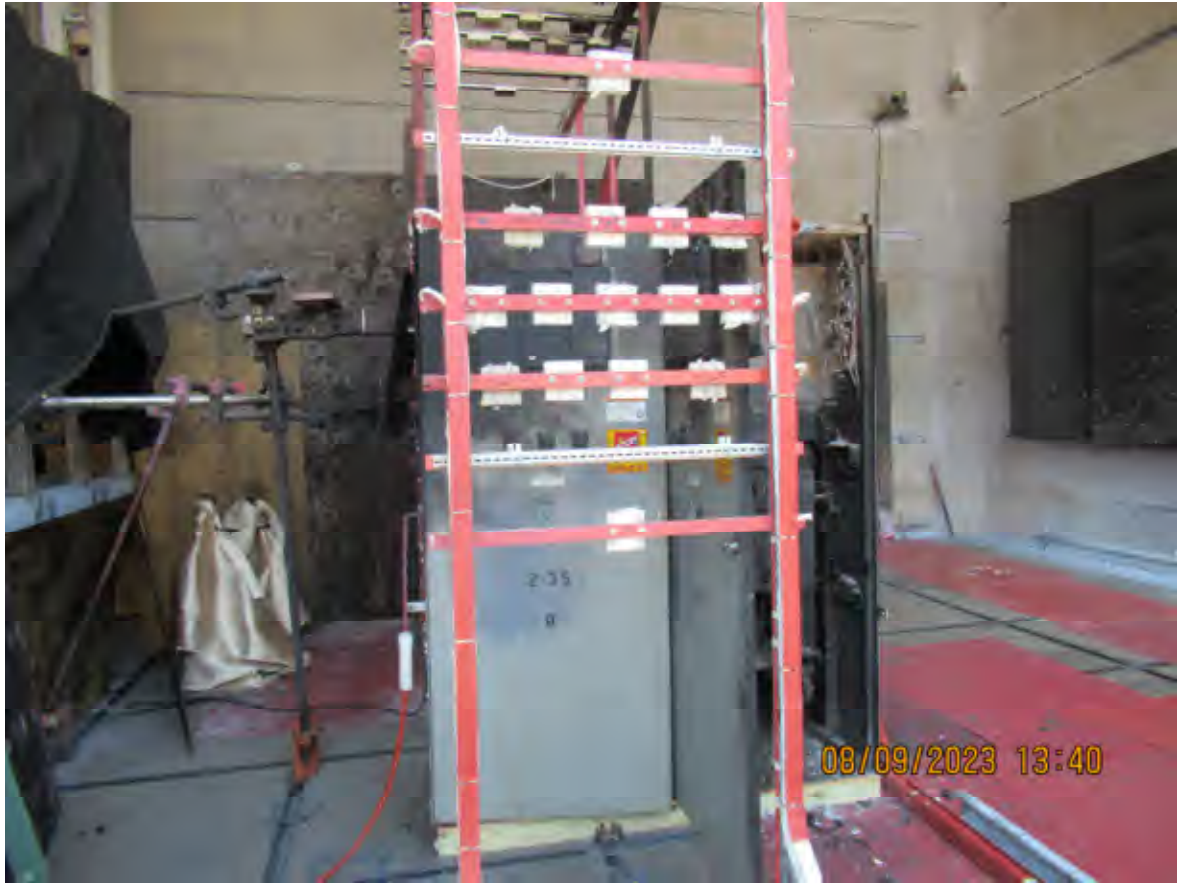
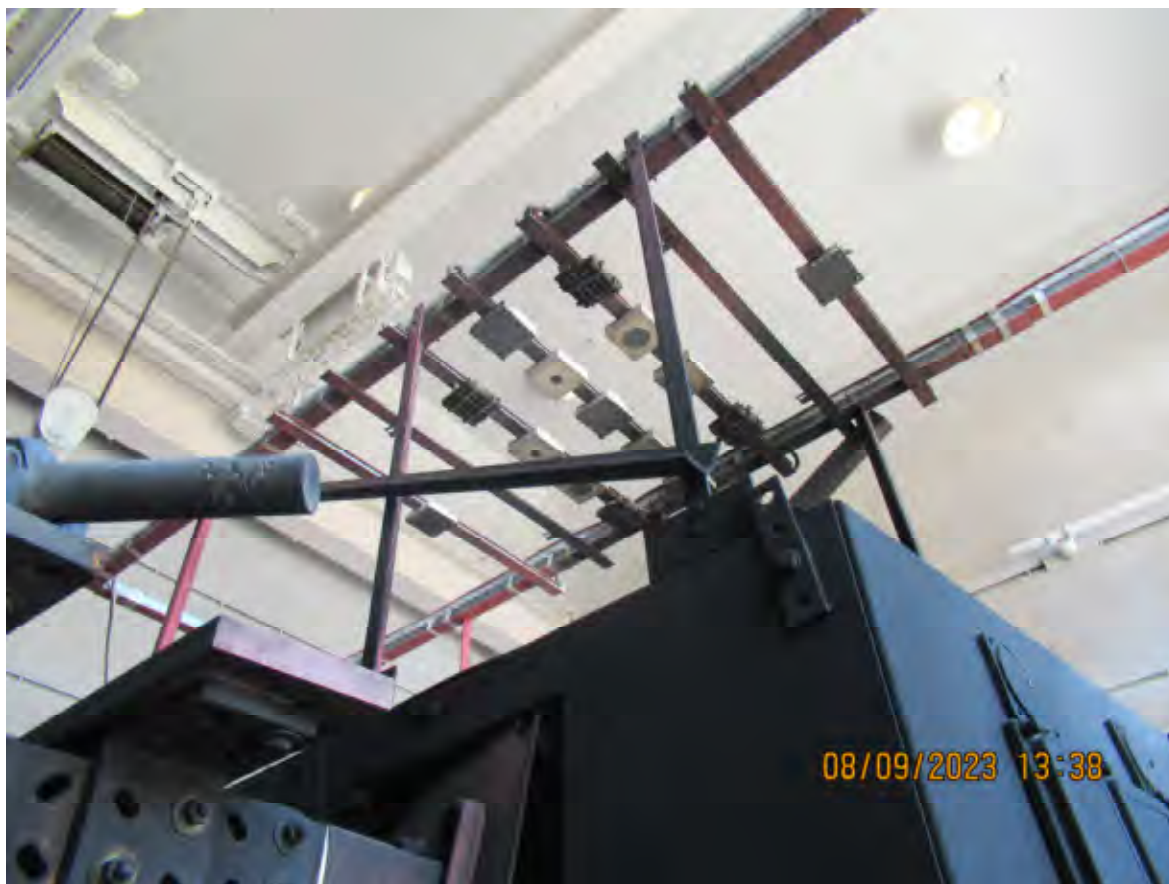
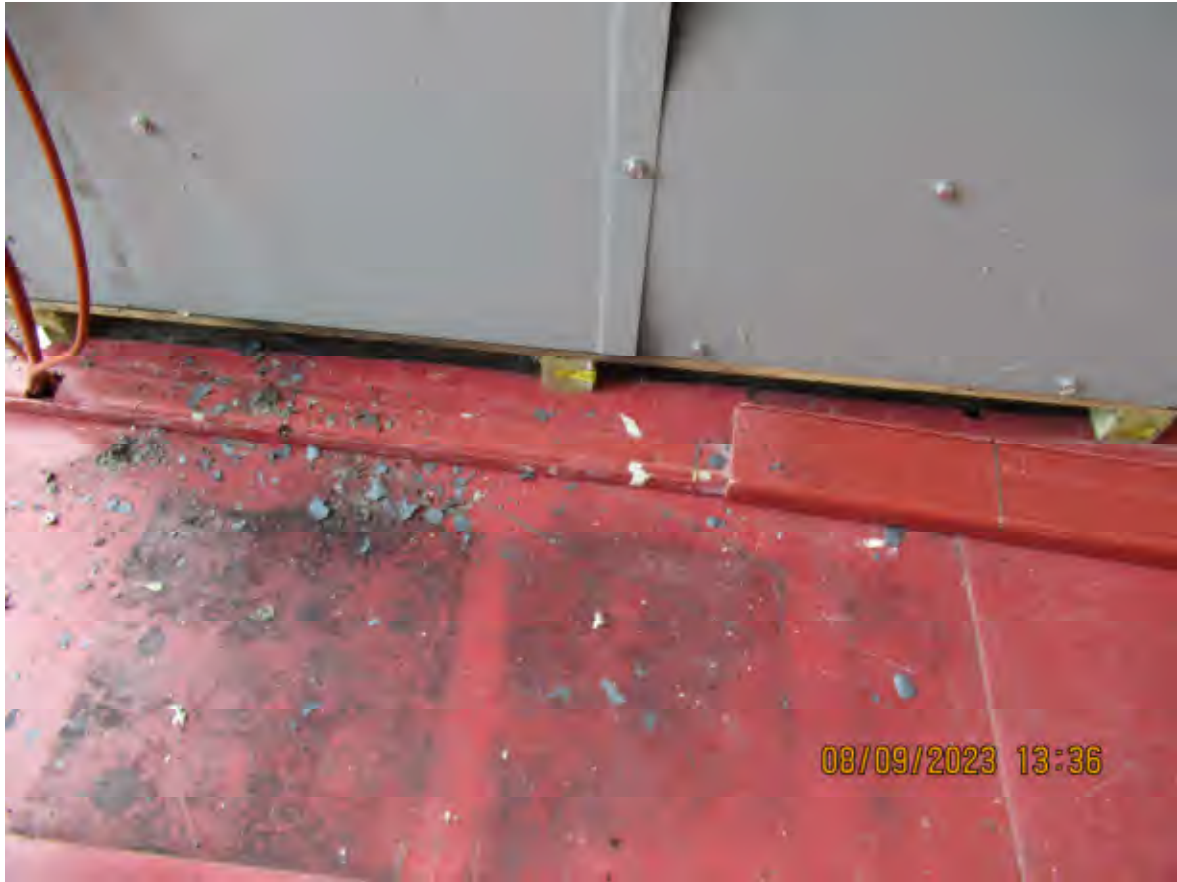
**8.6 Photograph after test**

Observations: Emission of flames and gas observed.  
 PT#1 1.6 psi above atmospheric  
 PT #2 0.68 psi above atmospheric

Interior and sides of the sample exterior were heavily burned.

Fire in the test gear burned for about 15 minutes before being extinguished.

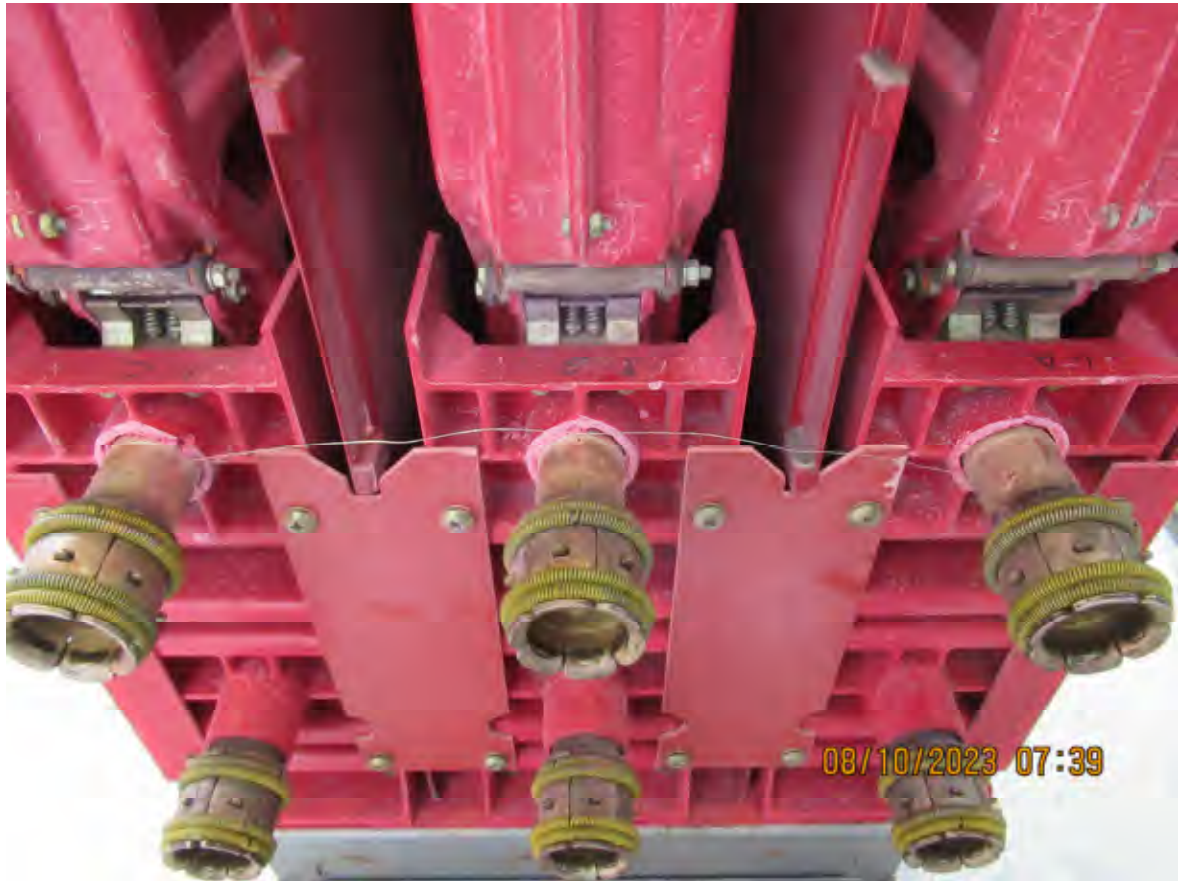
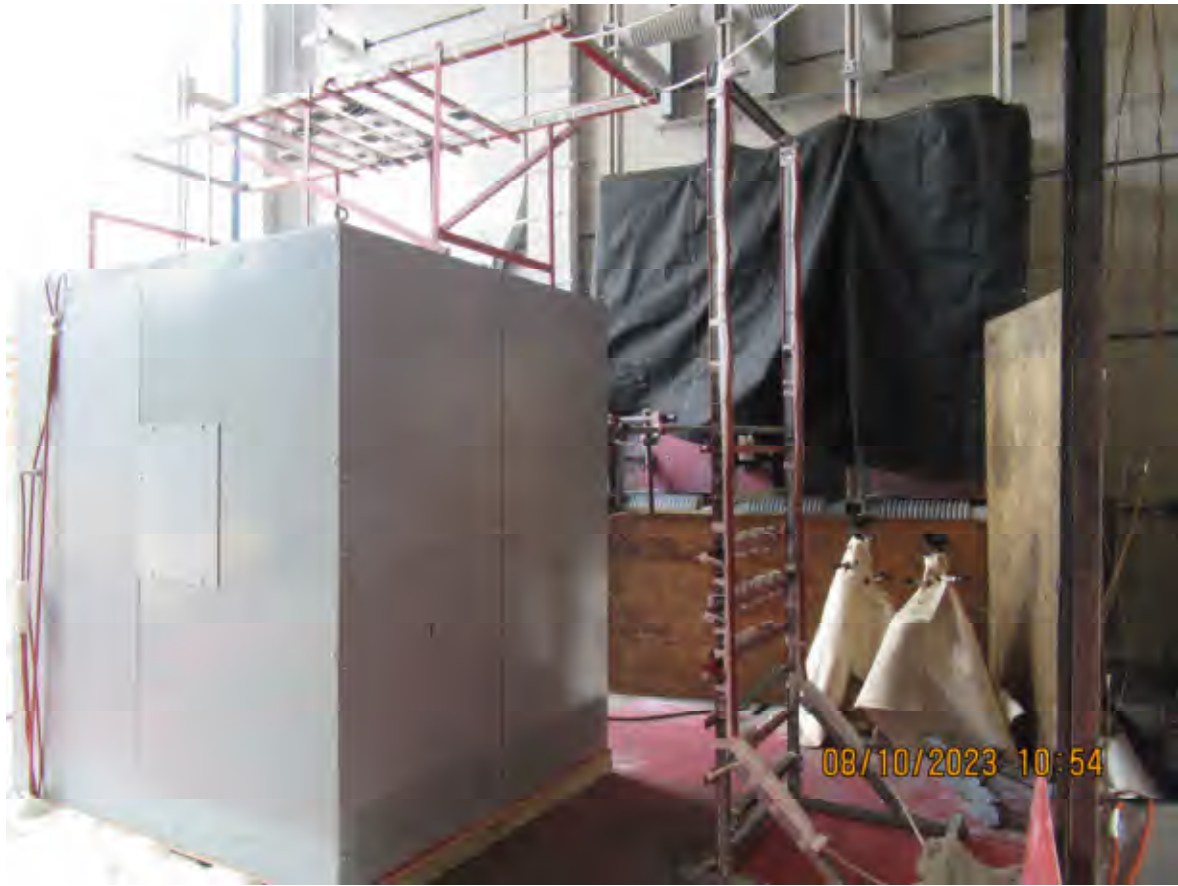
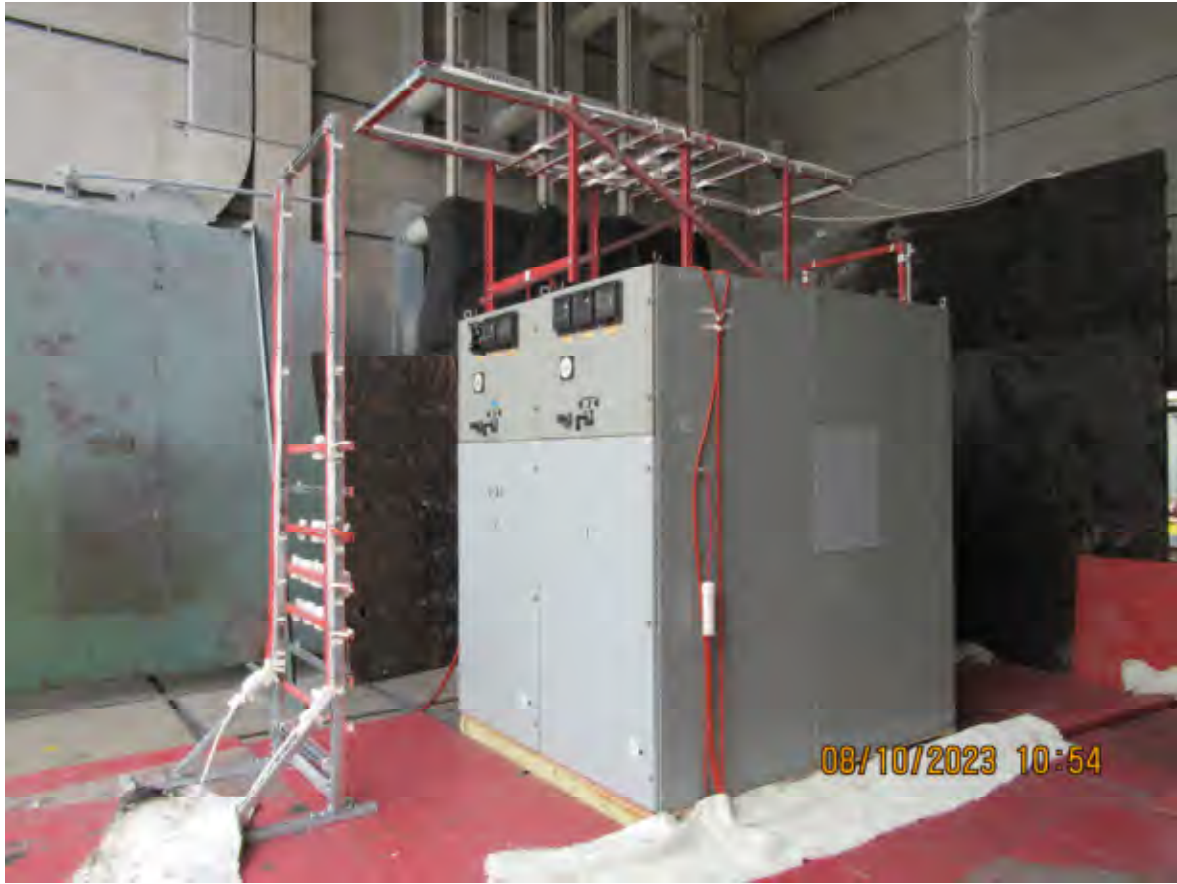
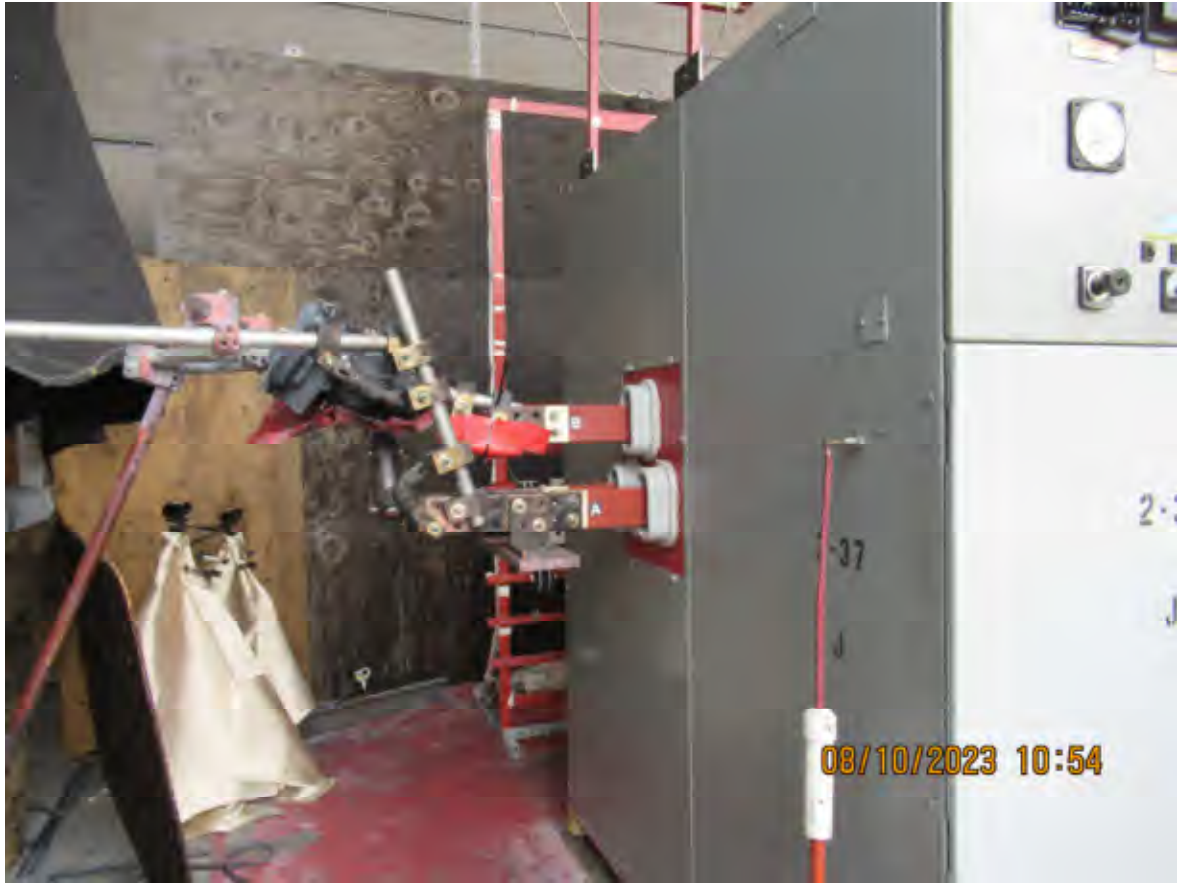
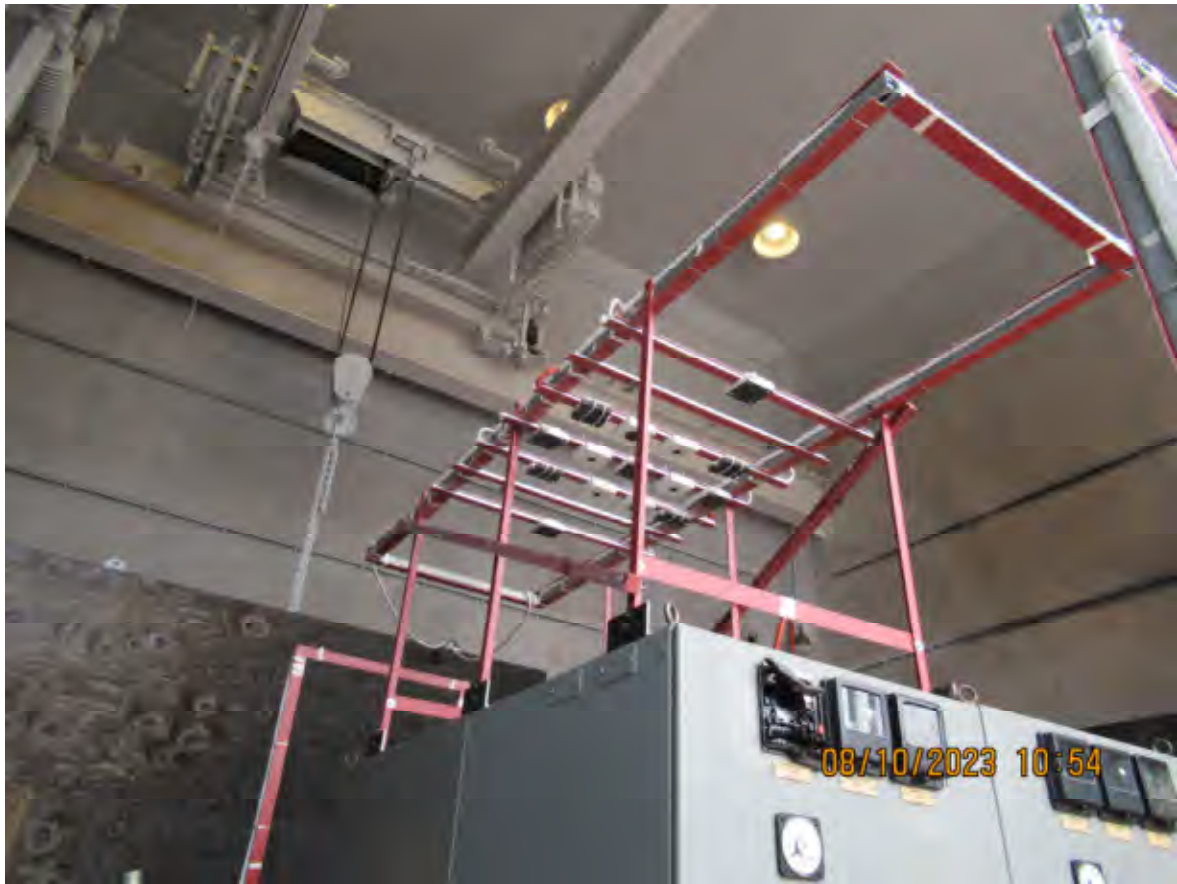
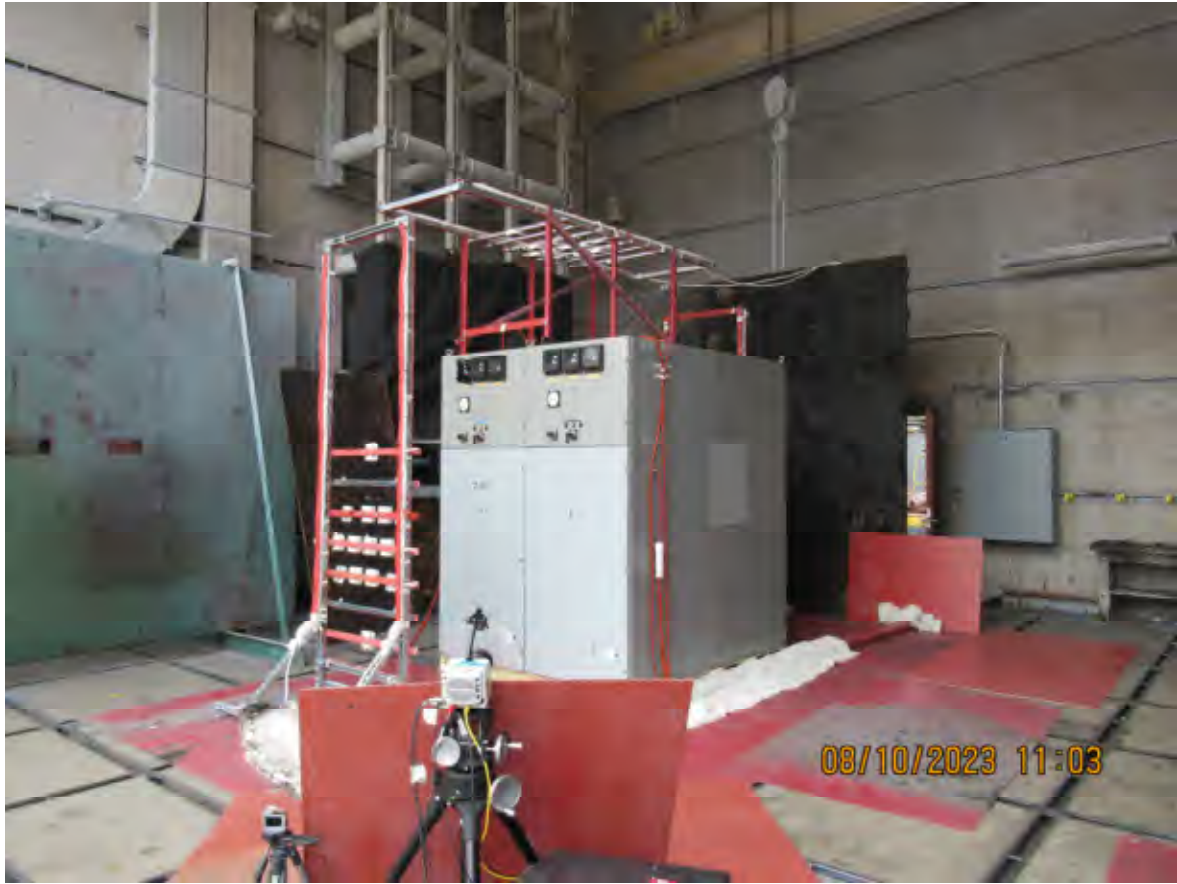
**9.3 Photograph before test**

Supply		
Power	MVA	302
Frequency	Hz	60
Phase(s)		3
Voltage	kV	6.97
Current	kA	25
Impedance	Ω	0.161
Power factor		< 0.1
Neutral		not earthed

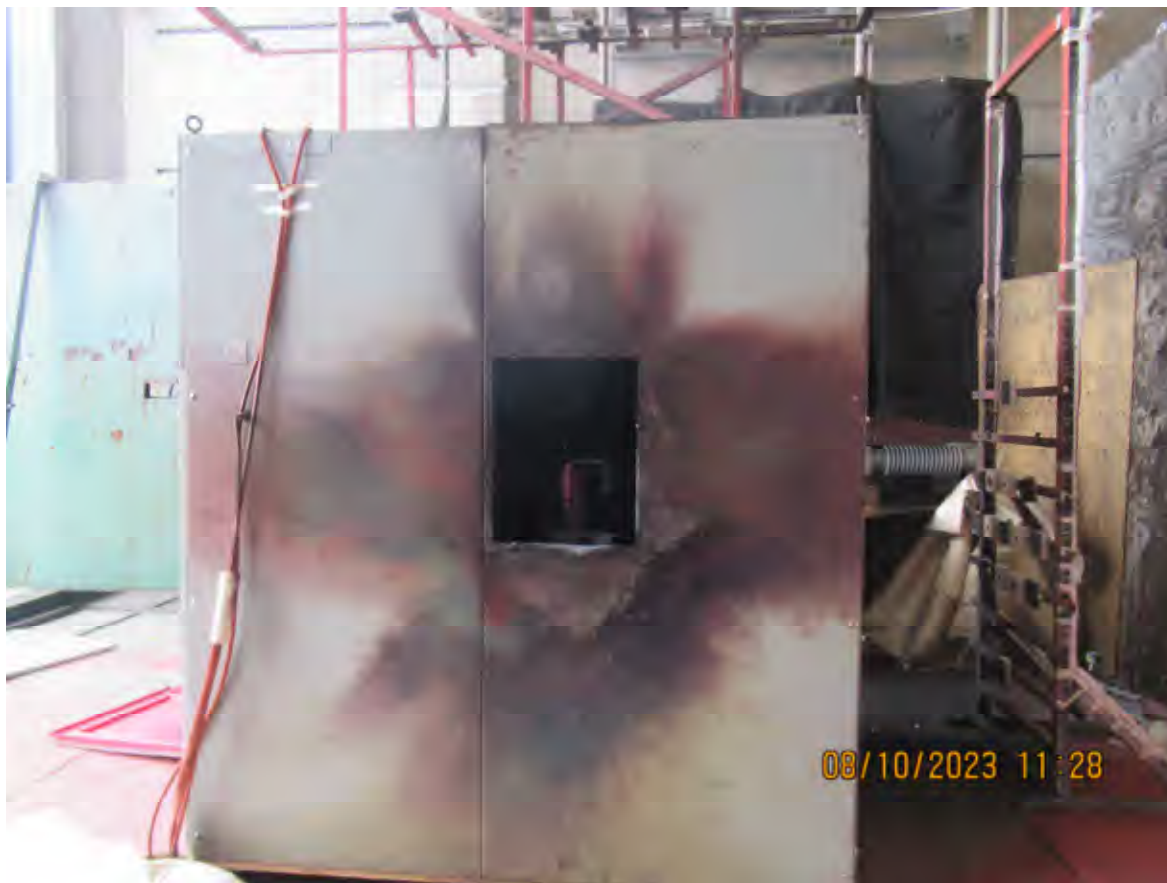
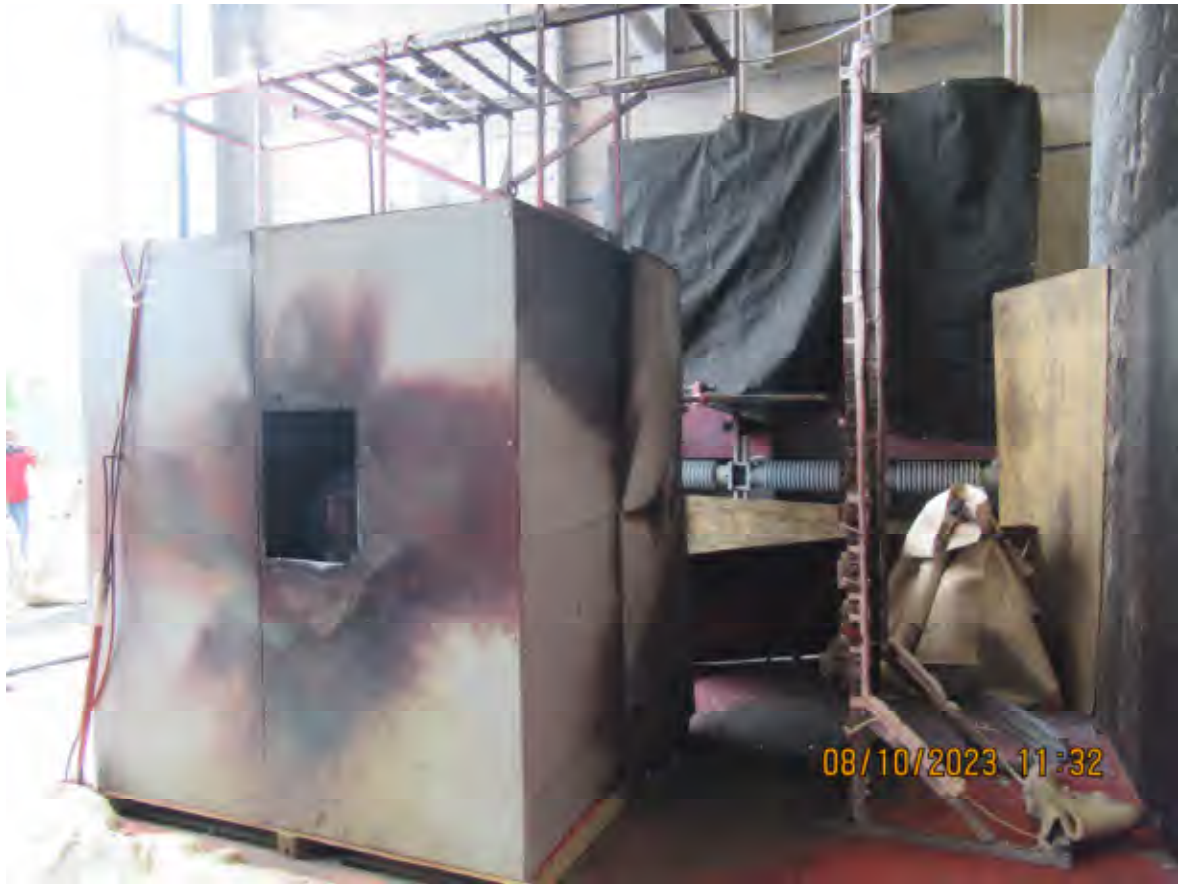
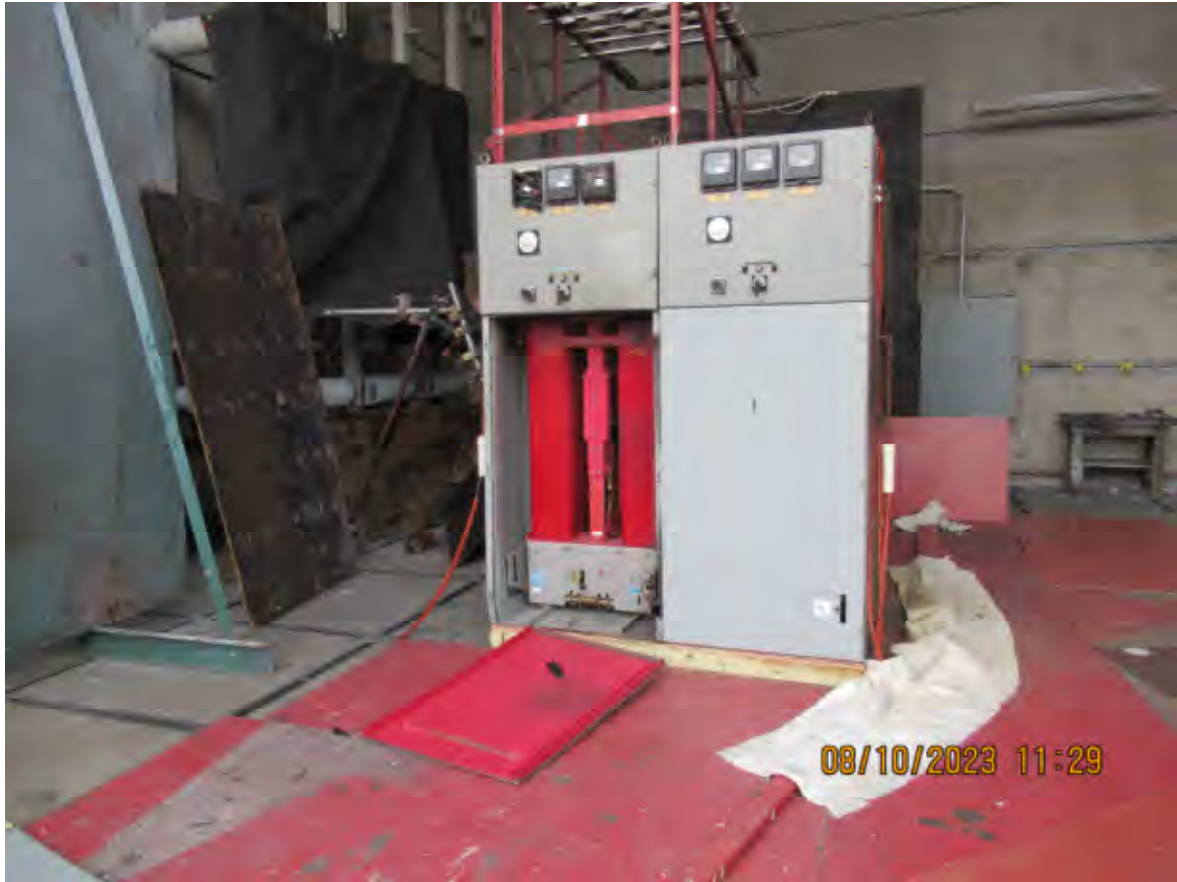
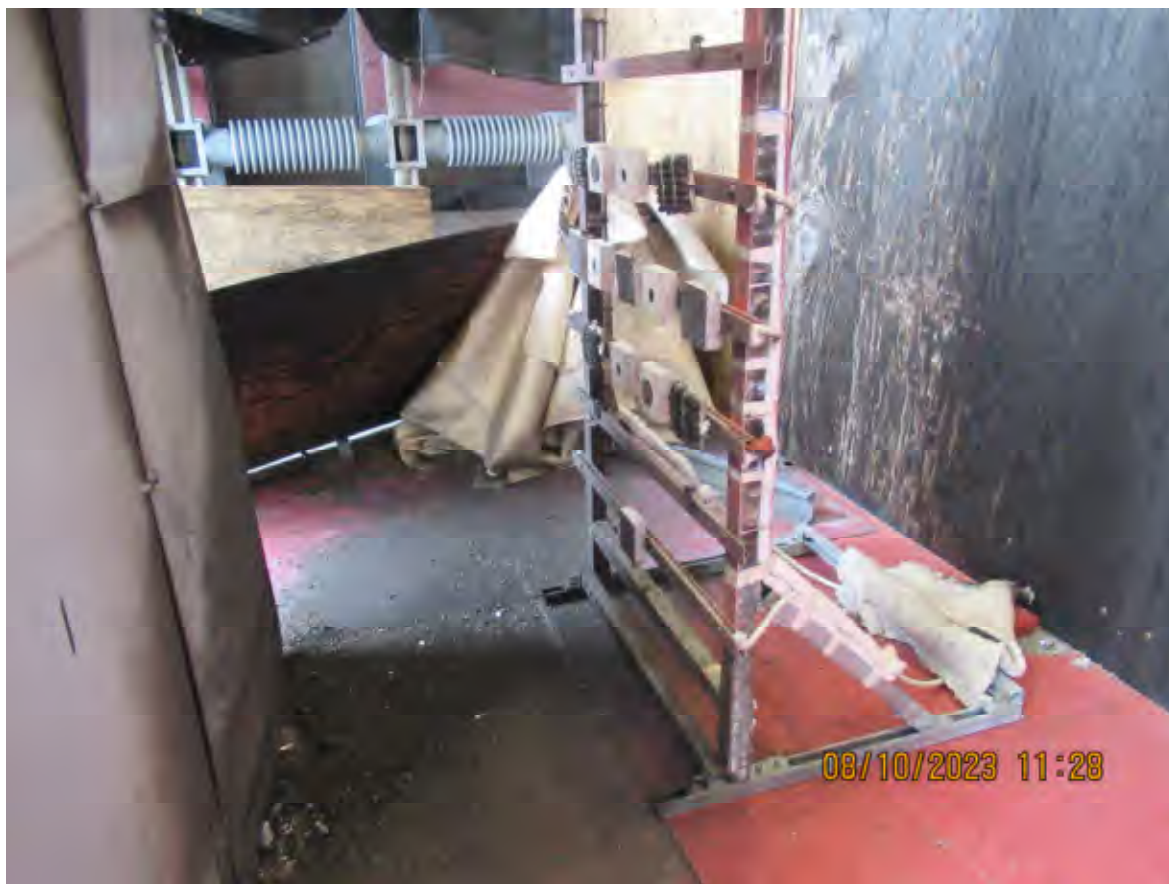
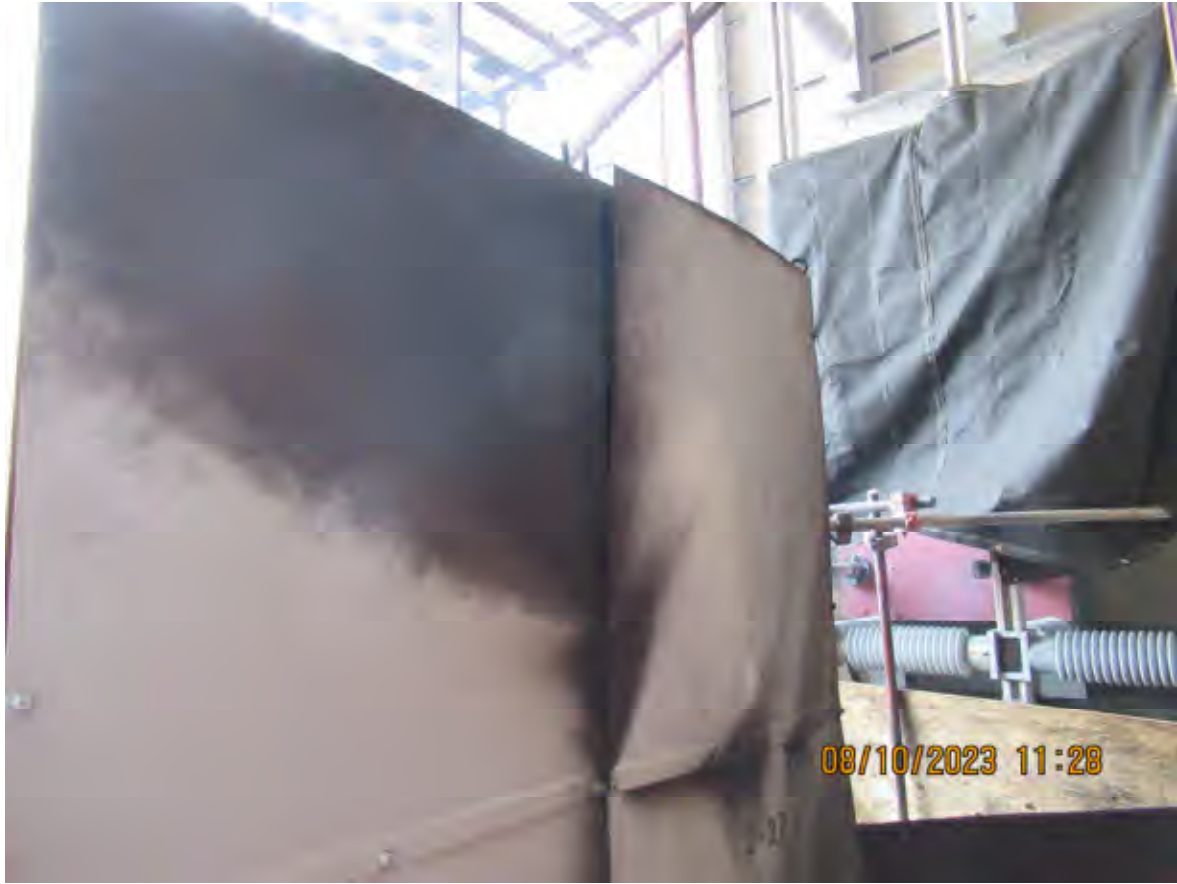
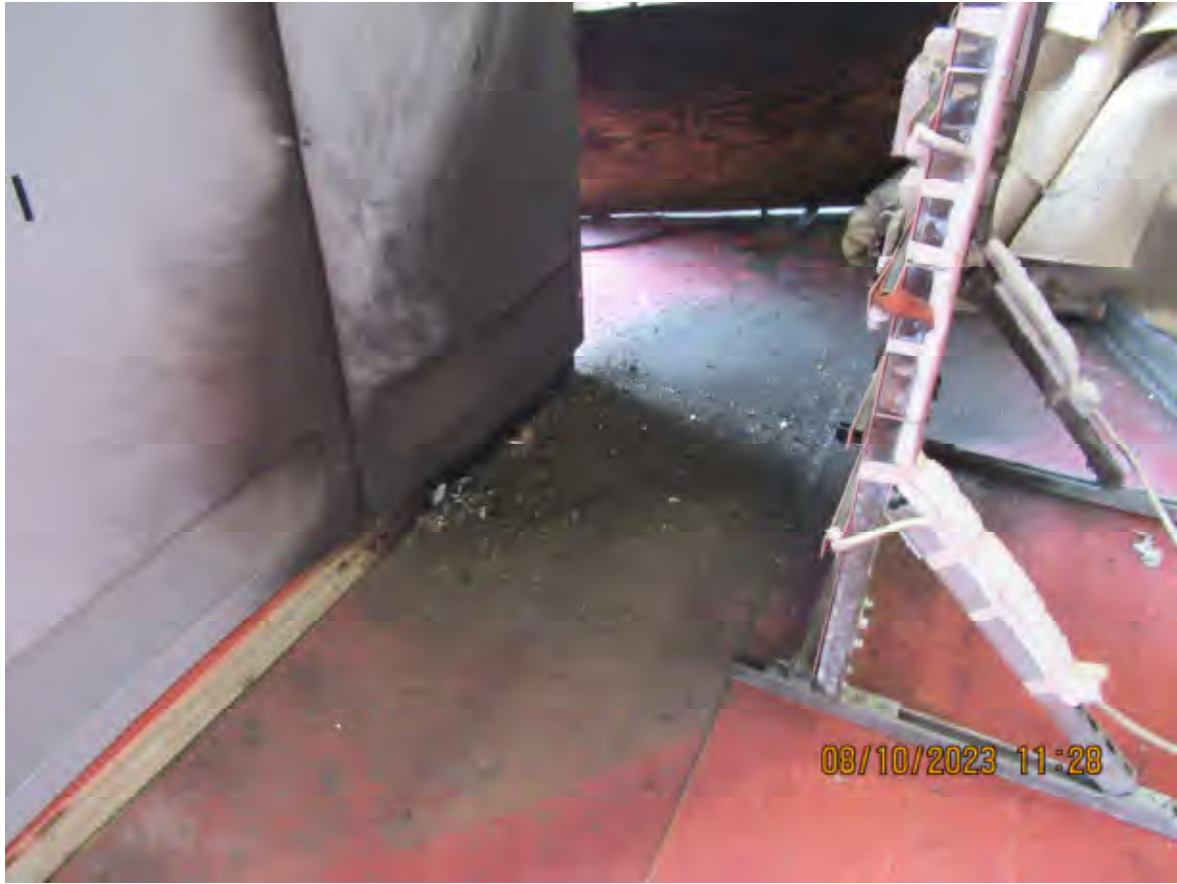
**9.6 Photograph after test**

Interior and sides of the sample exterior were heavily burned.

Fire in the test gear self-extinguished.

Observations: Emission of flames and gas observed.  
 PT#1 6.16 psi above atmospheric  
 PT #2 0.5 psi above atmospheric

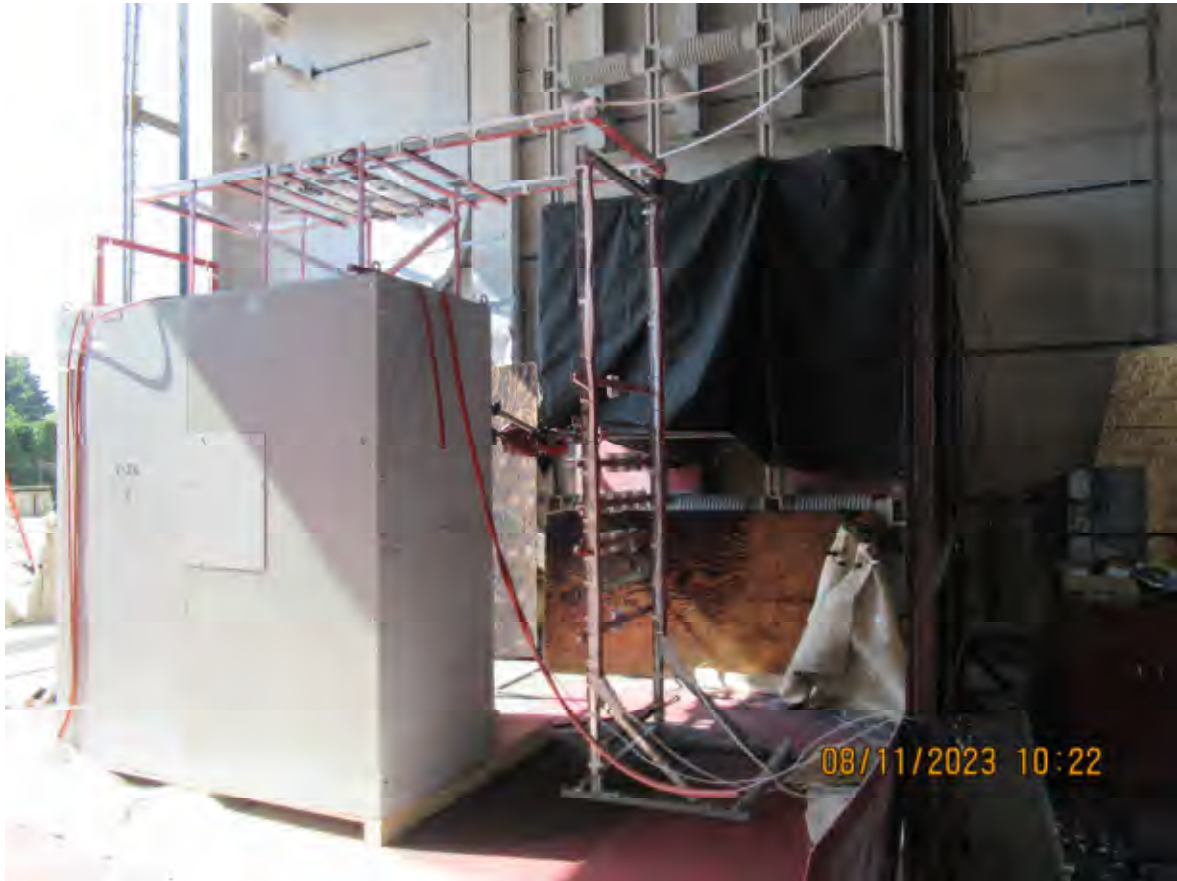
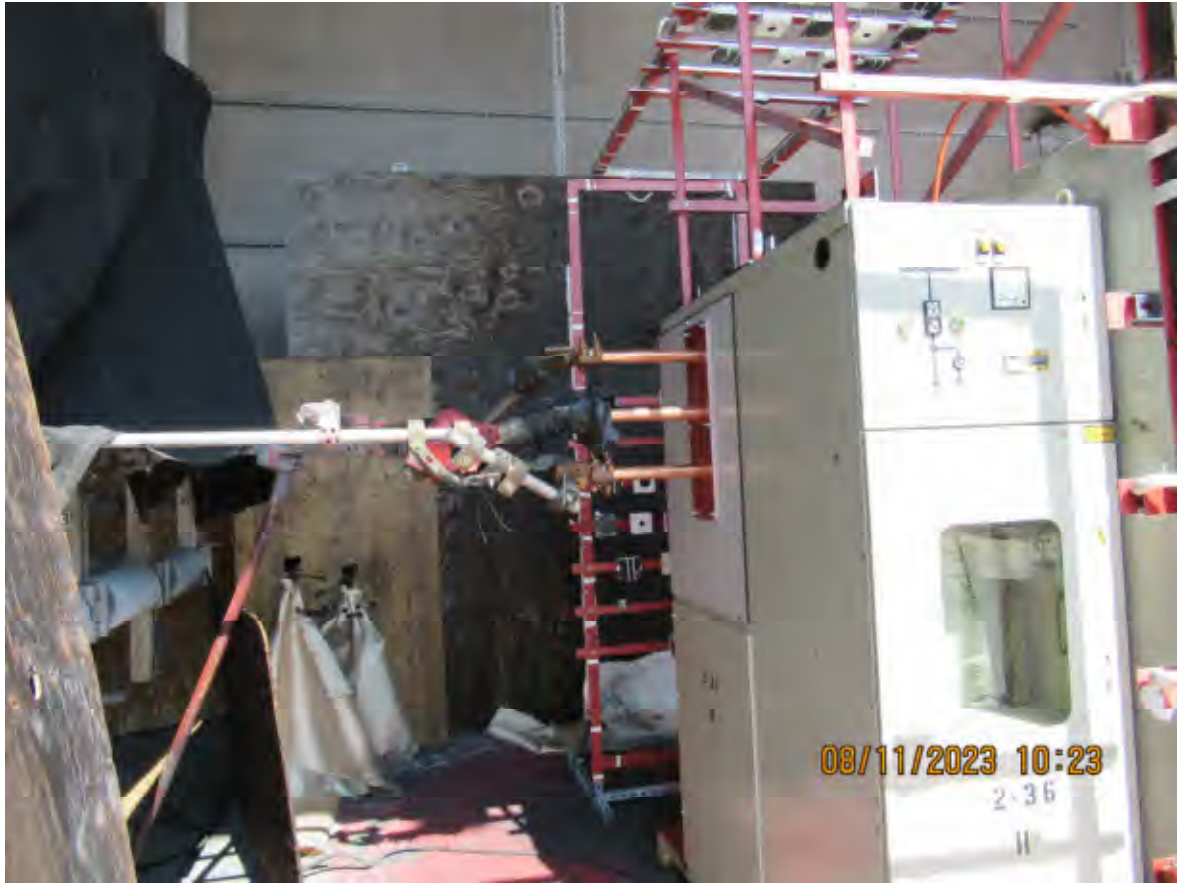
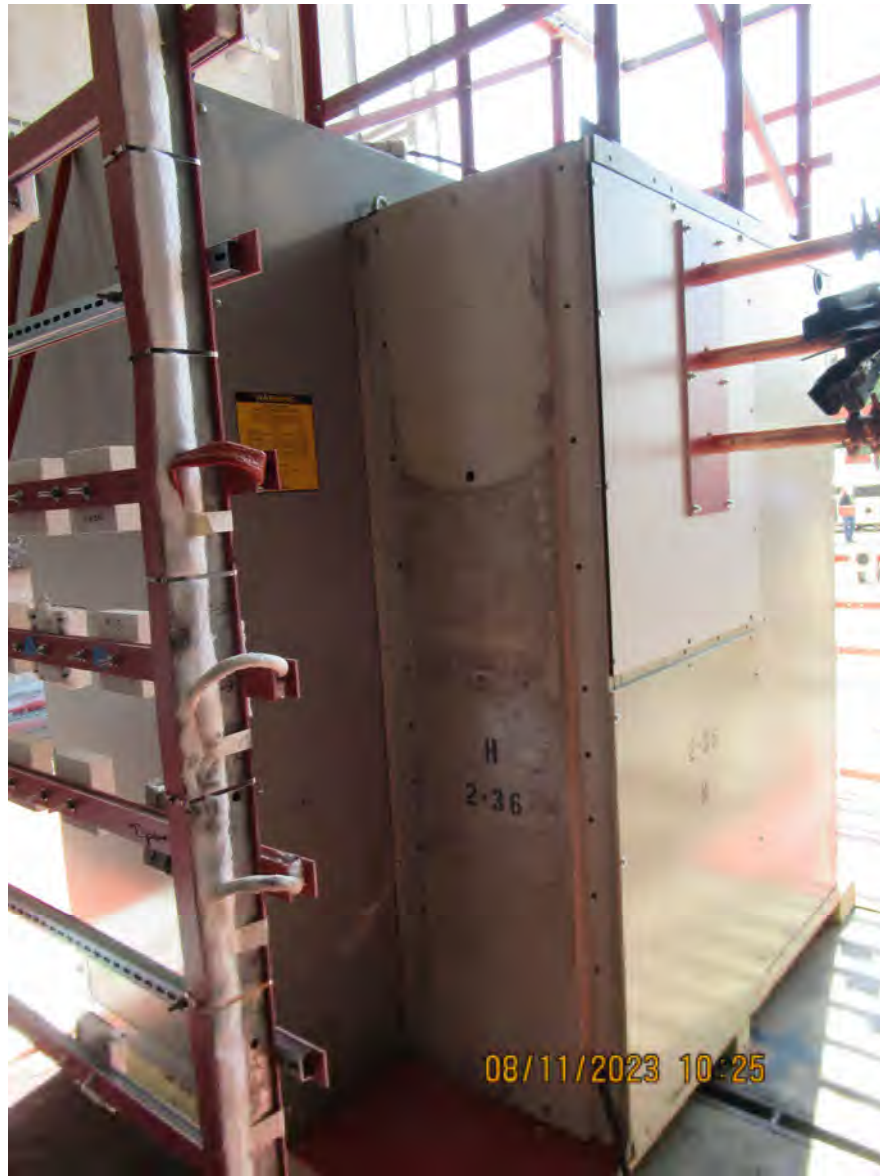
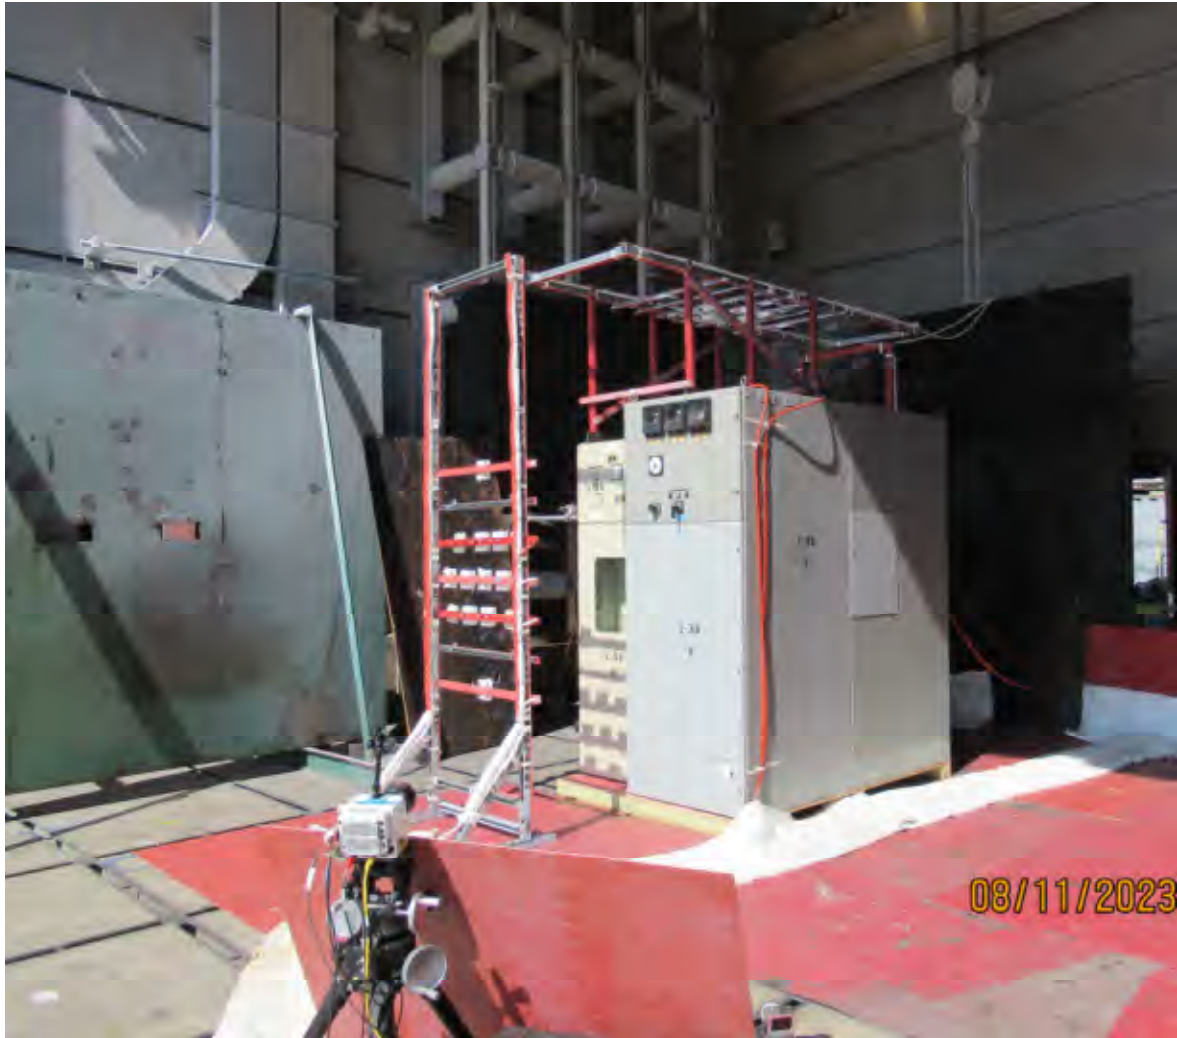
**10.3 Photograph before test**

Supply		
Power	MVA	302
Frequency	Hz	60
Phase(s)		3
Voltage	kV	6.97
Current	kA	25
Impedance	Ω	0.161
Power factor		< 0.1
Neutral		not earthed
