# Understanding High Energy Arcing Faults

Course No: E05-018

*This course was adapted from the NIST U.S. Department of Commerce, Publication No. NIST TN 2290, “Report on High Energy Arcing Fault Experiments”, which is in the public domain.*

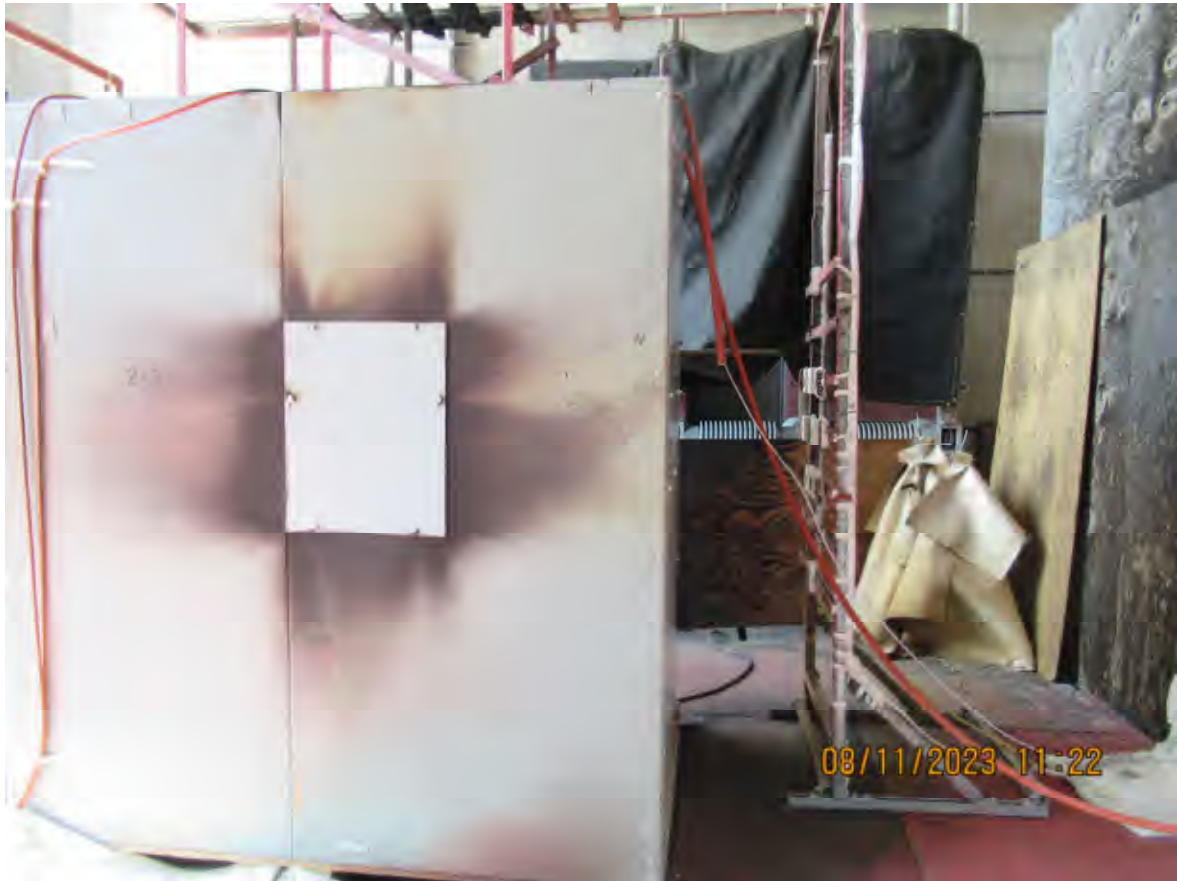
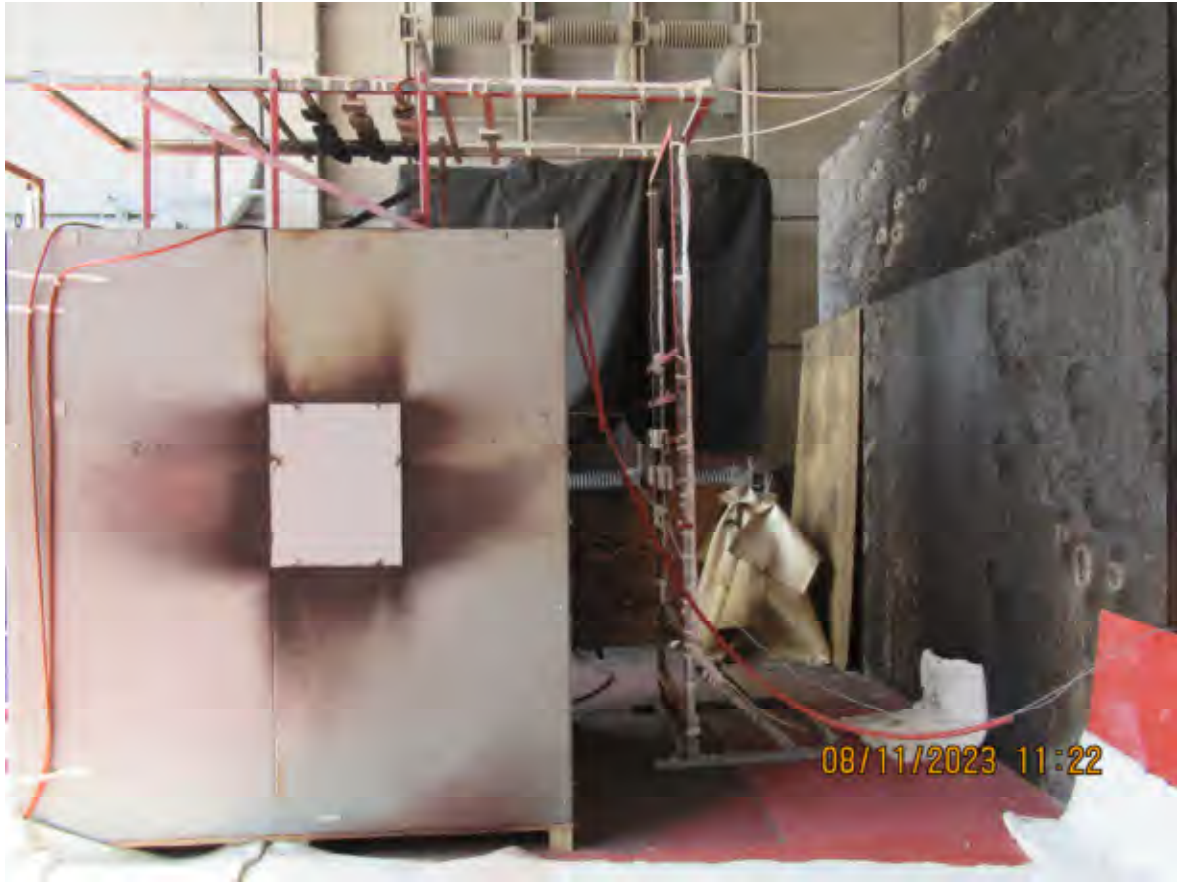
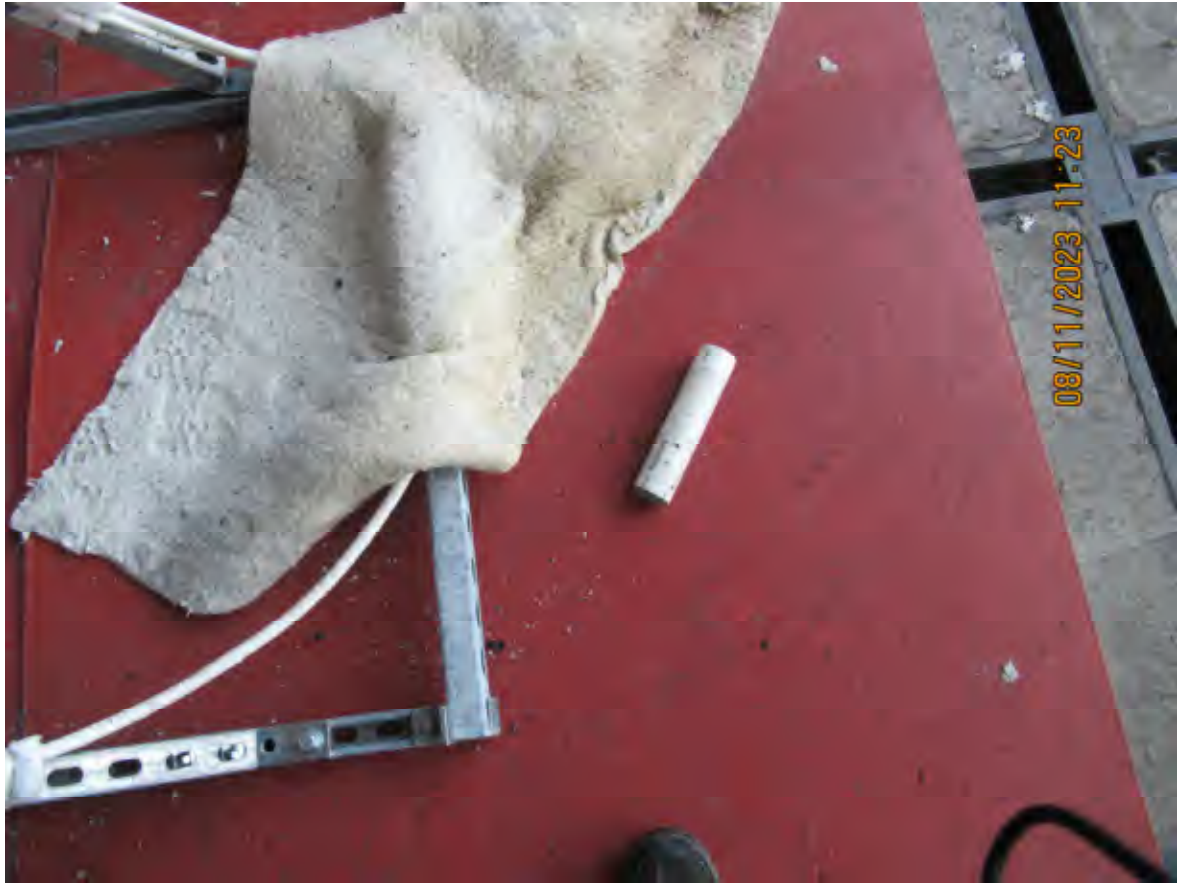
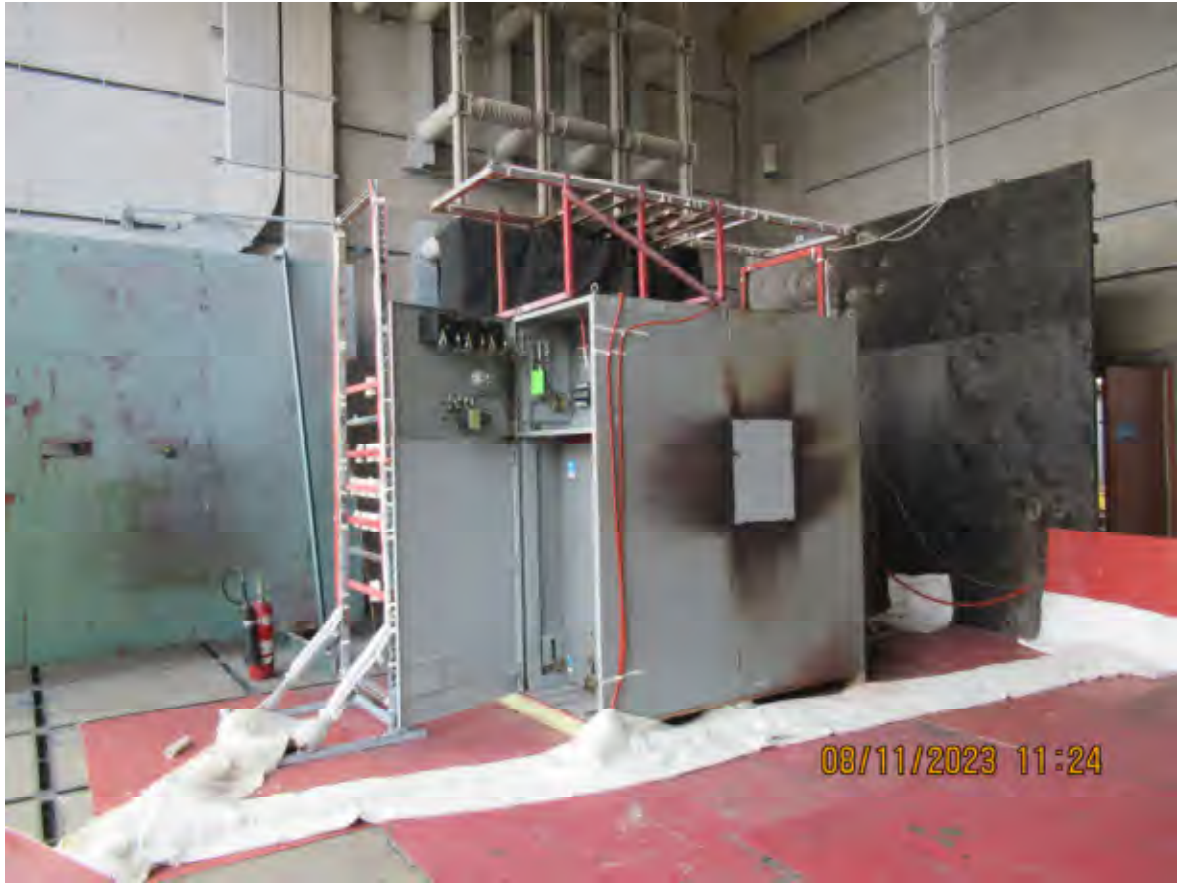
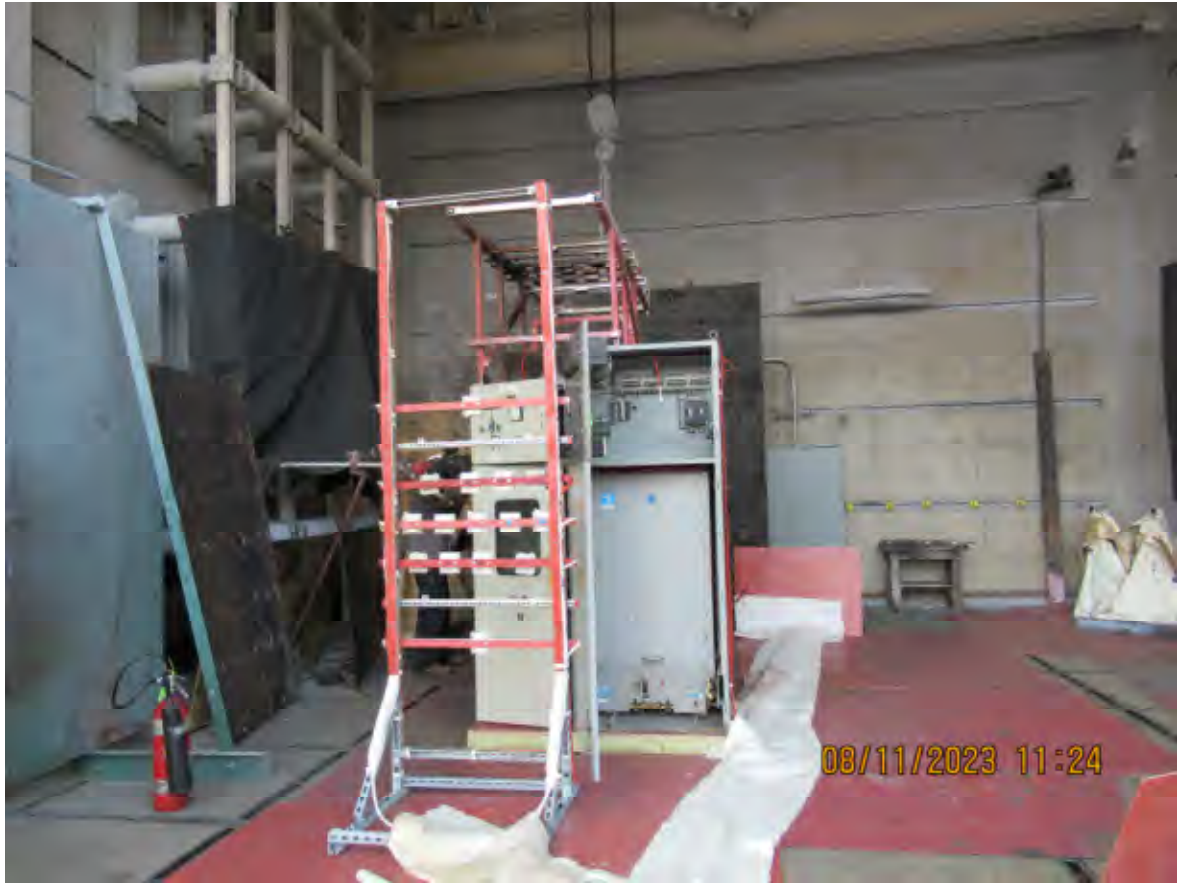
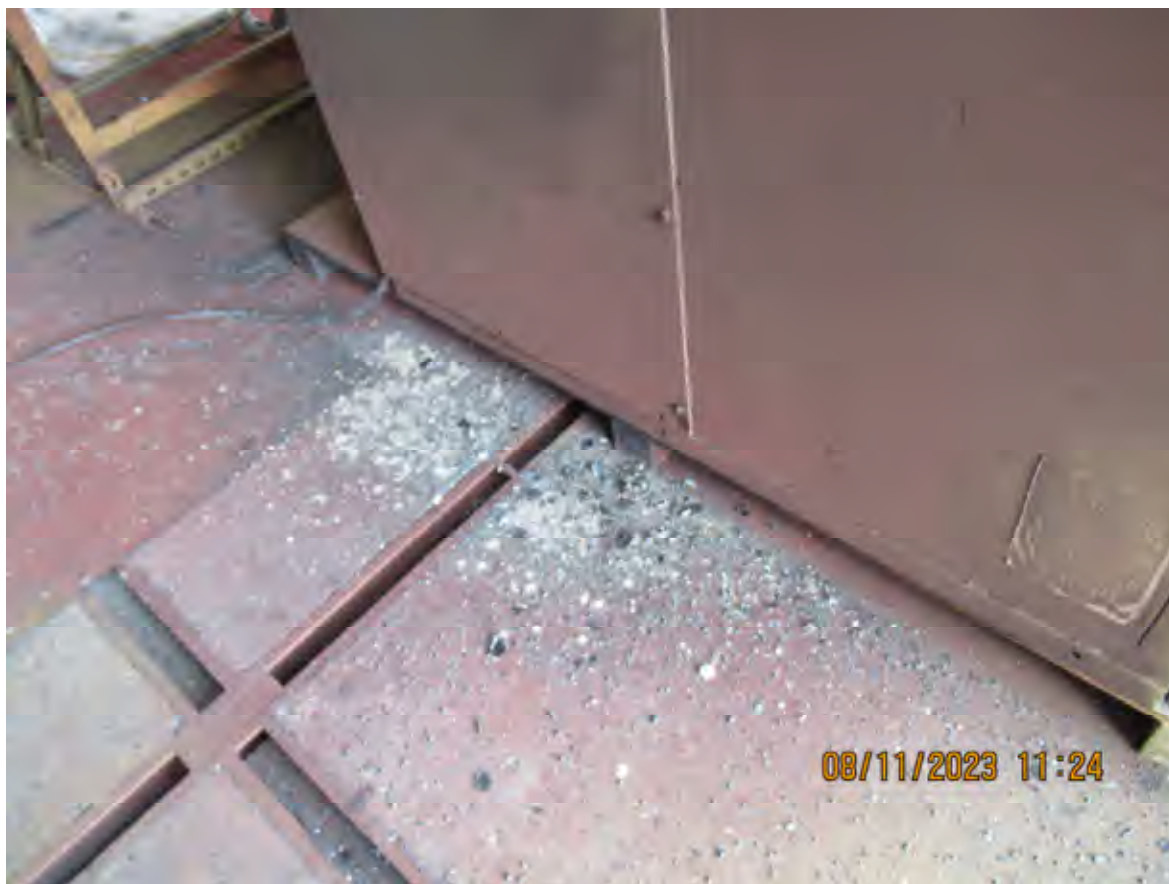
**10.6 Photograph after test**

Interior and sides of the sample exterior were heavily burned.

Fire in the test gear burned for about 20 minutes before being extinguished.

Pressure transducer 1 found on the ground with the rubber tube cut and transducer dislodged from PVC tubing,

Observations: Emission of flames and gas observed.  
PT#1 10.8 psi above atmospheric  
PT #2 0.4 psi above atmospheric

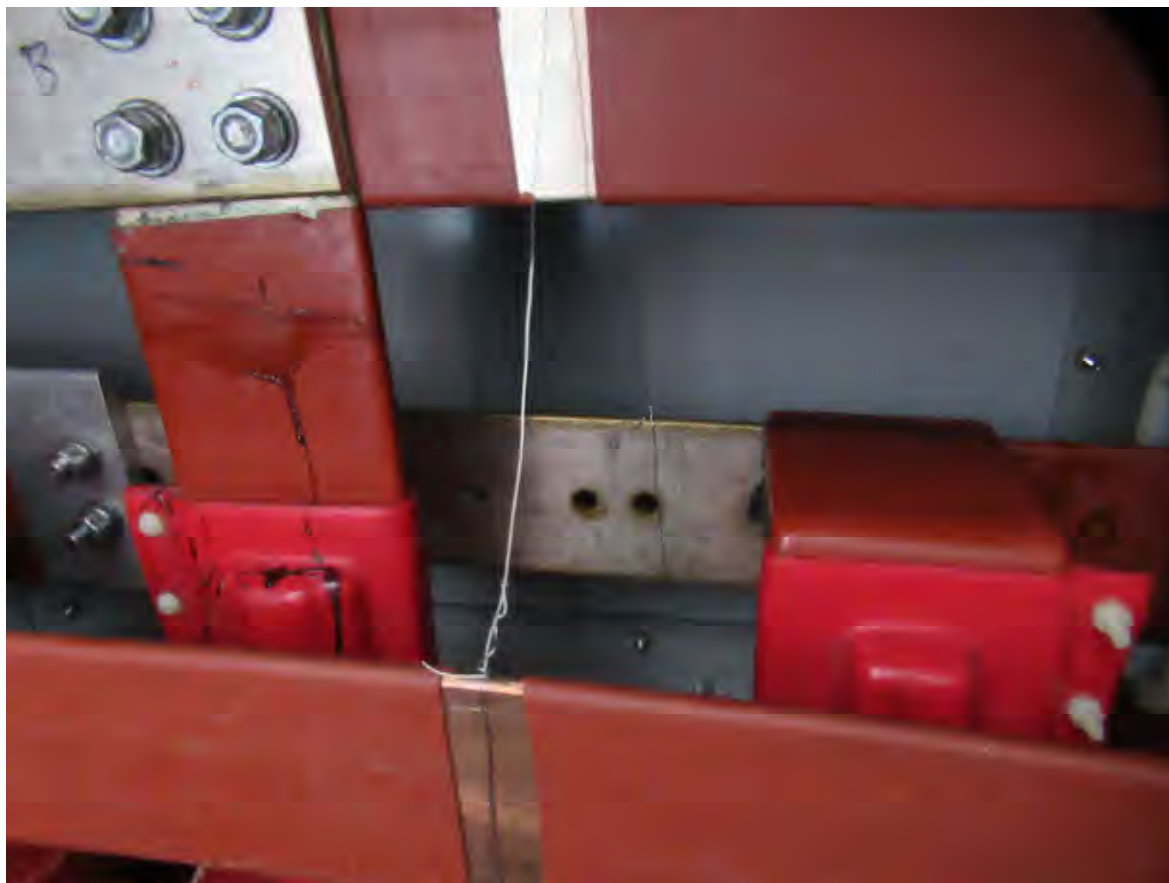
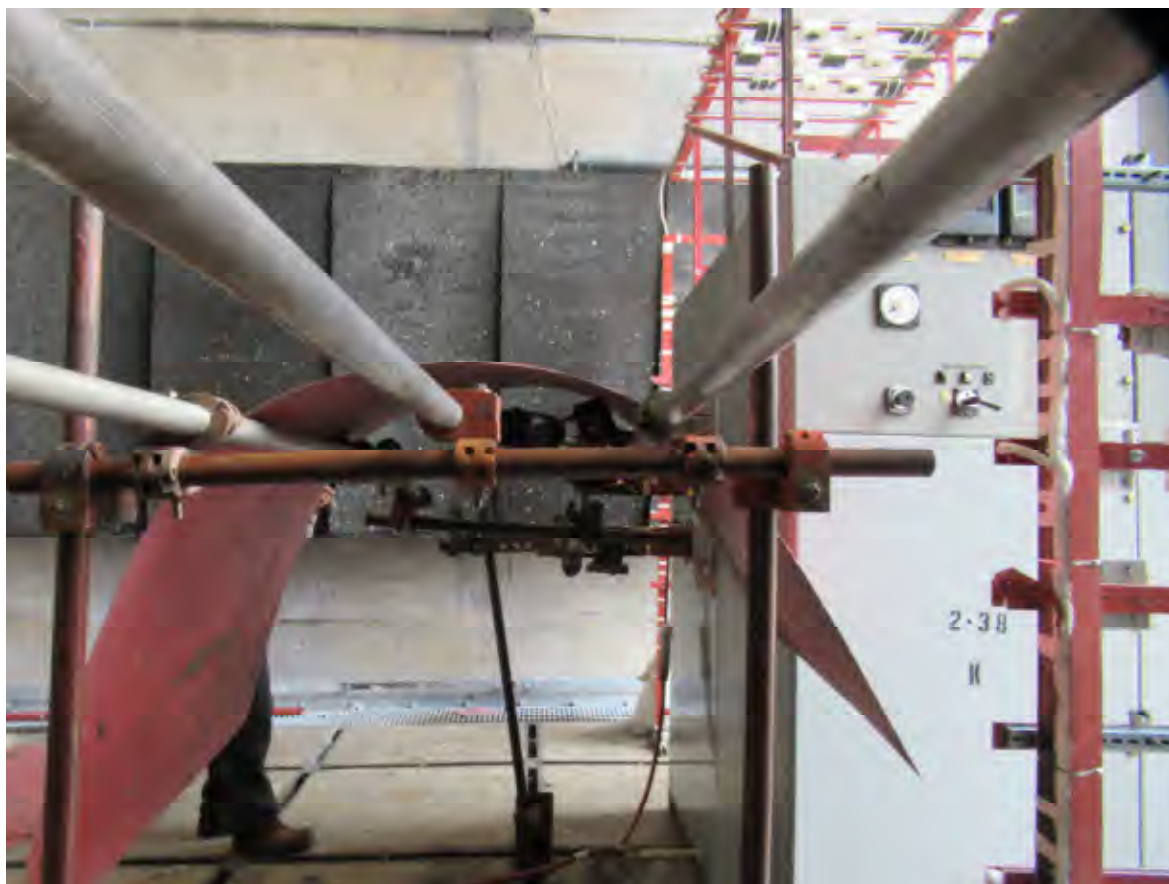
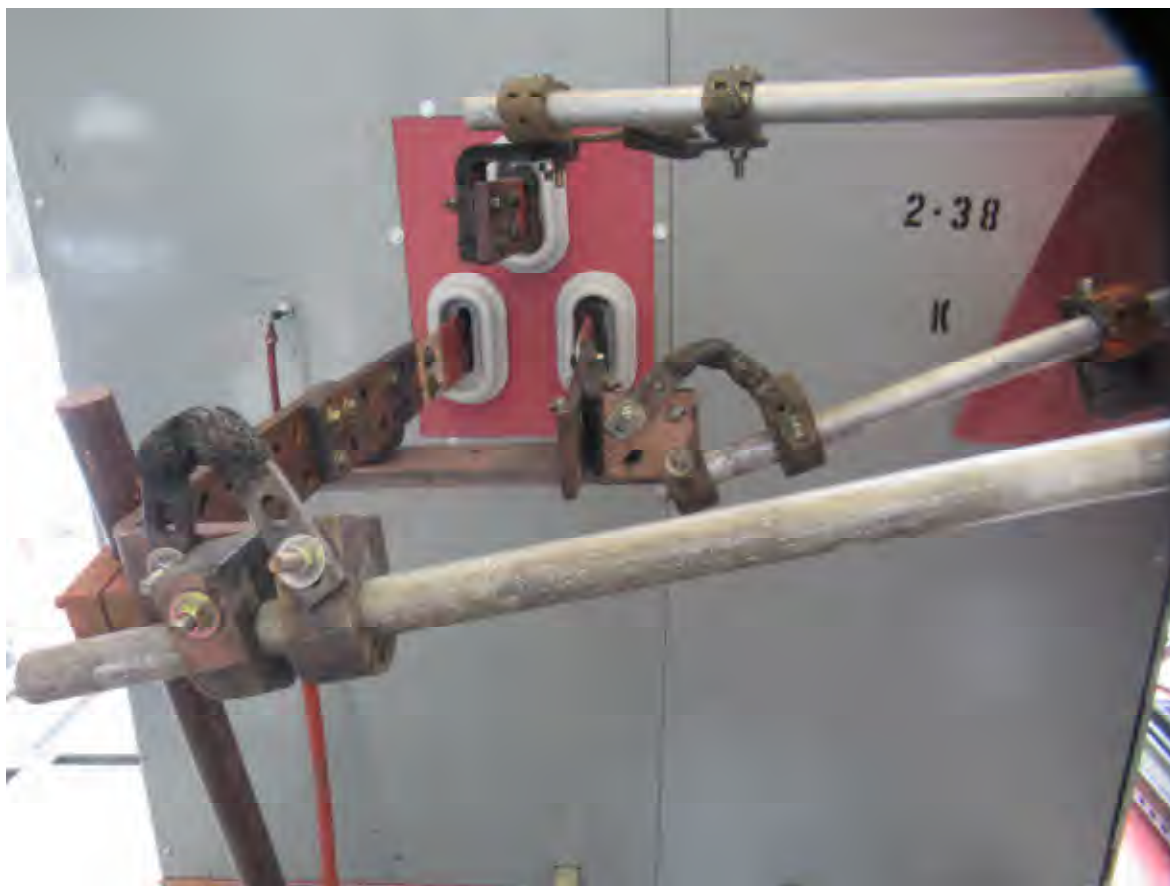
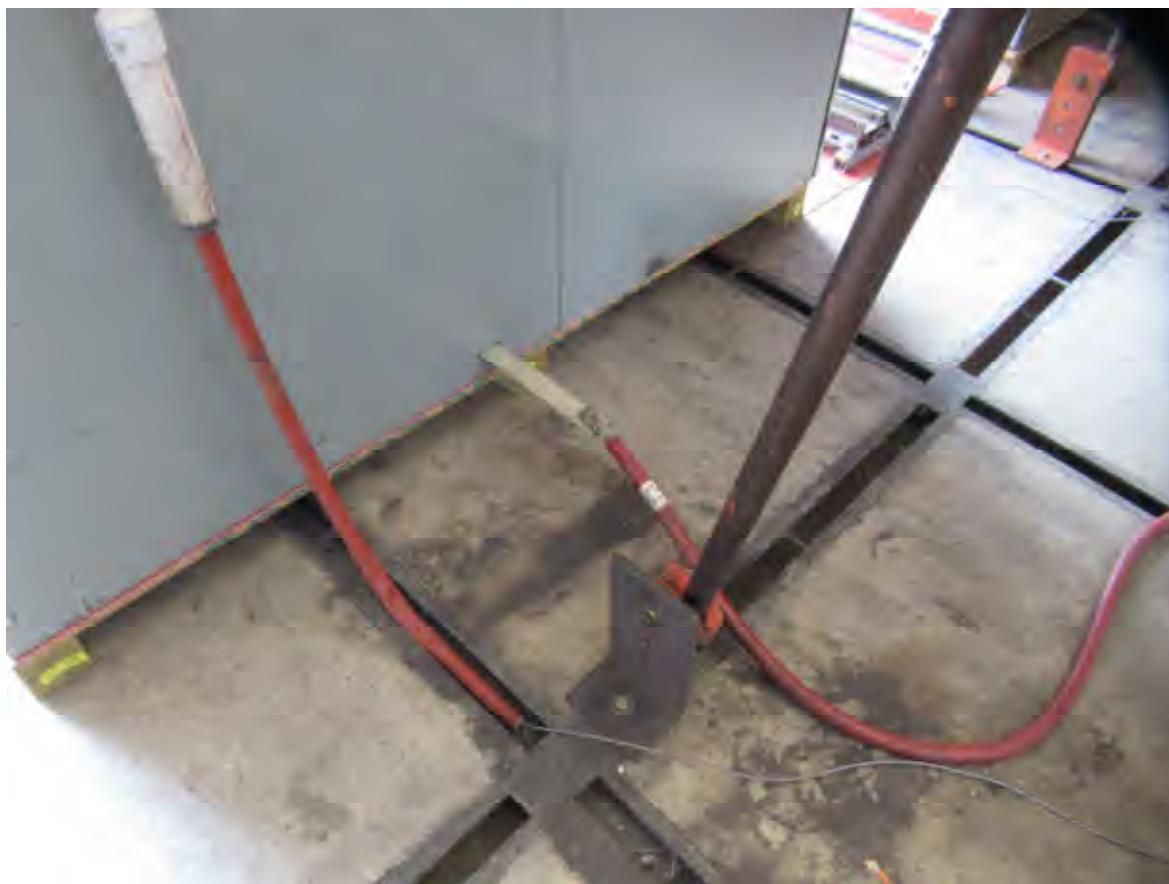
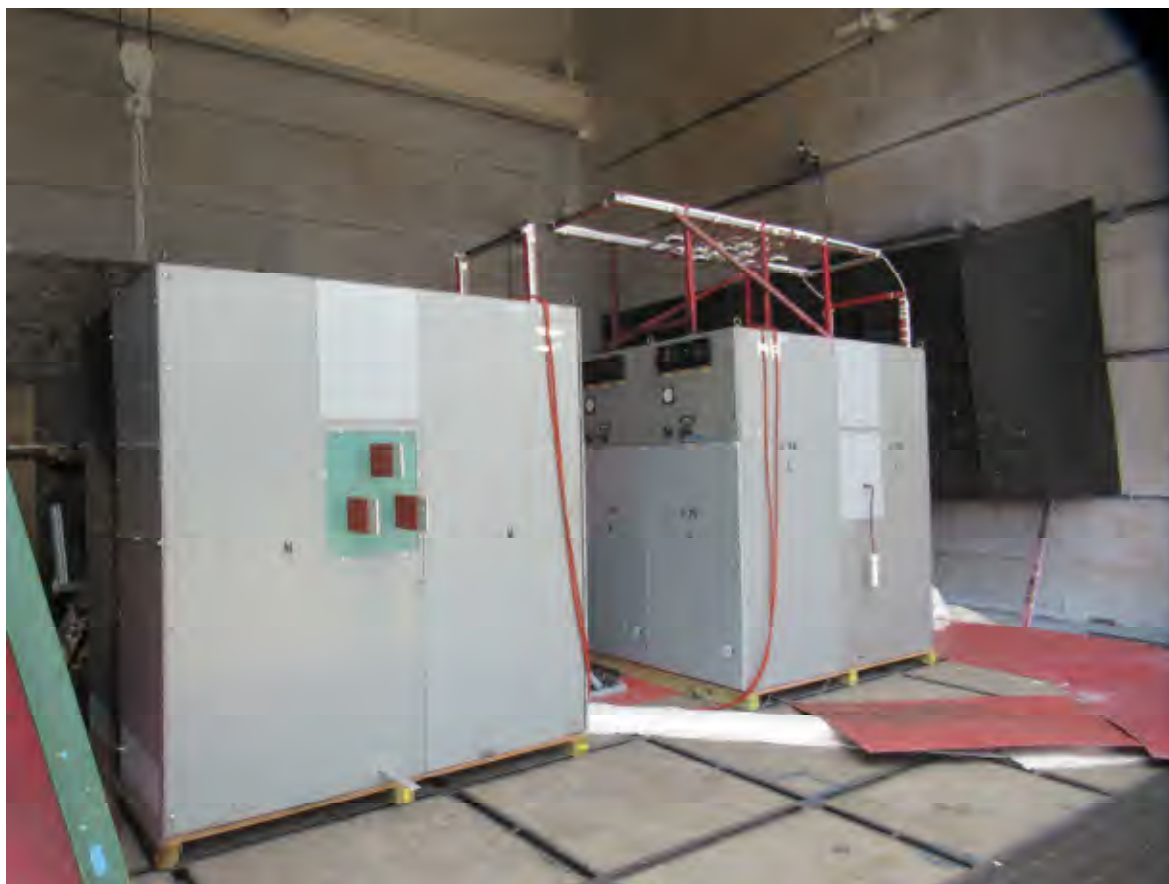
**11.3 Photograph before test**

Supply		
Power	MVA	302
Frequency	Hz	60
Phase(s)		3
Voltage	kV	6.97
Current	kA	25
Impedance	Ω	0.161
Power factor		< 0.1
Neutral		not earthed

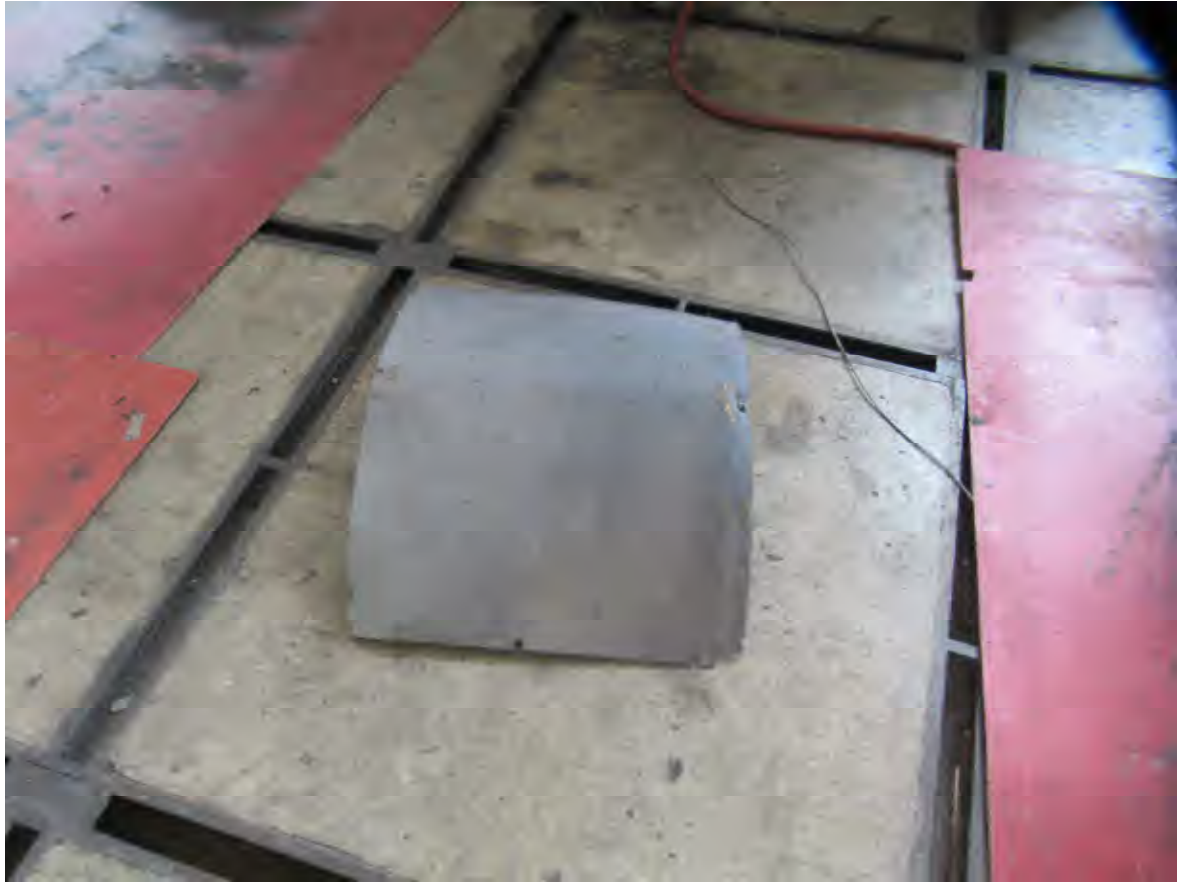
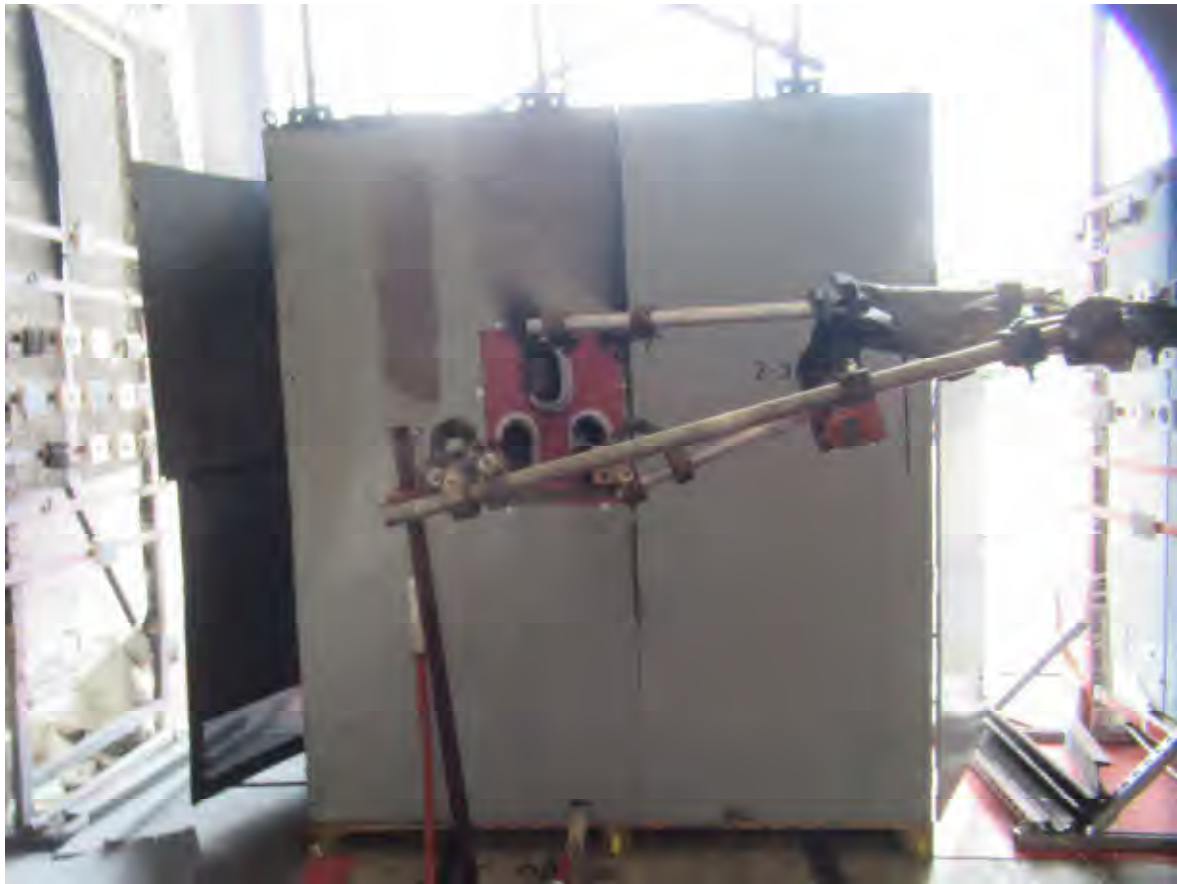
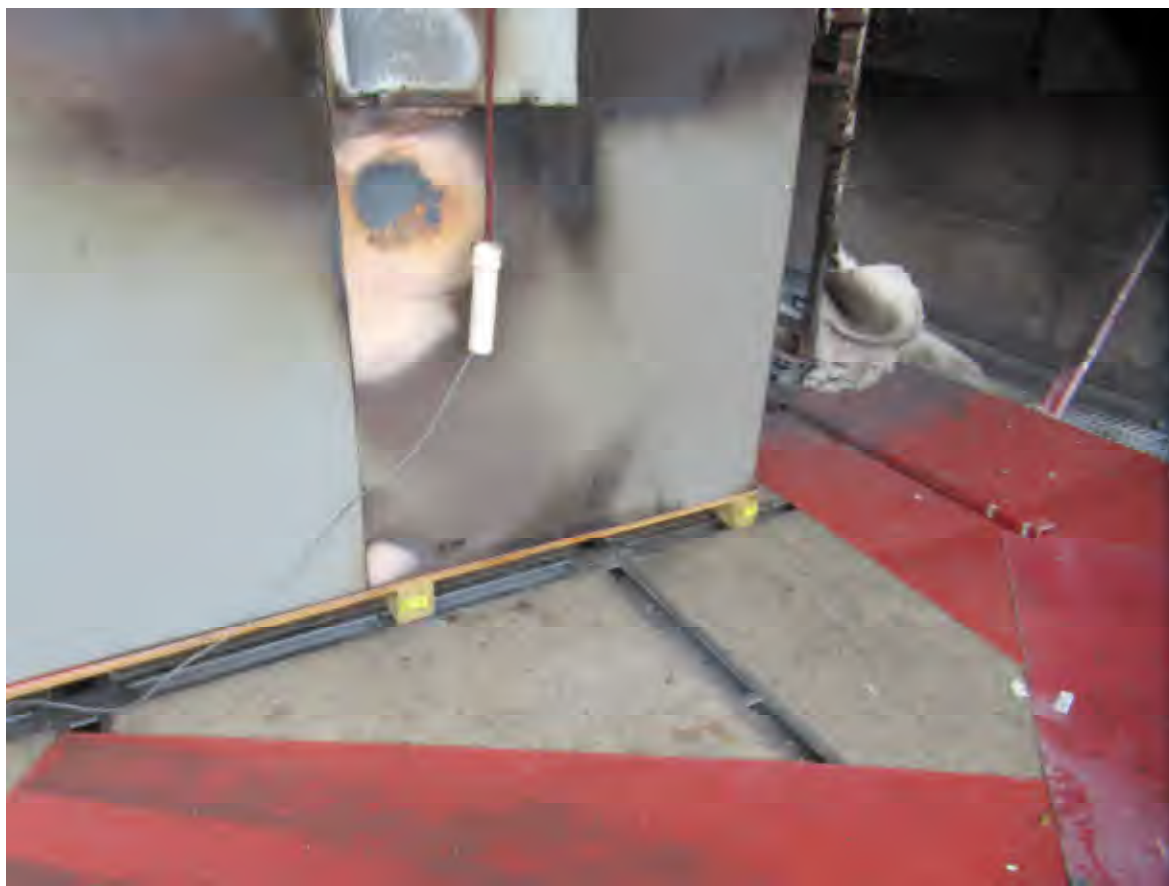
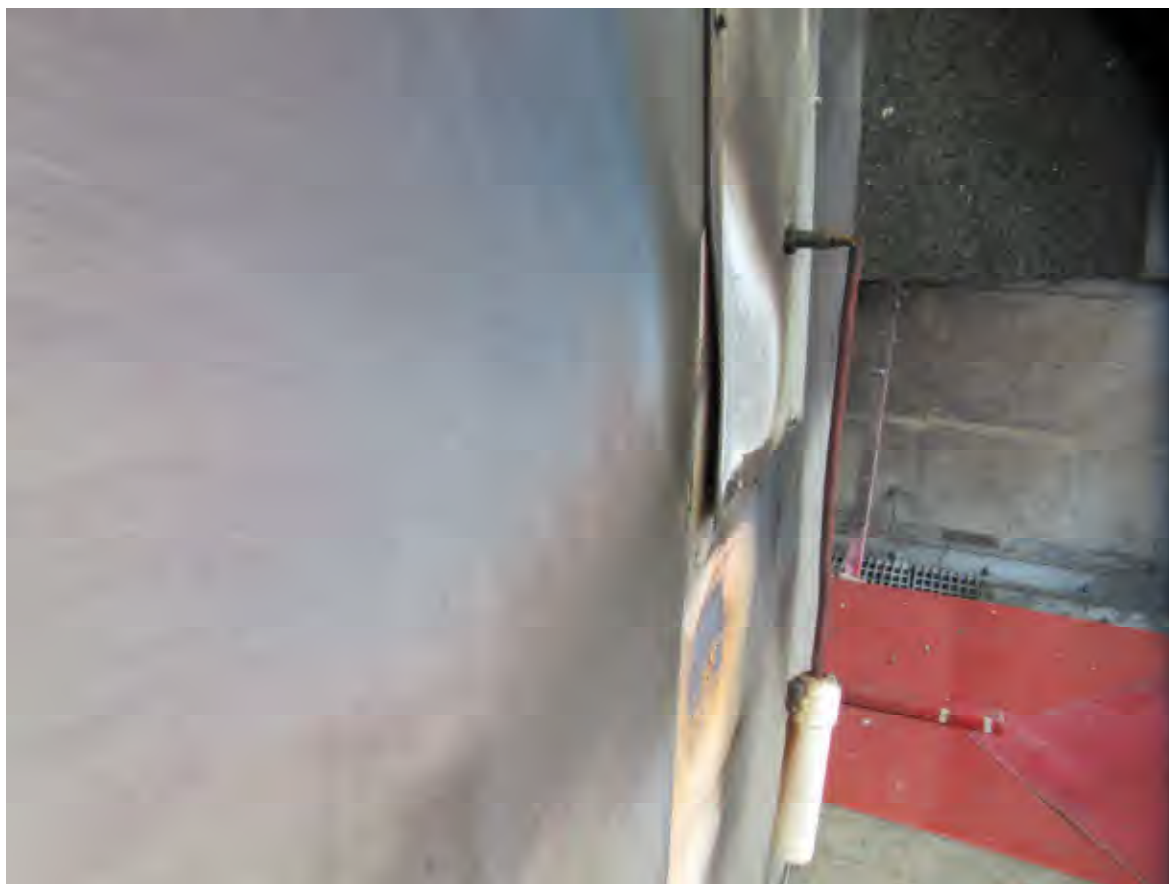
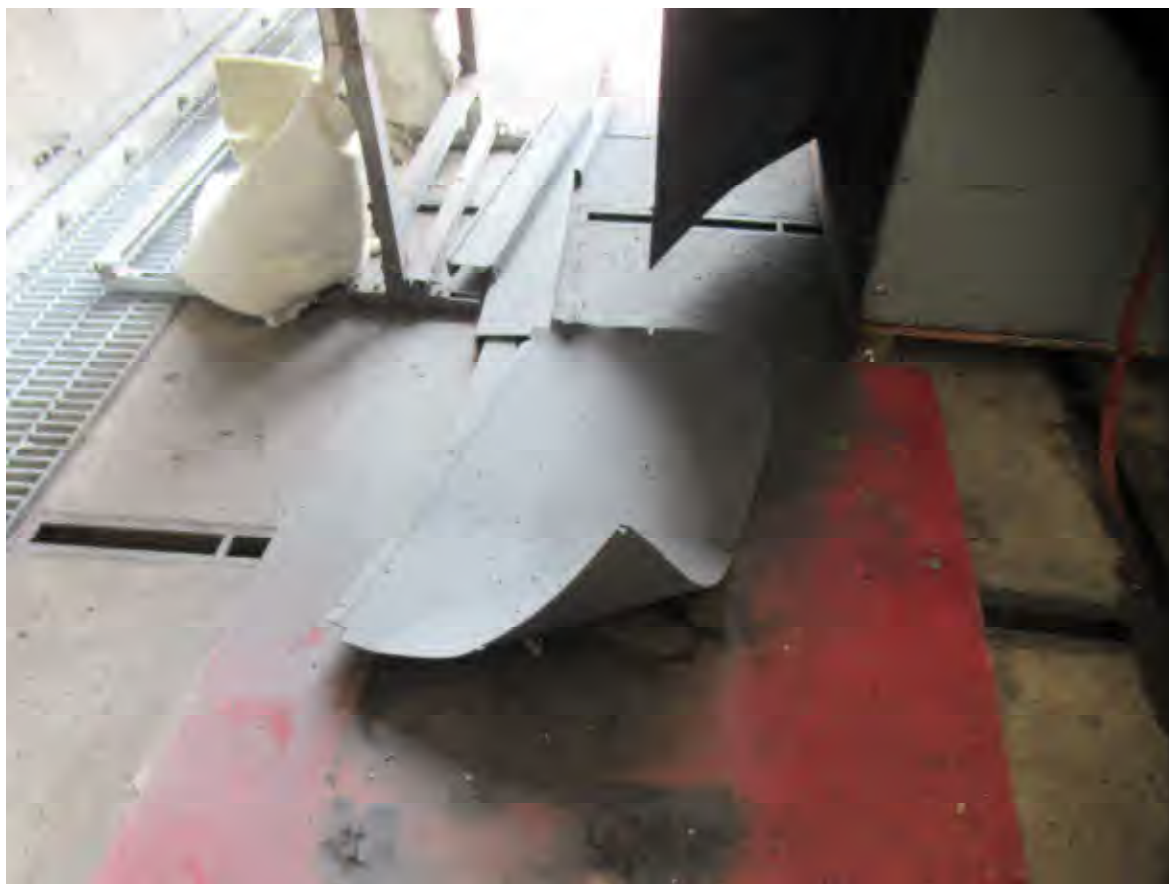
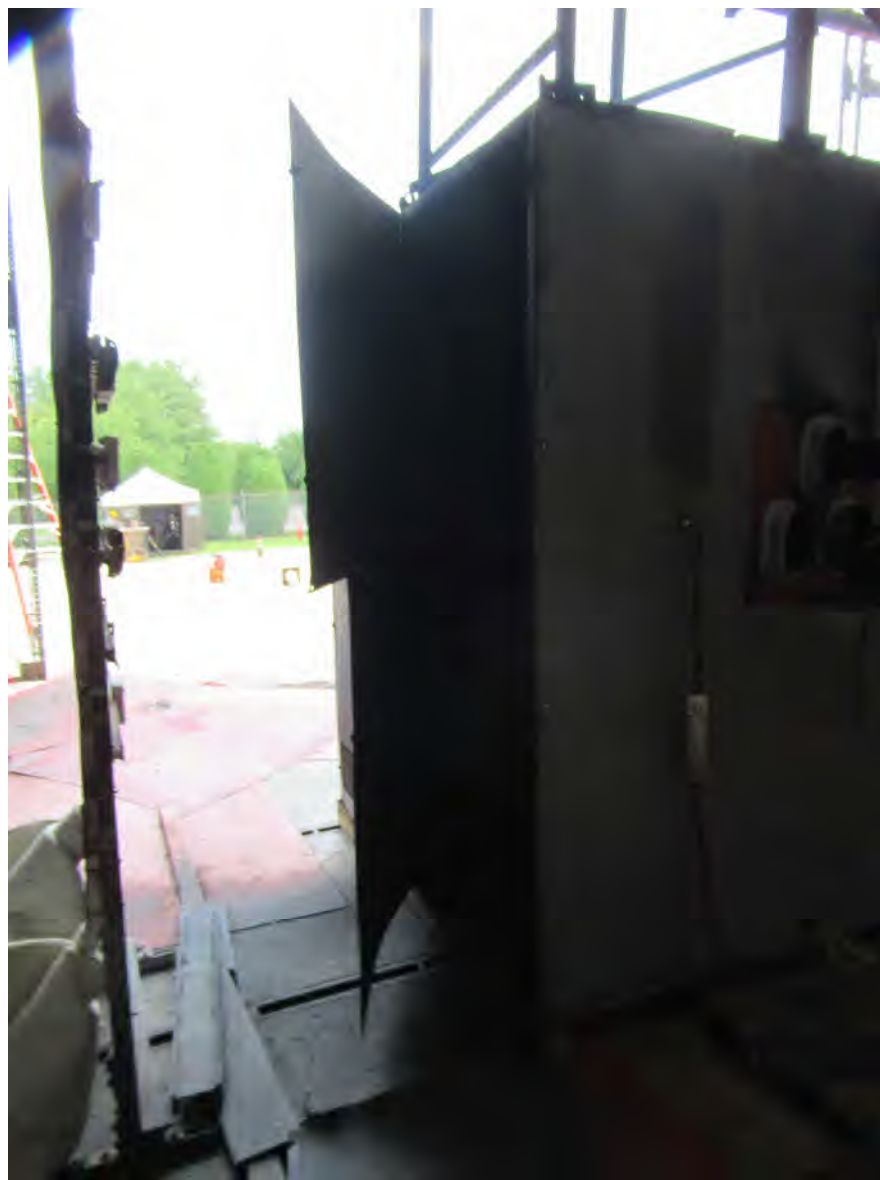
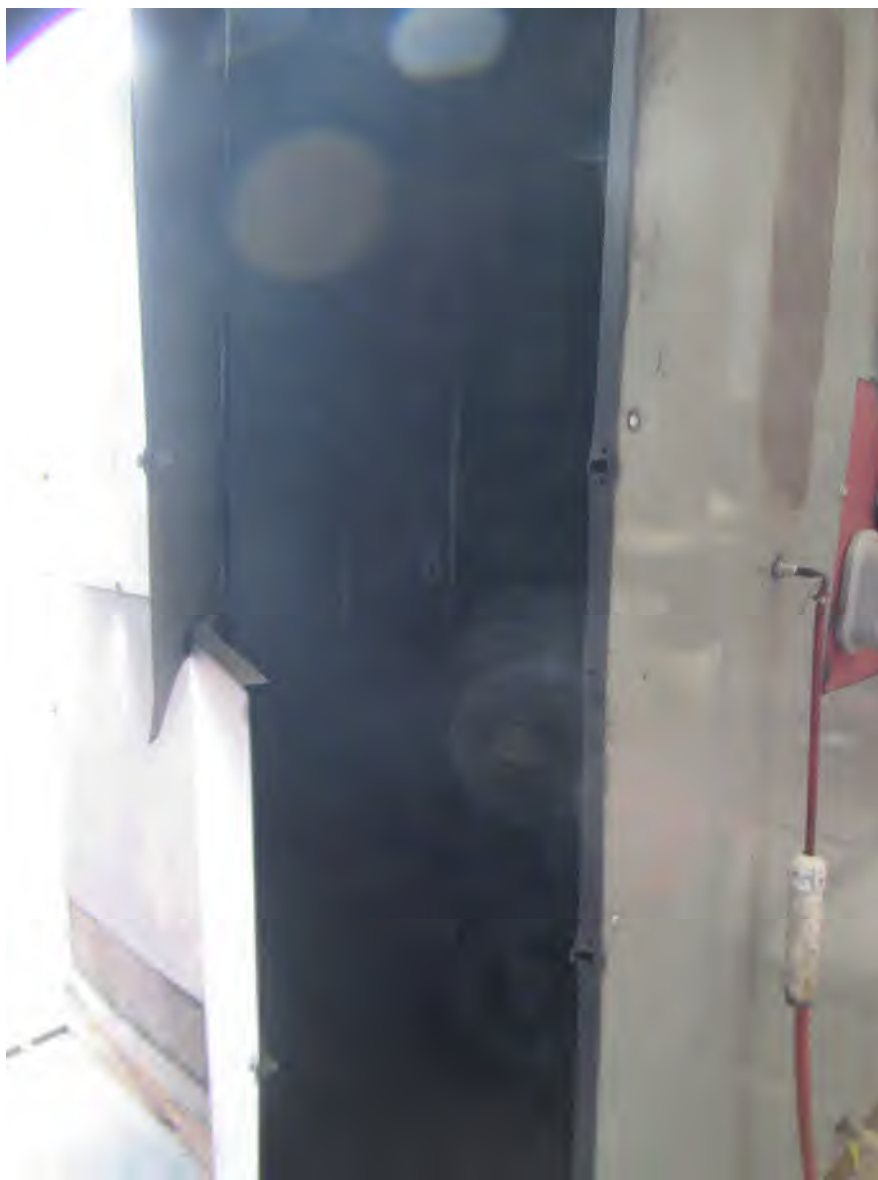
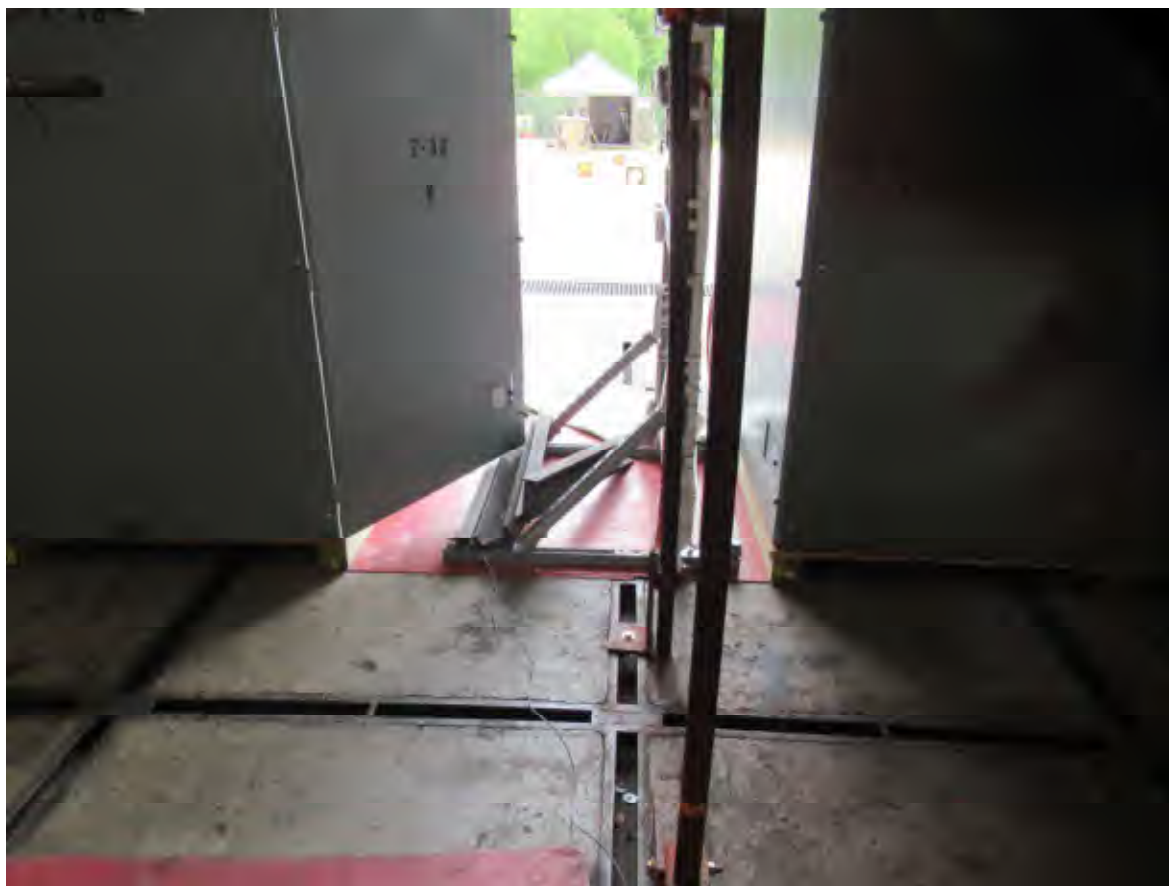
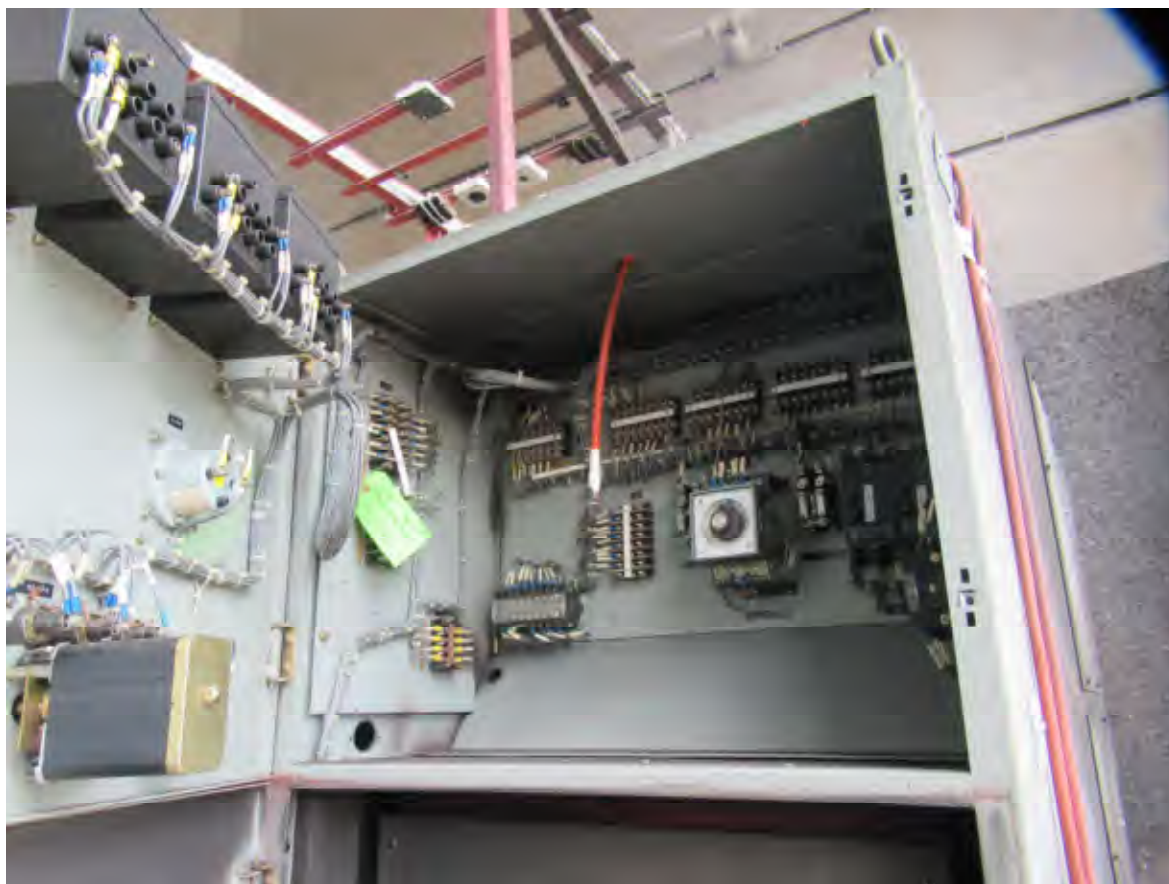
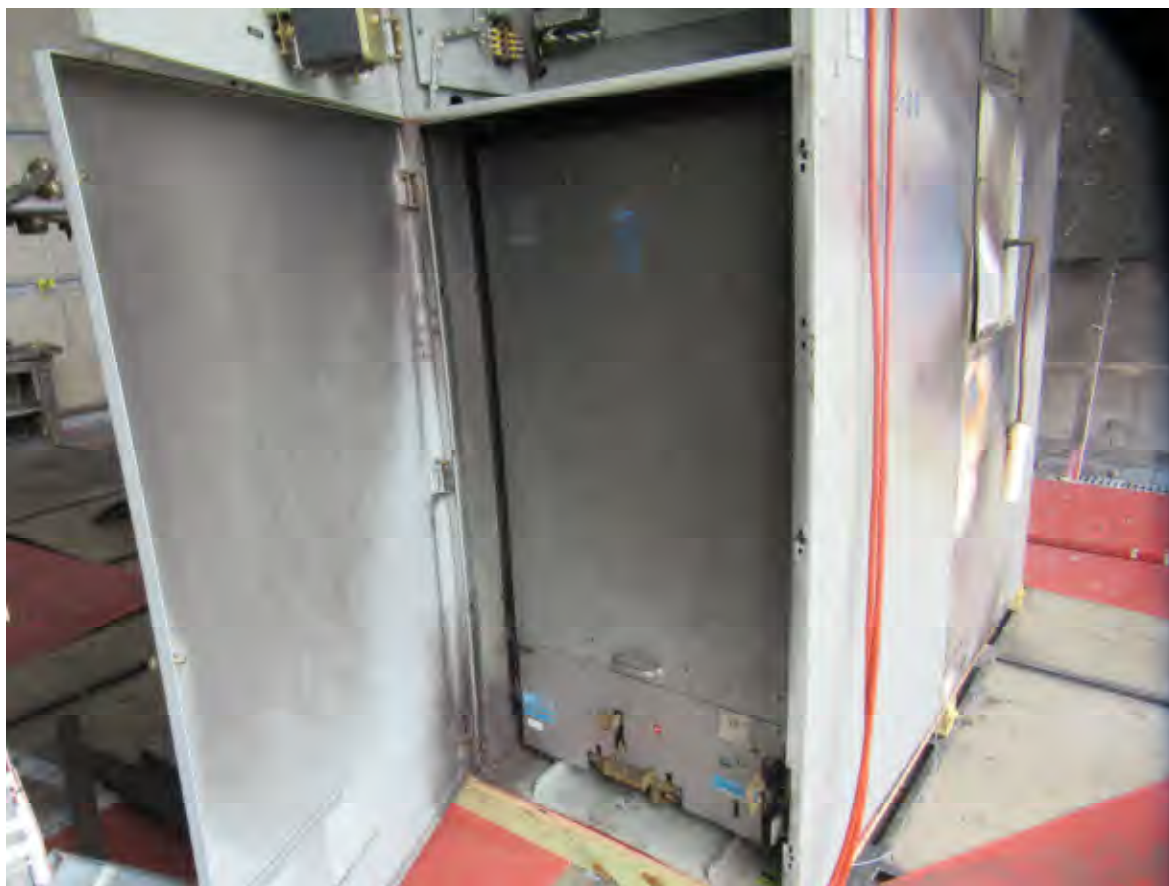
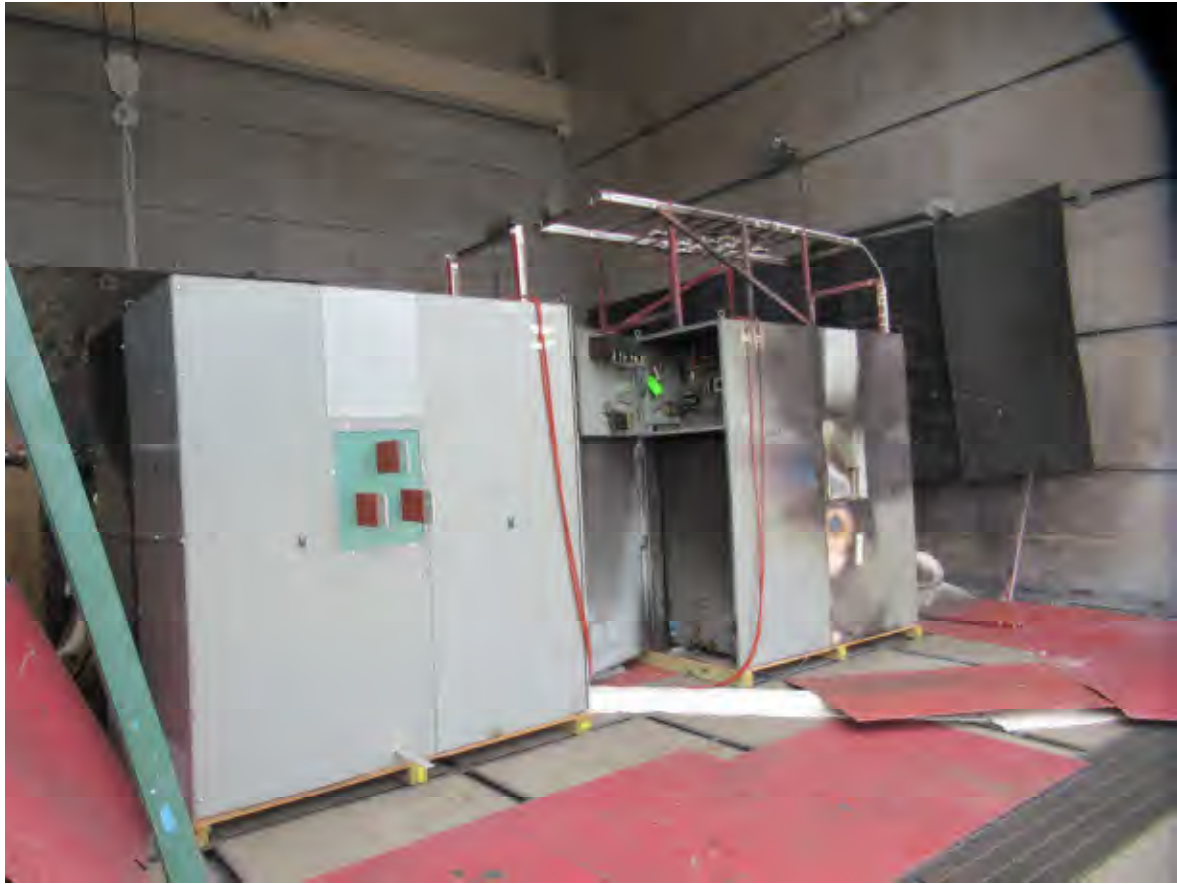
**11.6 Photograph after test**

No burn throughs of enclosure observed.  
Internal enclosure panels found laying on ground after test.

Observations: Emission of flames and gas observed.  
 PT#1 3.85 psi above atmospheric.  
 PT#2 1.18 psi above atmospheric.
