# Understanding High Energy Arcing Faults

Course No: E05-018

*This course was adapted from the NIST U.S. Department of Commerce, Publication No. NIST TN 2290, “Report on High Energy Arcing Fault Experiments”, which is in the public domain.*

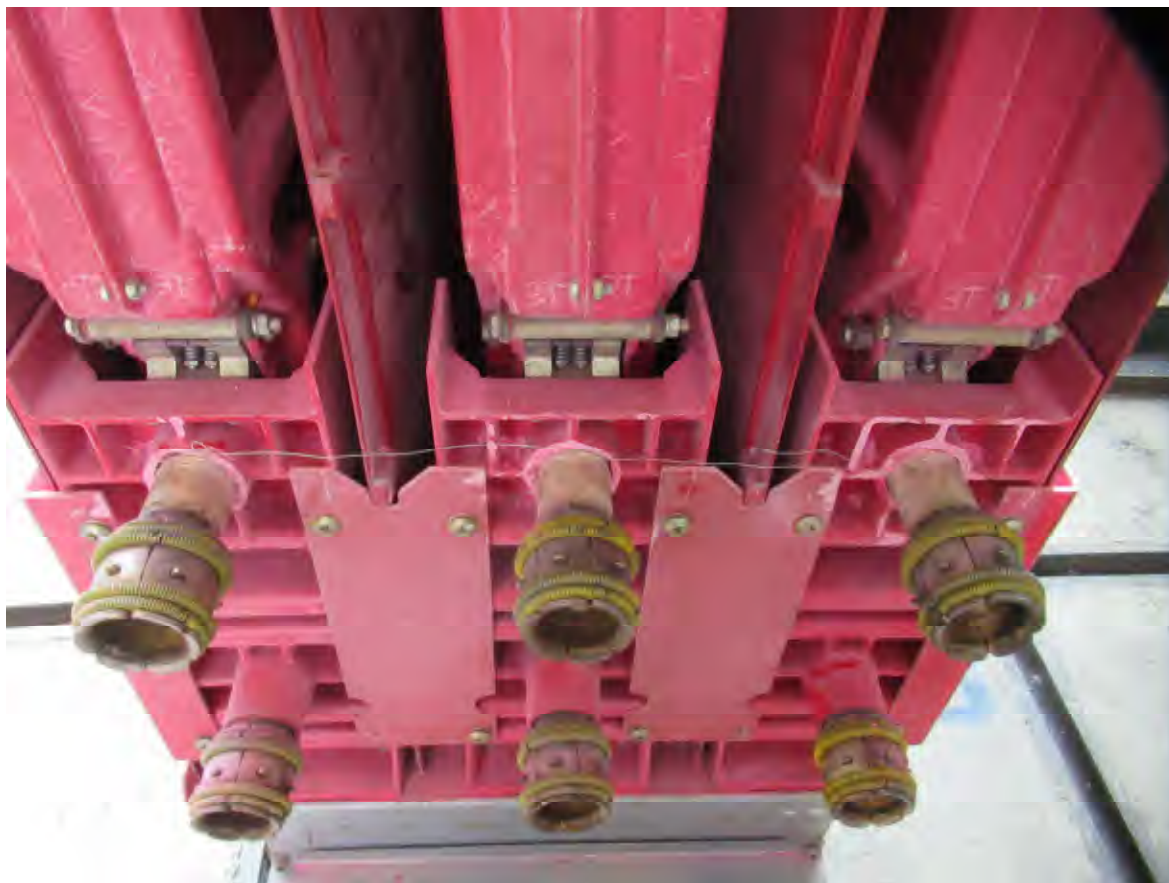
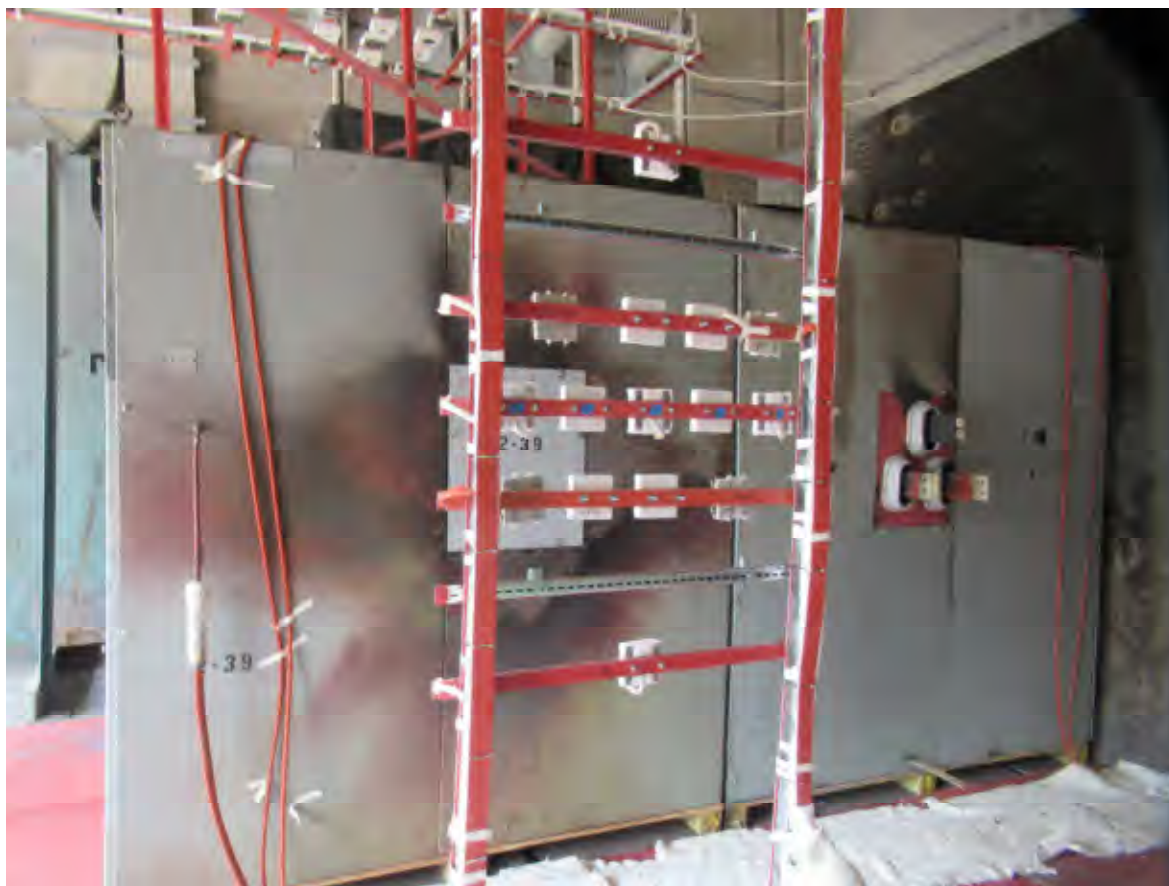
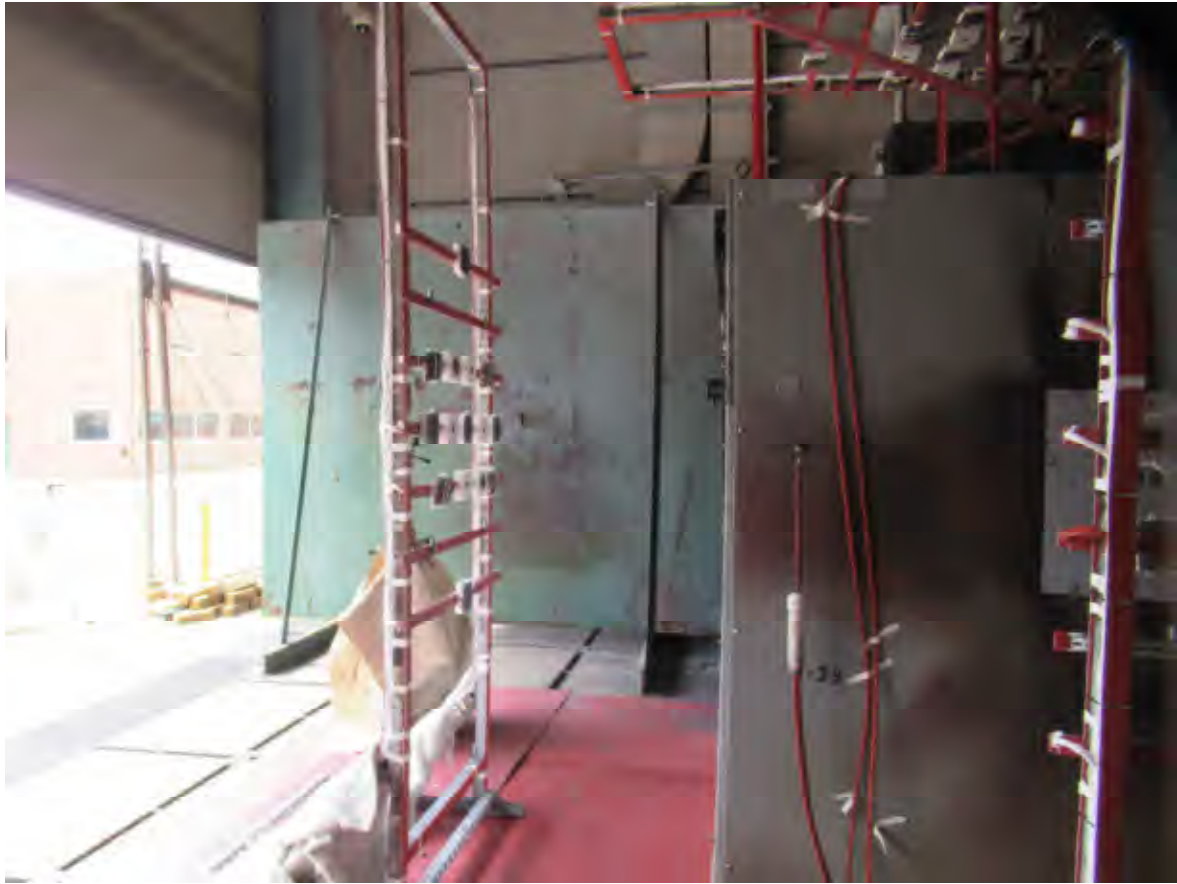
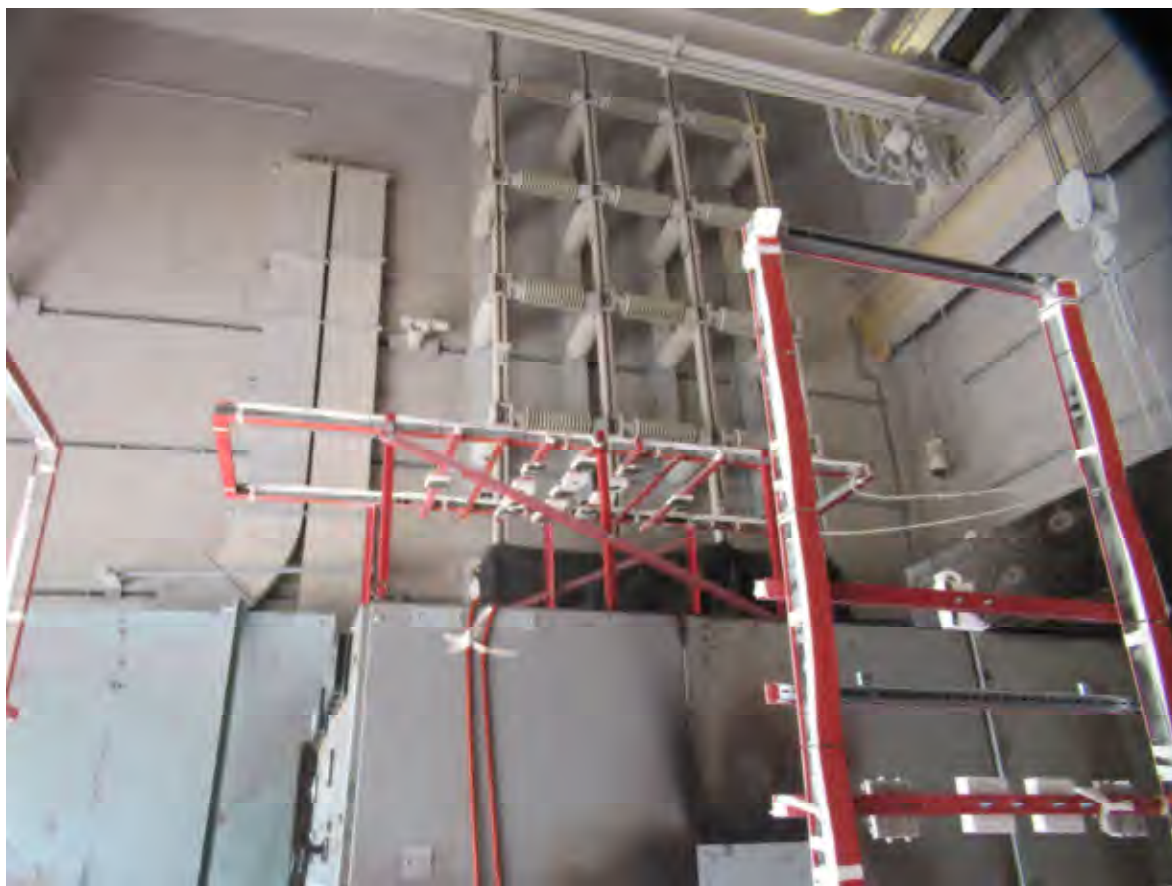
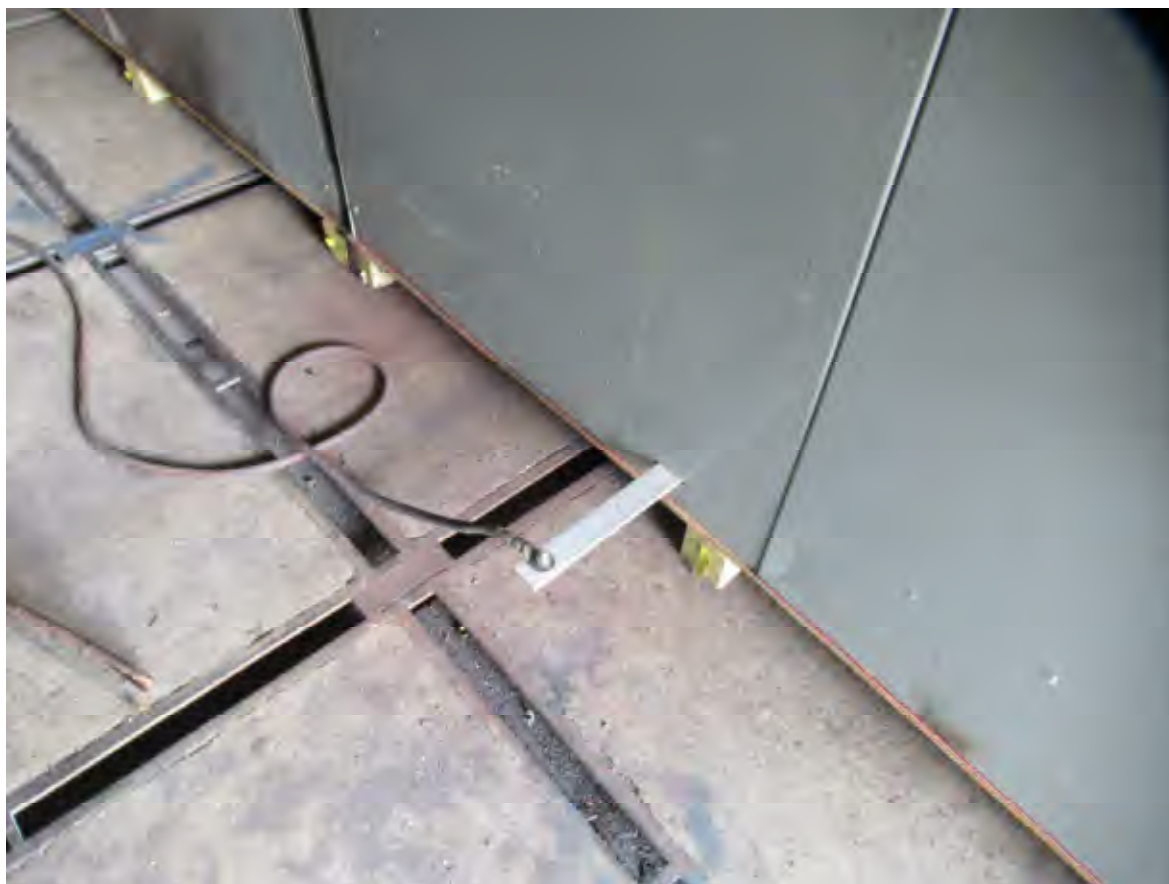
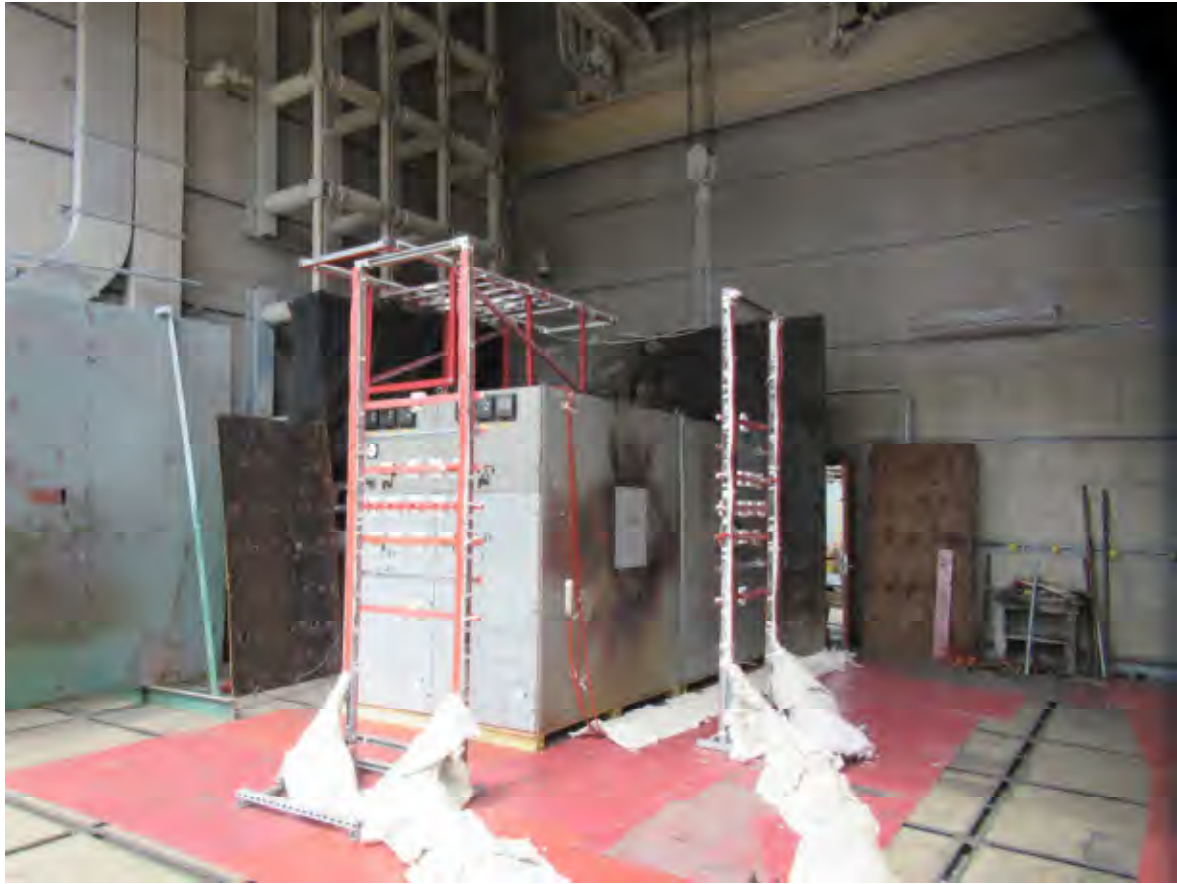
**12.3 Photograph before test**

Test sample new. All adjacent enclosures were used in prior tests and re-conditioned for this test.

Supply		
Power	MVA	302
Frequency	Hz	60
Phase(s)		3
Voltage	kV	6.97
Current	kA	25
Impedance	Ω	0.161
Power factor		< 0.1
Neutral		not earthed

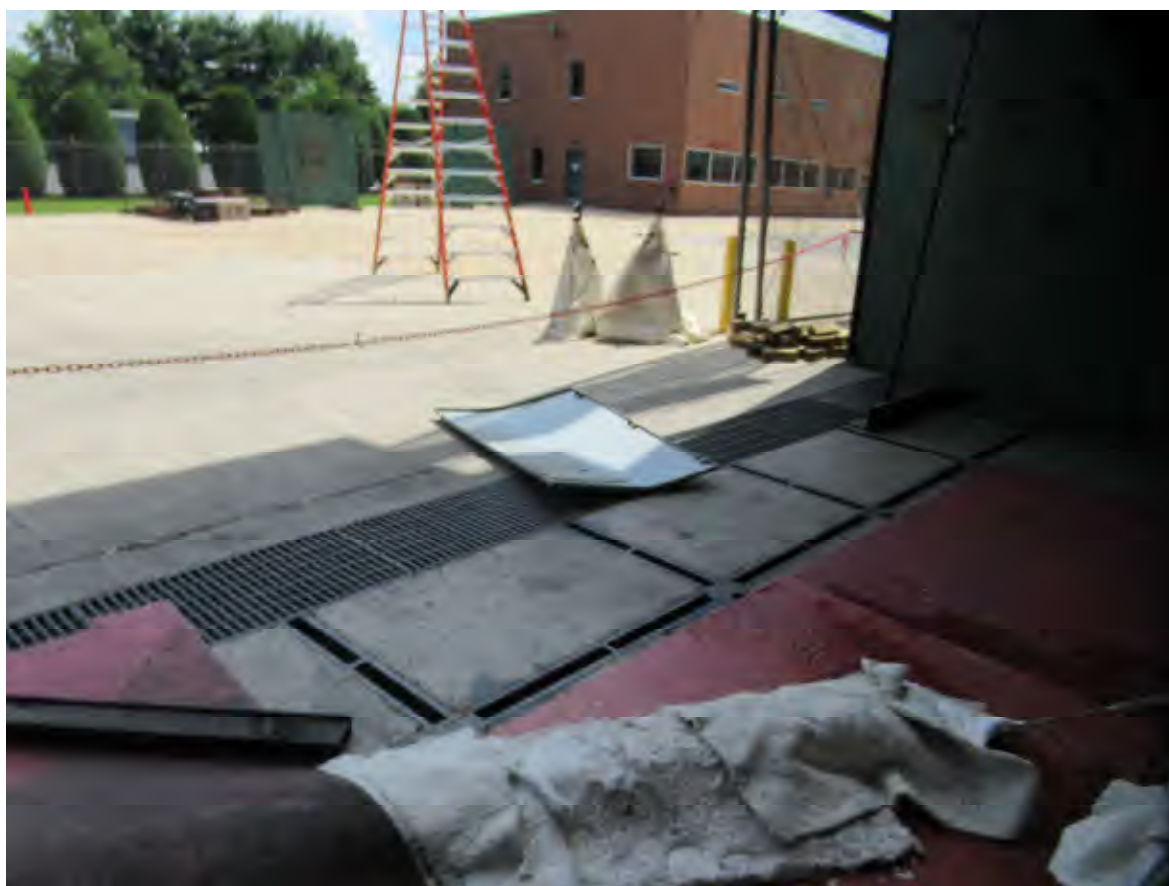
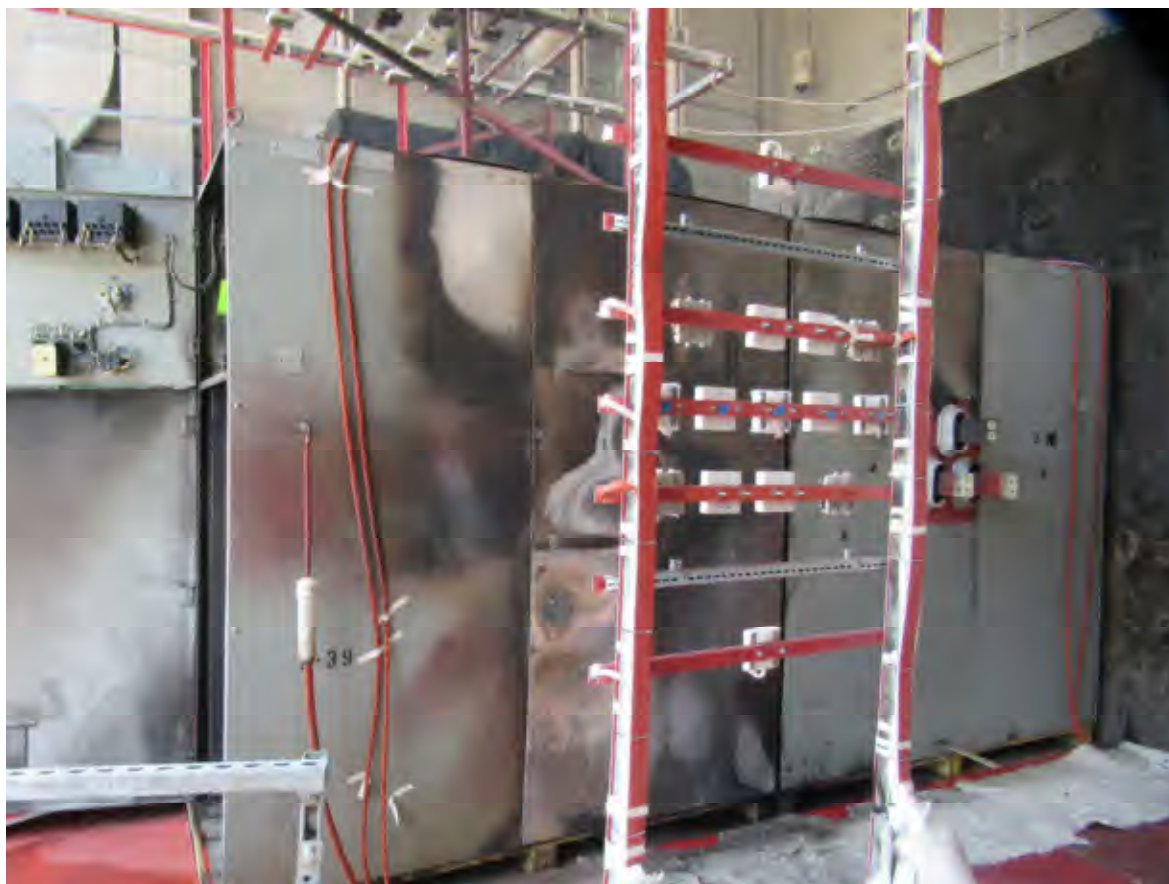
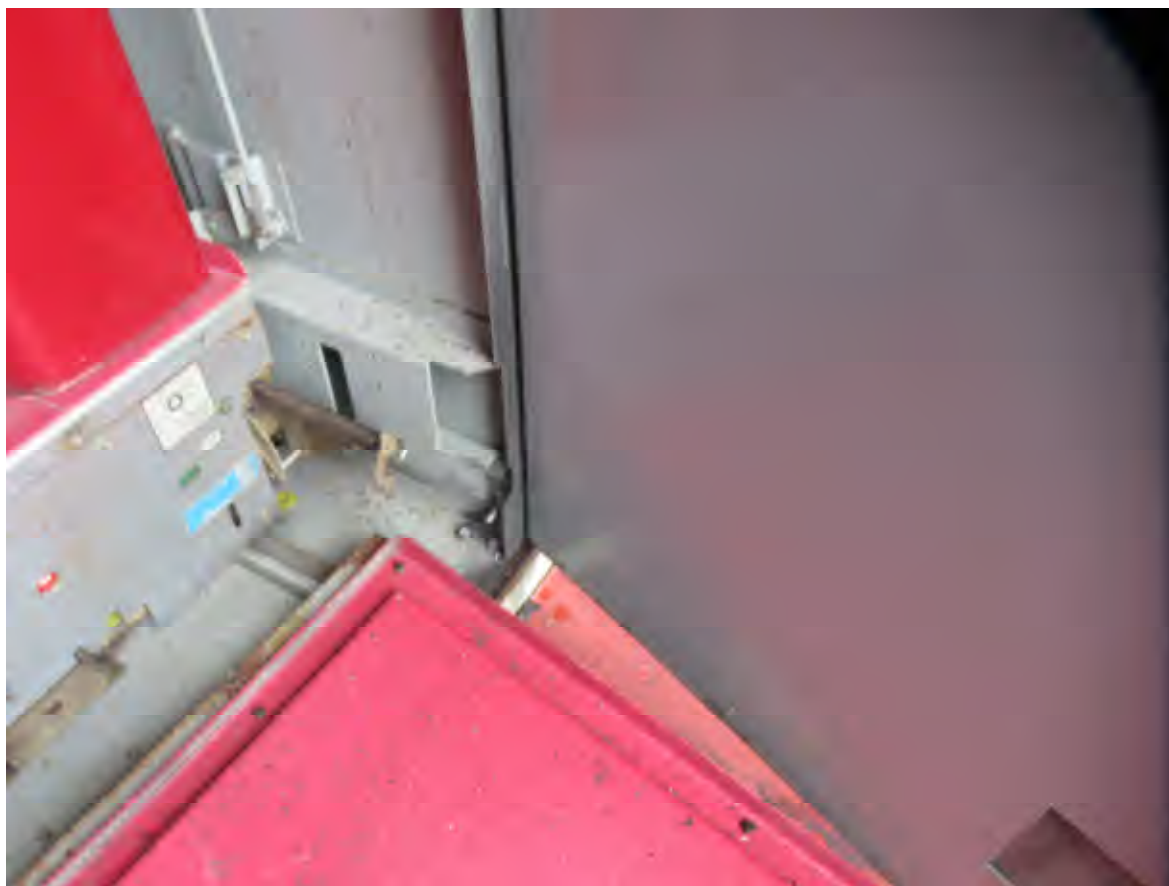
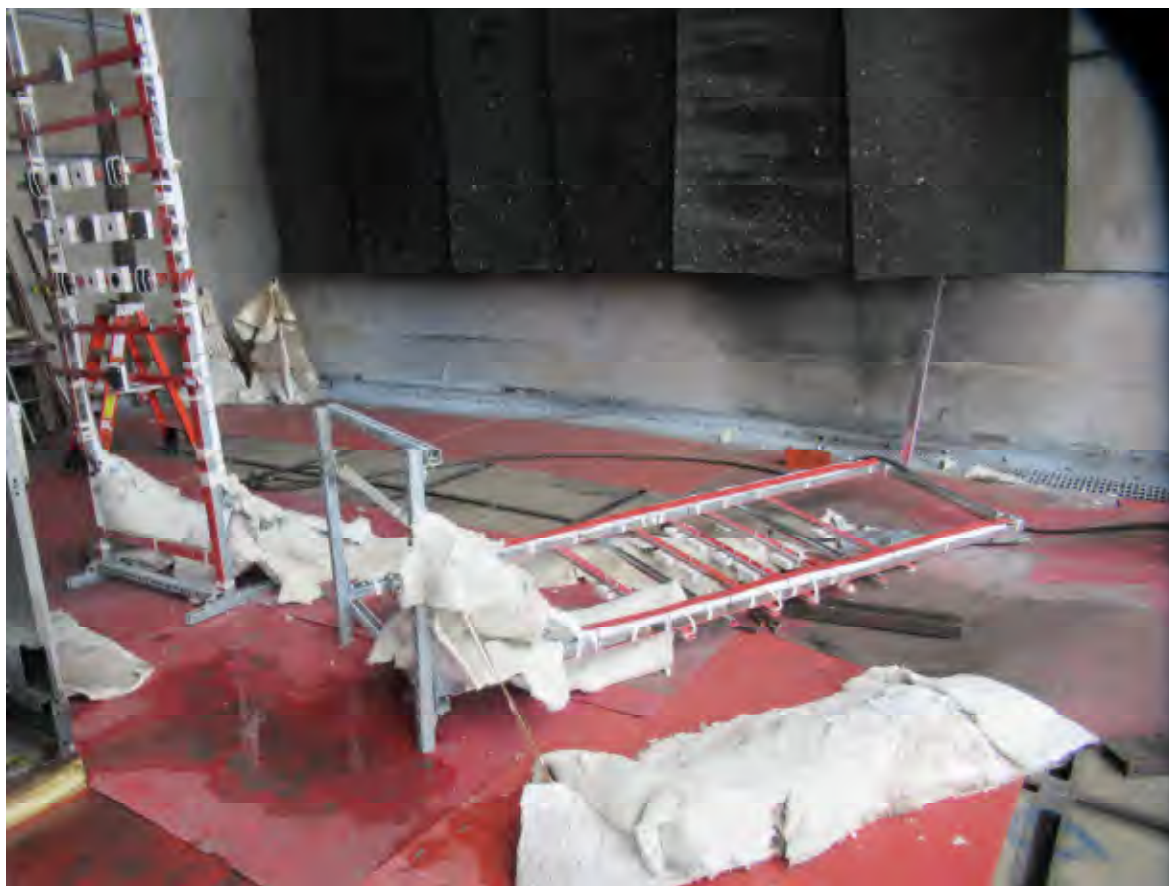
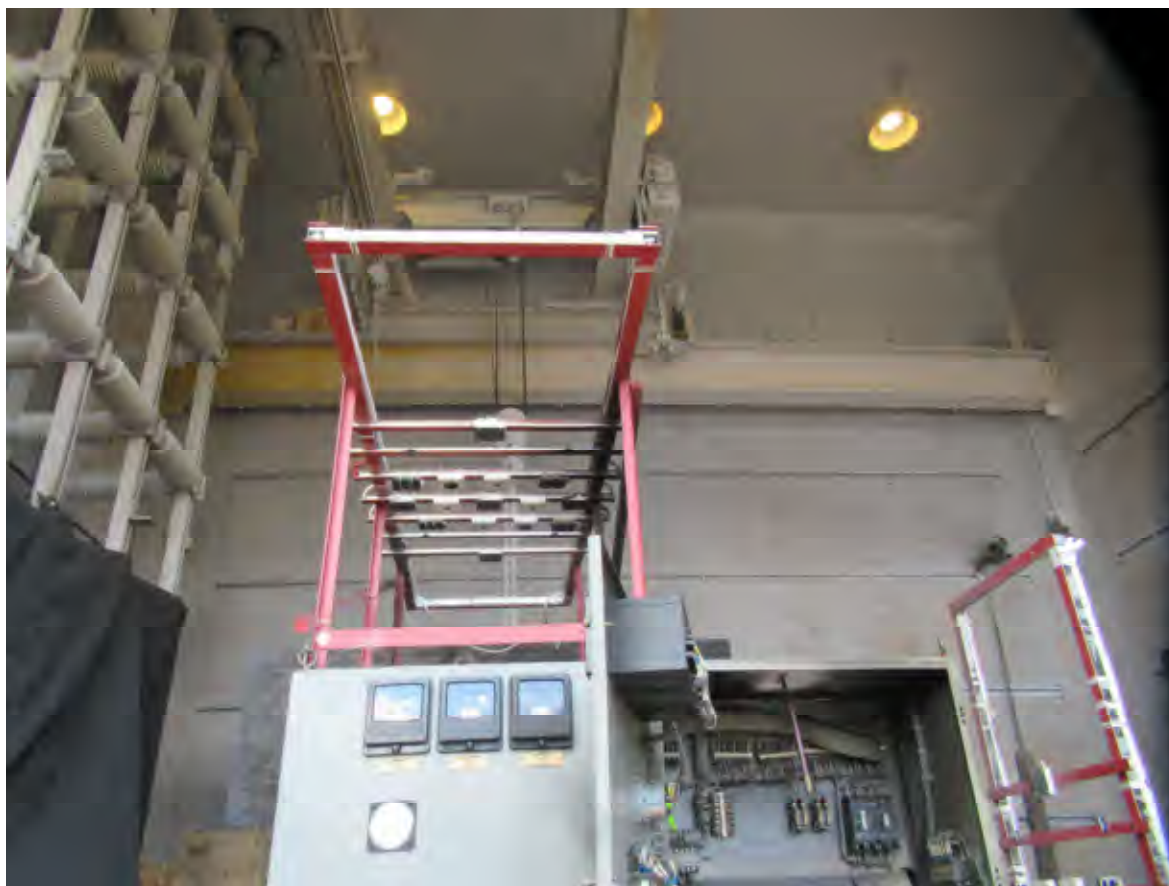
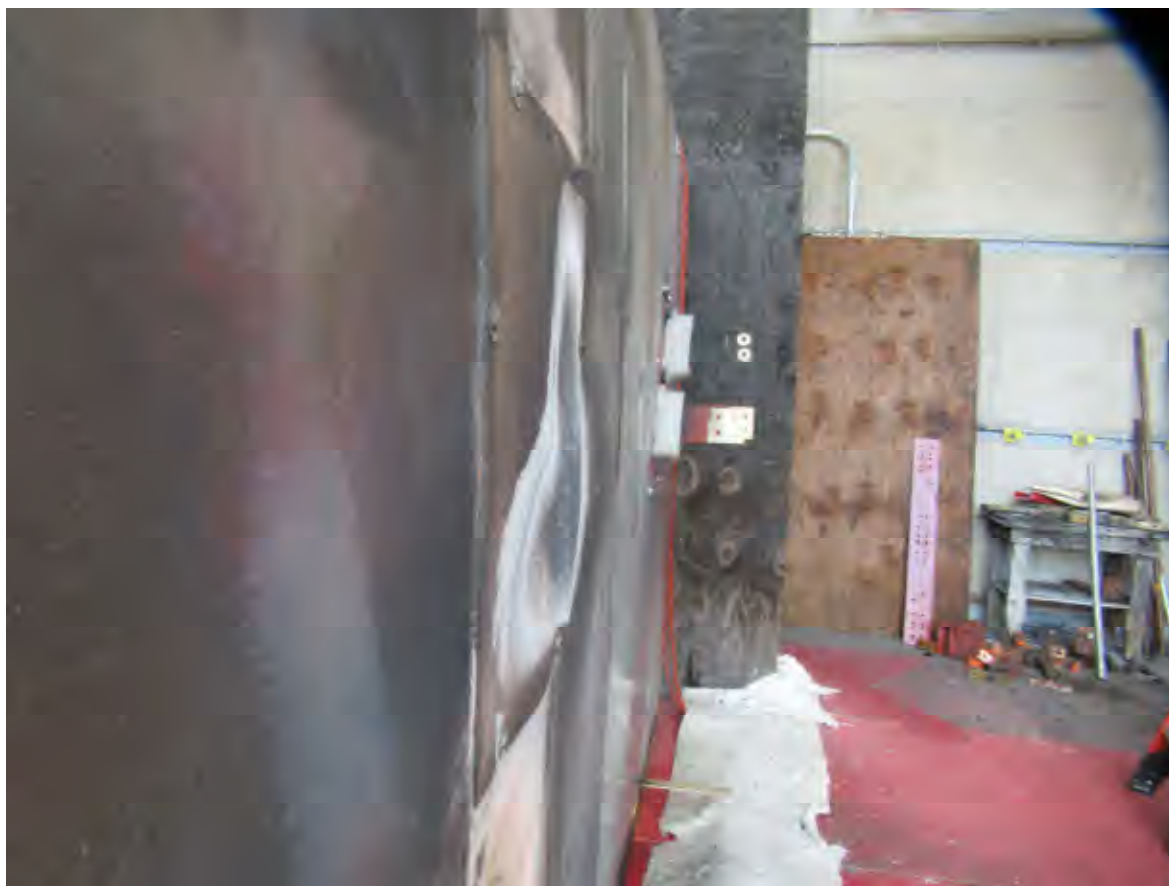
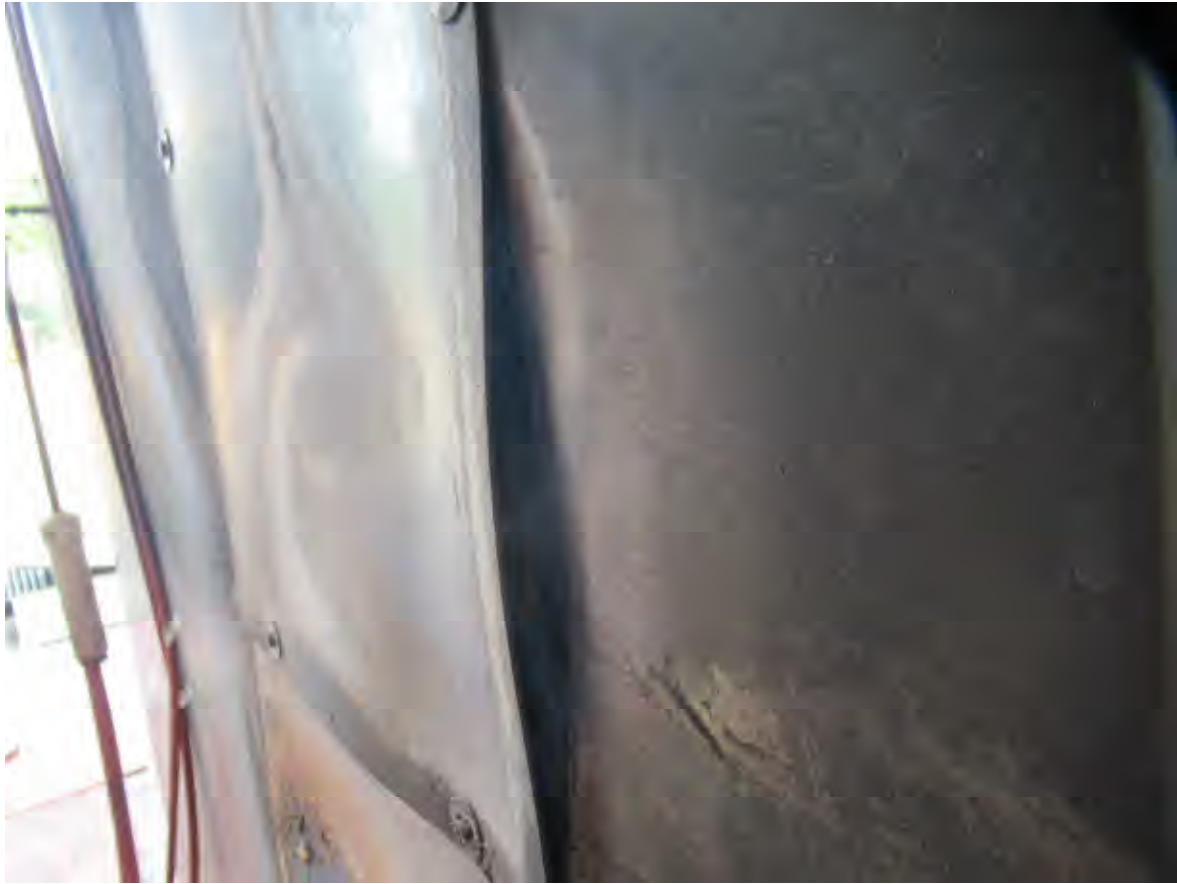
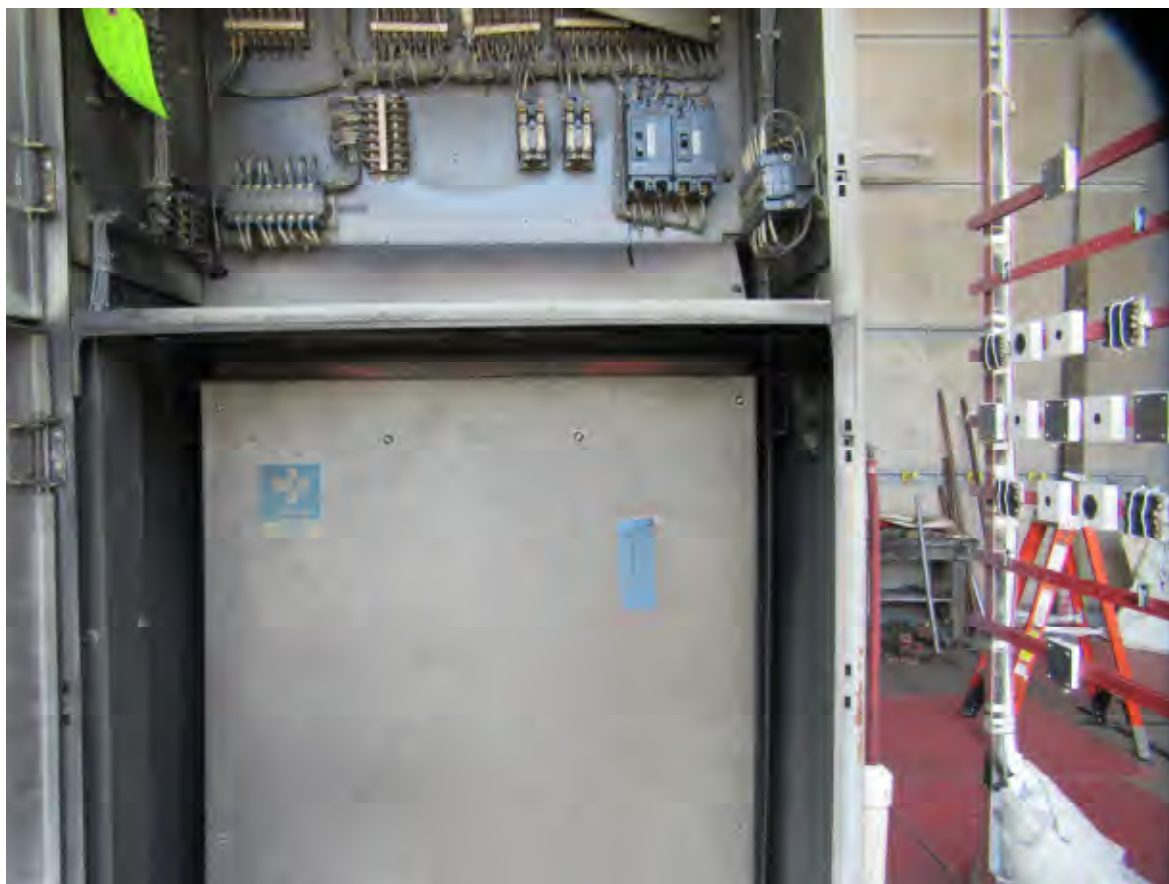
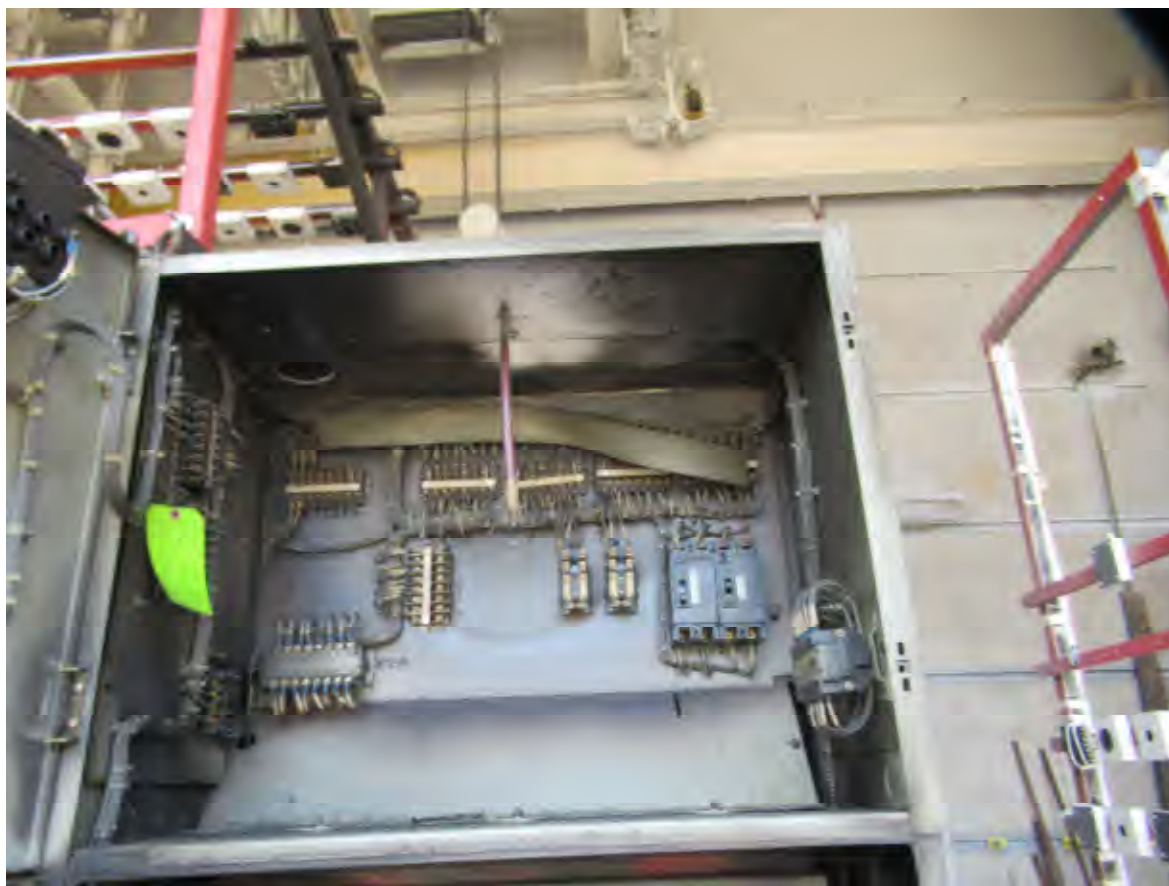
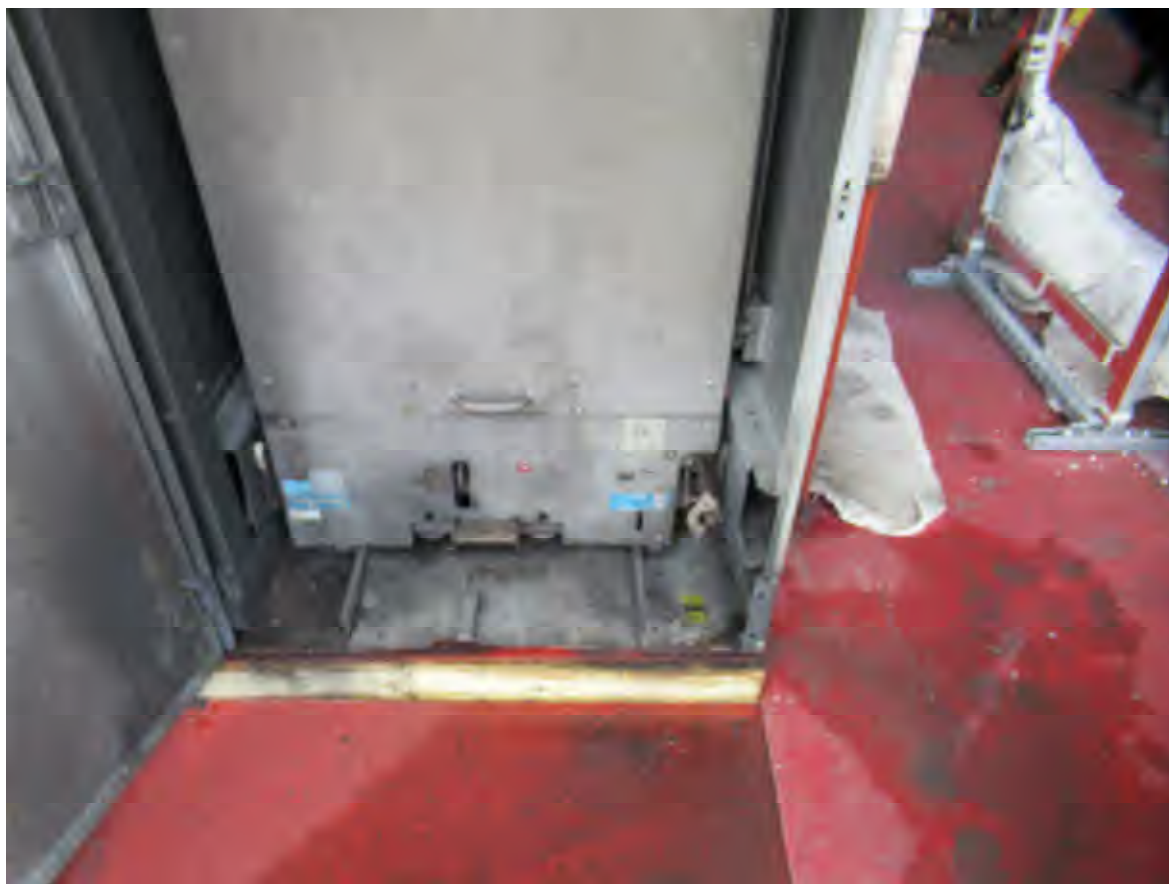
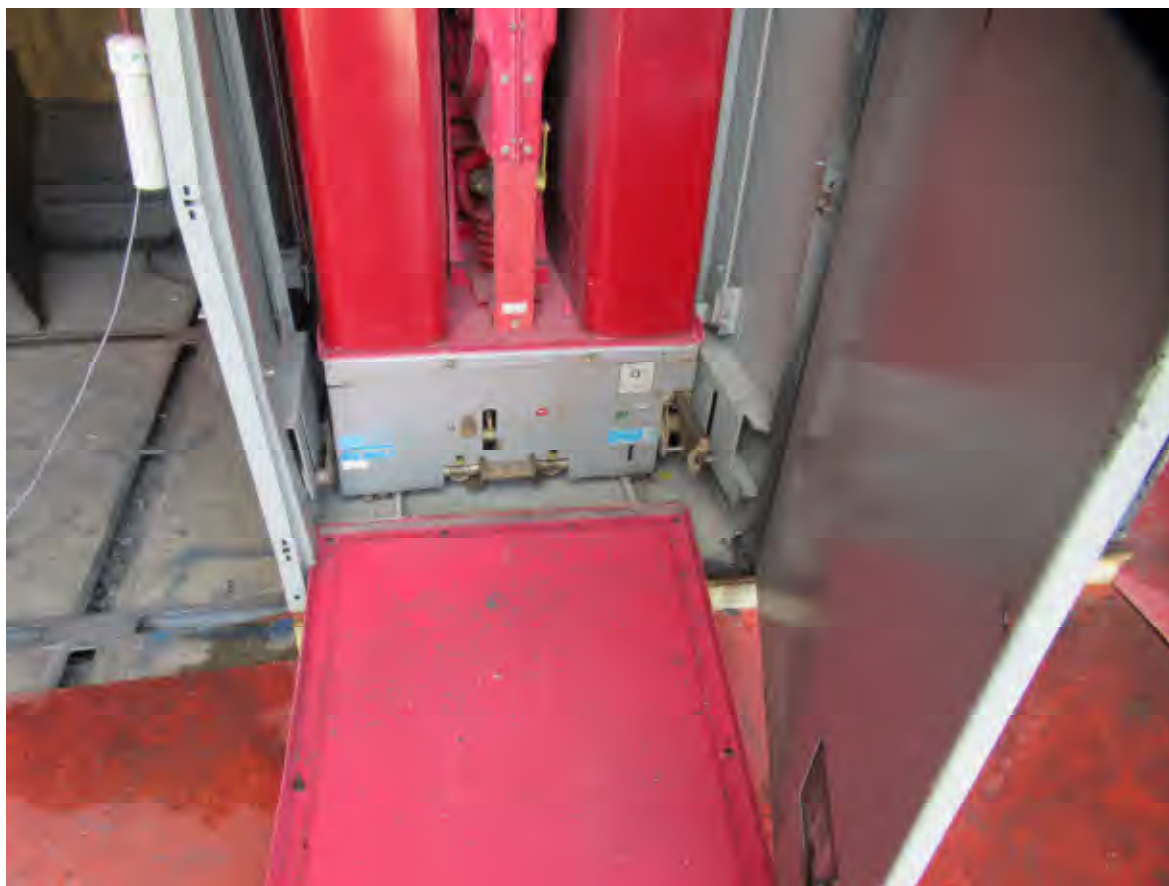
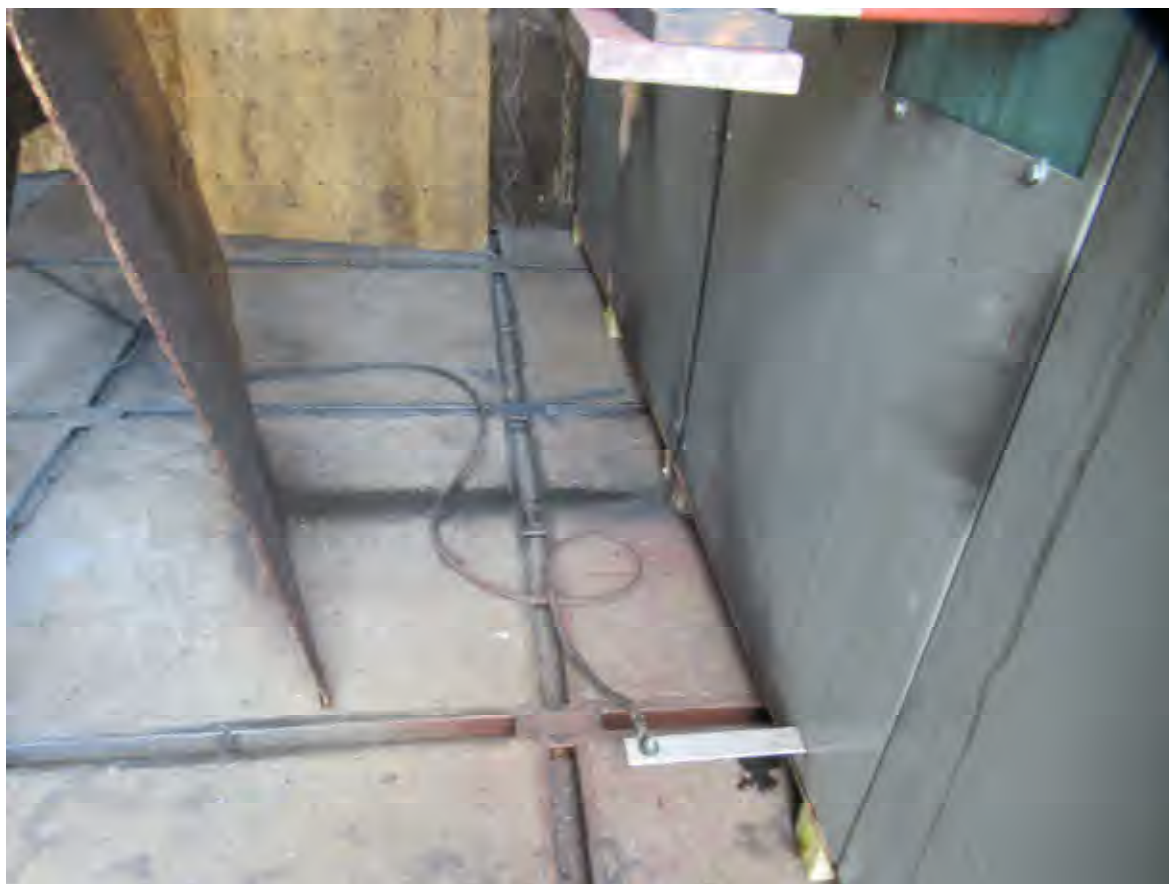
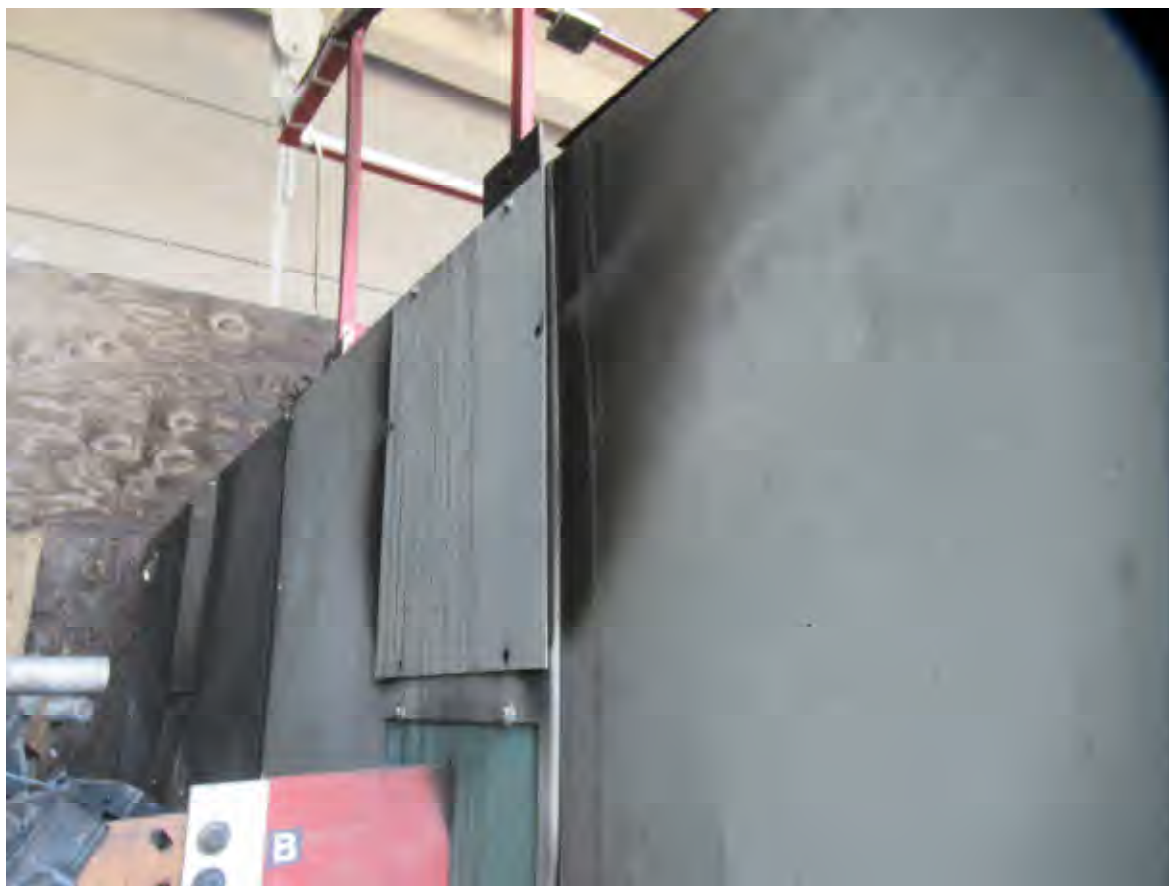
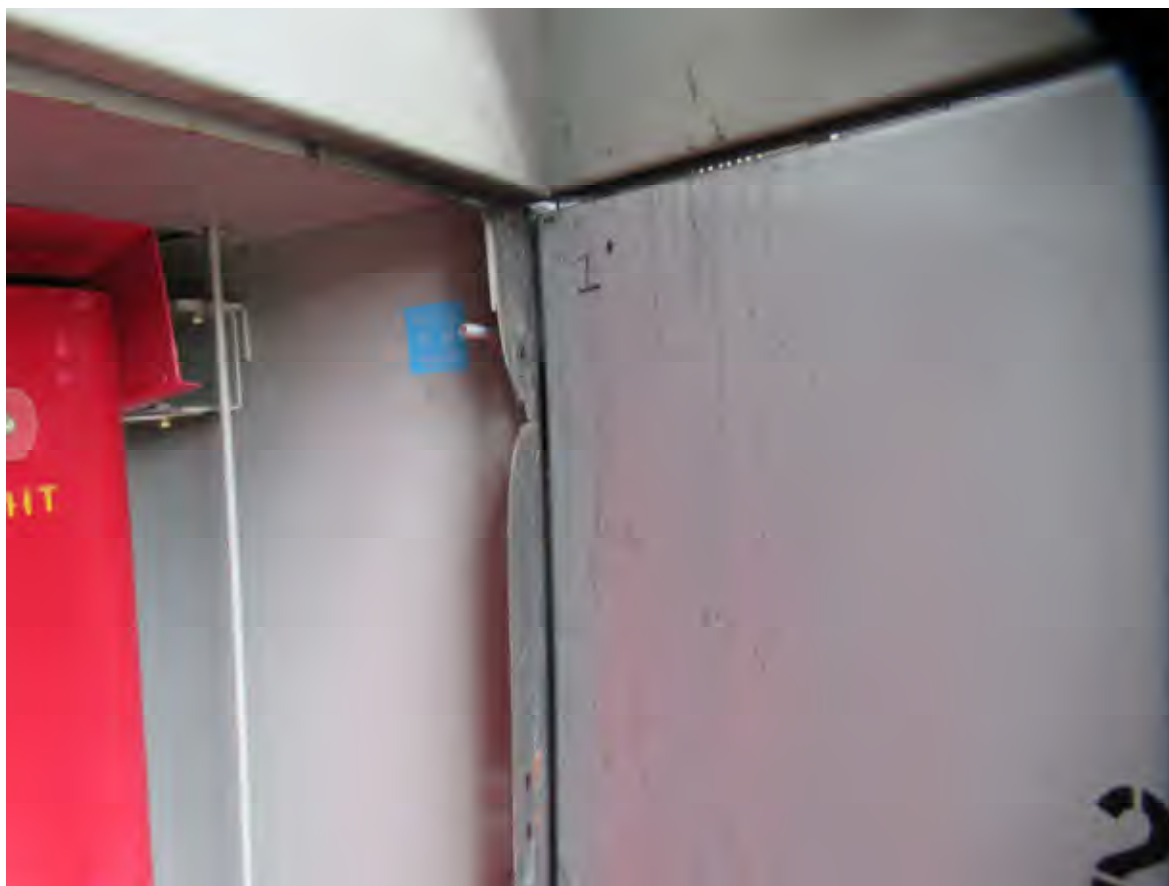
**12.6 Photograph after test**

Fire was allowed to burn for about 14 minutes before opening cabinet K top and bottom front doors.

Fire continued to burn after opening and eventually extinguished using water.

Arc blast knocked off instrument rack in front of cabinet K.

Observations: Emission of flames and gas observed.  
 PT#1 0.57 psi above atmospheric  
 PT#2 6.04 psi above atmospheric
