# Understanding High Energy Arcing Faults

Course No: E05-018

*This course was adapted from the NIST U.S. Department of Commerce, Publication No. NIST TN 2290, “Report on High Energy Arcing Fault Experiments”, which is in the public domain.*

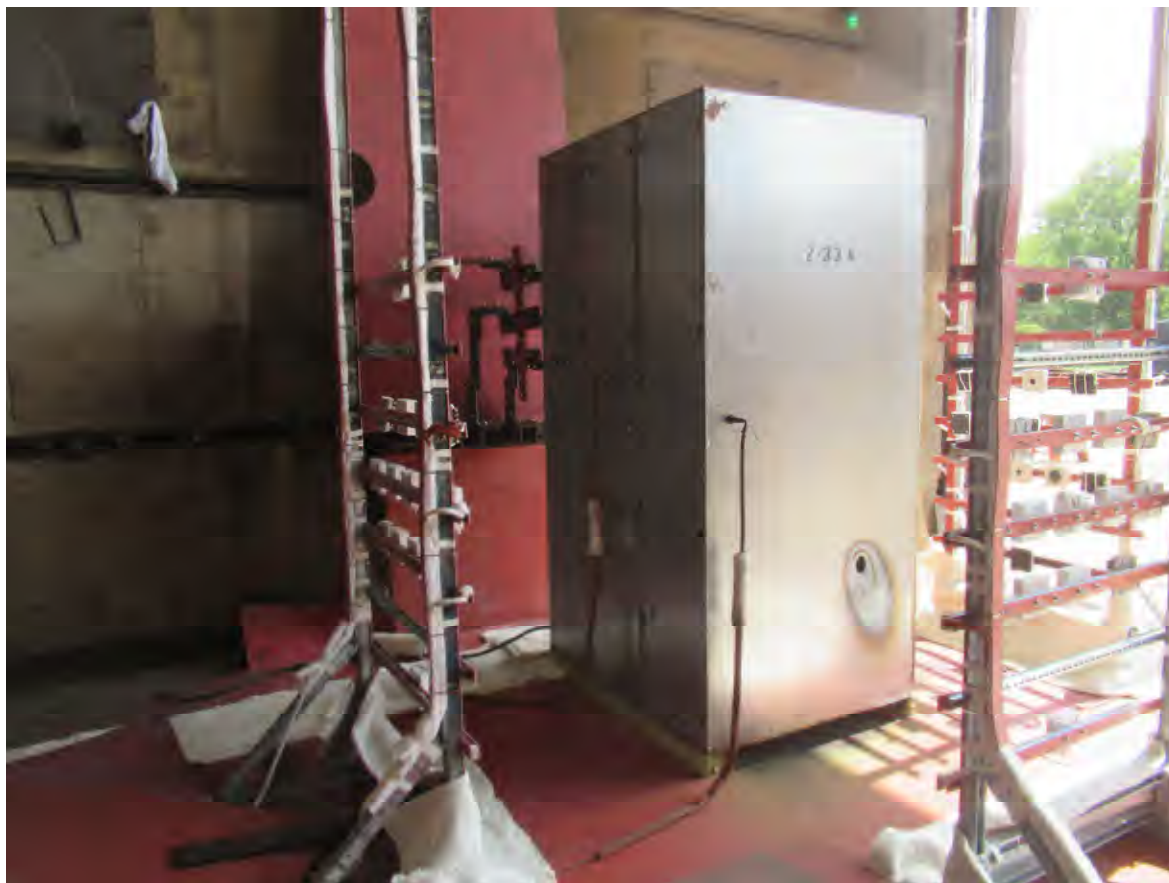
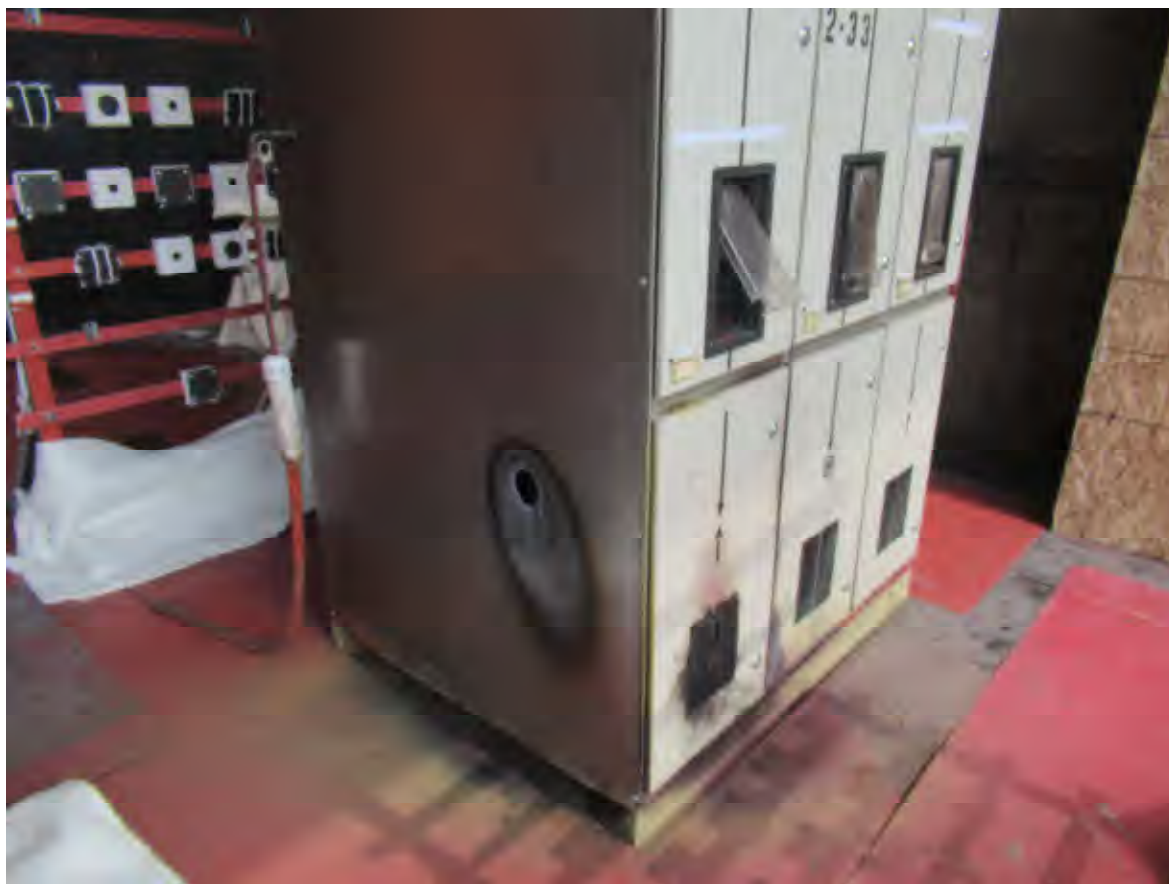
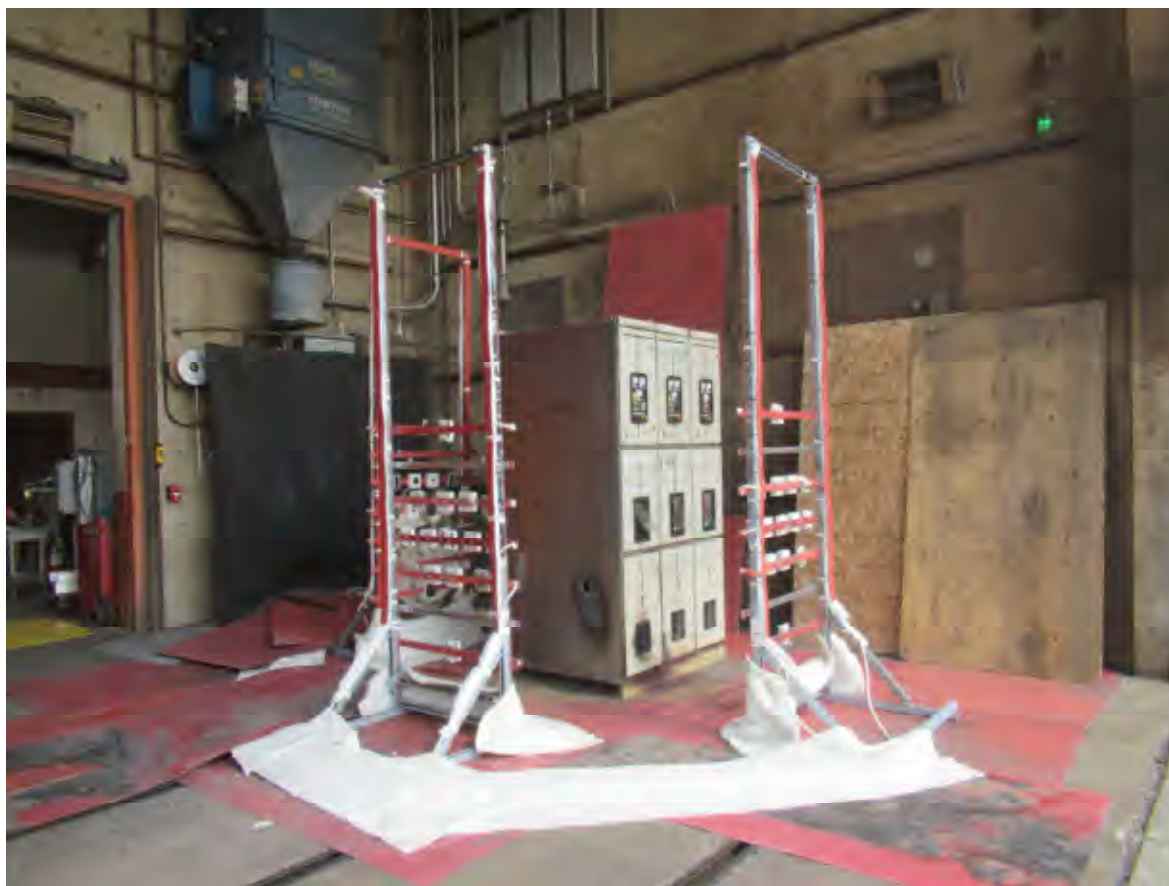
**14.6 Photograph after test**

Burn-through of enclosure on the side of the cabinet in which arc was initiated.

Observations: Emission of flames and gas observed.  
 Arc self-extinguished. Test source voltage held on for 8 seconds.  
 PT#1 0.47 psi above atmospheric.  
 PT#2 1.09 psi above atmospheric.

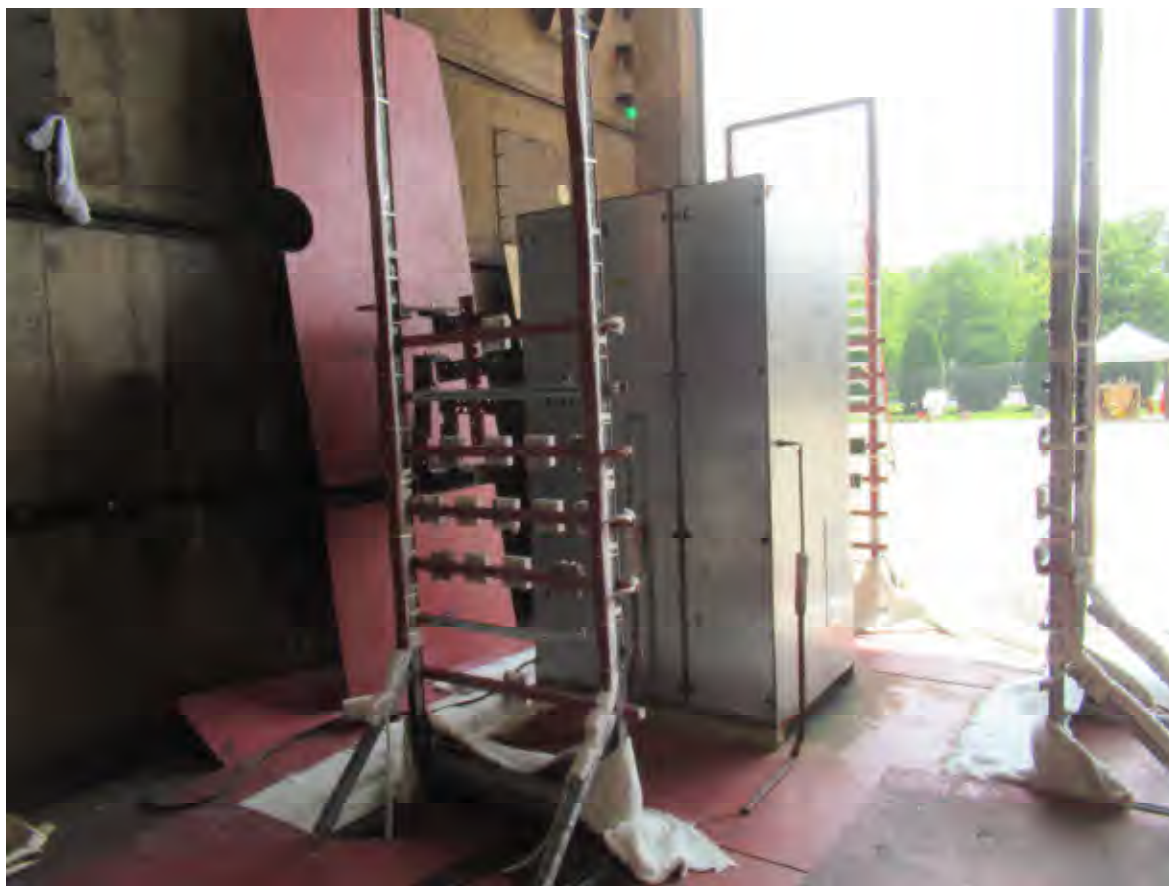
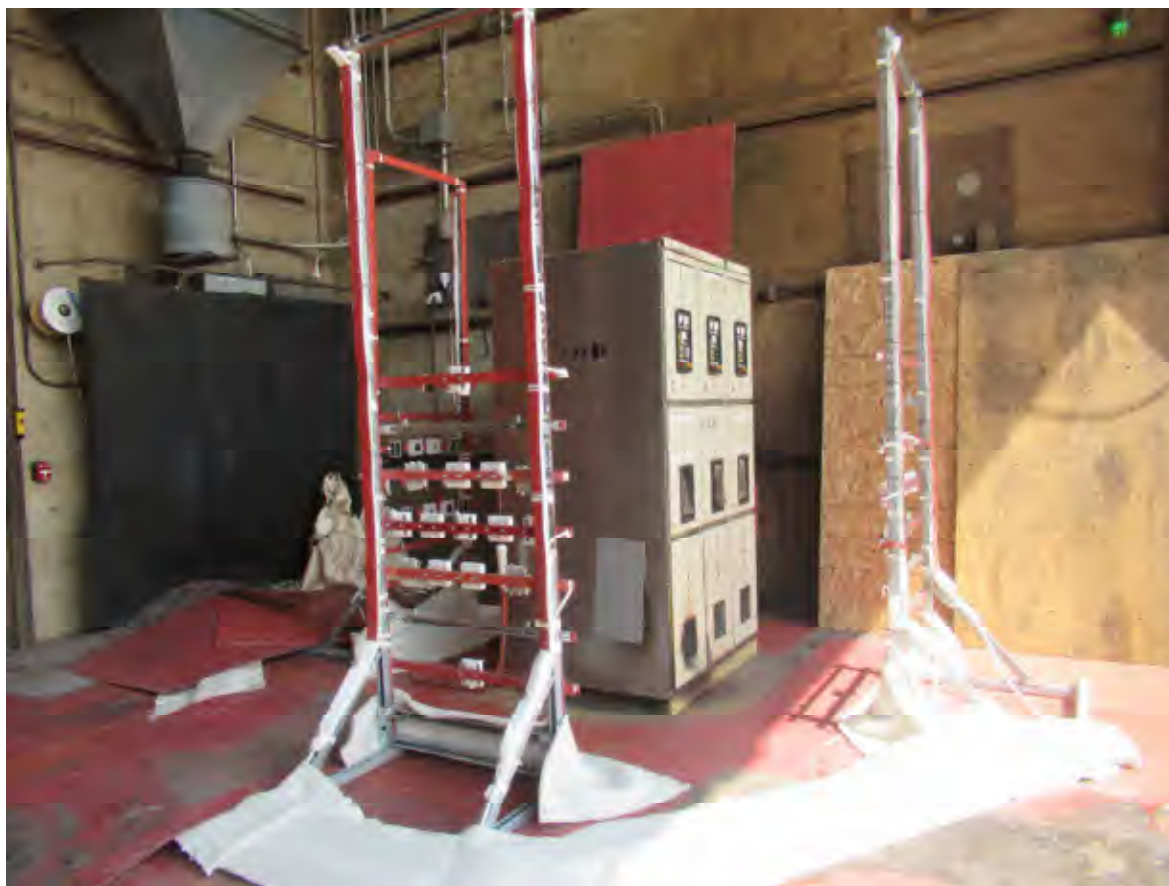
**15.3 Photograph before test**

Test sample in the same condition as after test 2-33A.

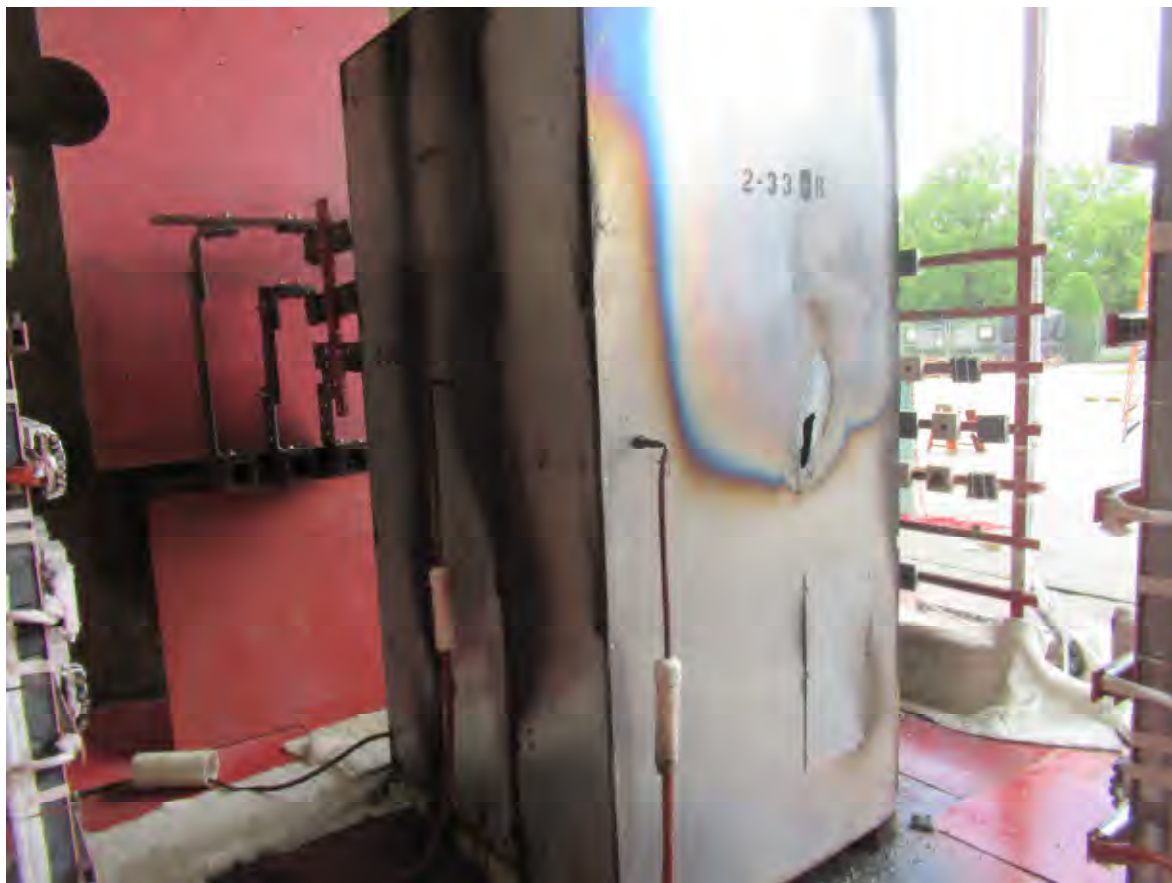
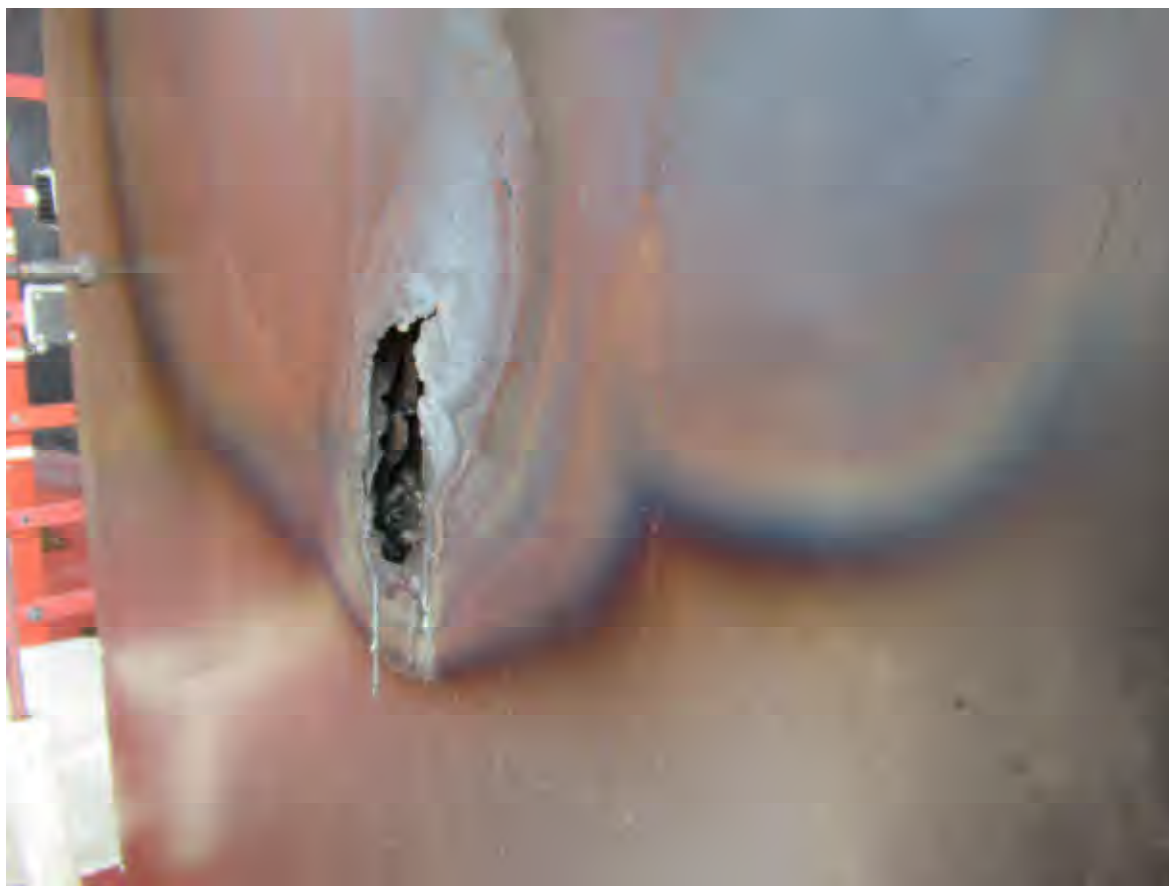
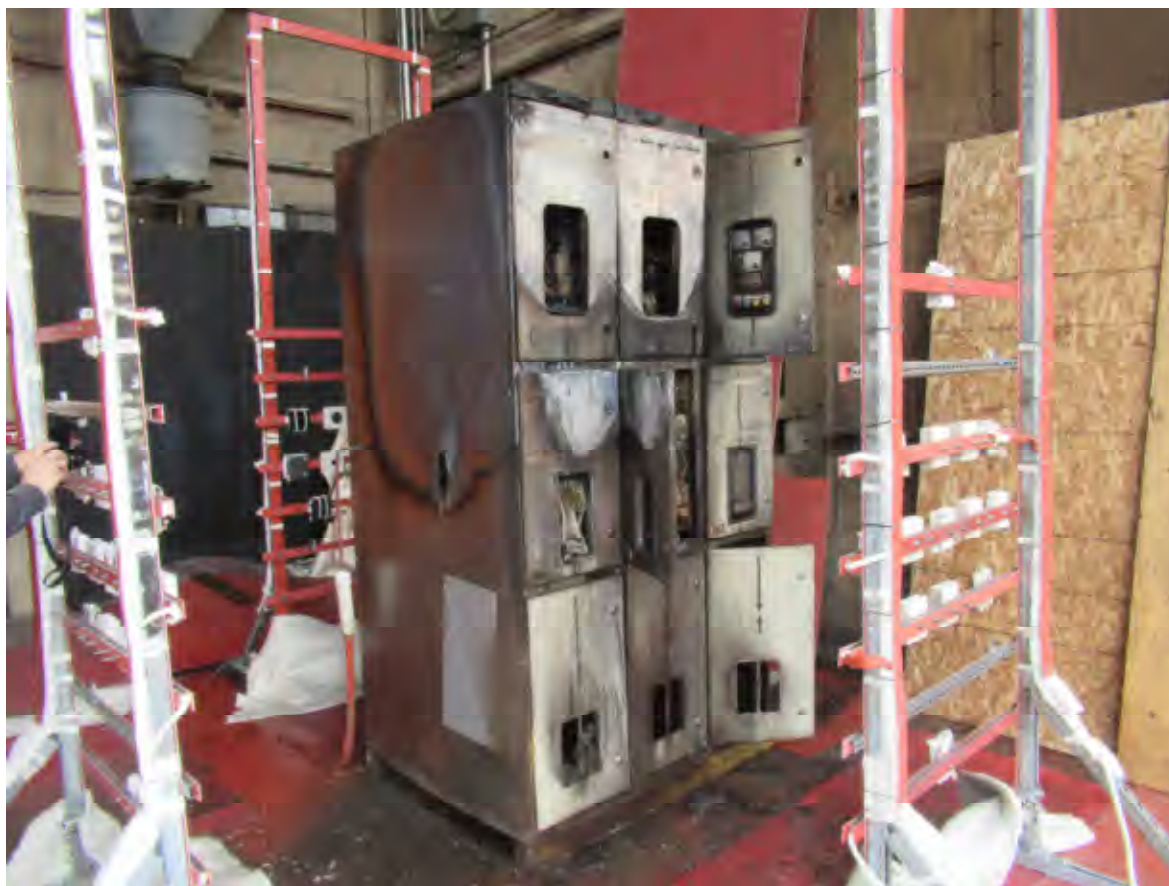
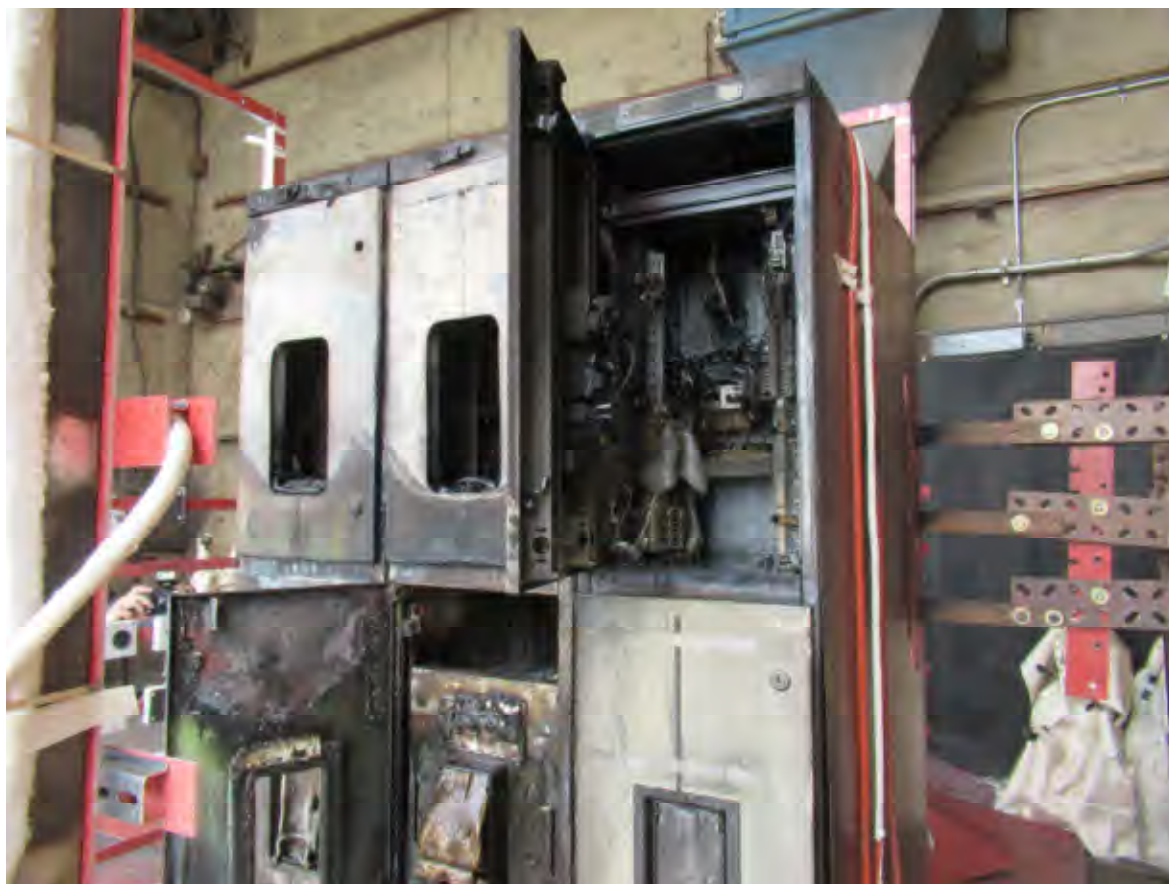
**15.6 Photograph after test**

Burn-through of enclosure (halfway through the length) on the side of the cabinet farthest from KEMA source.

Observations: Emission of flames and gas observed.  
 Arc self-extinguished approximately 5 seconds into test and re-established after 0.5 seconds.  
 PT#1: 0.587 psi above atmospheric.  
 PT#2: 0.3306 psi above atmospheric.

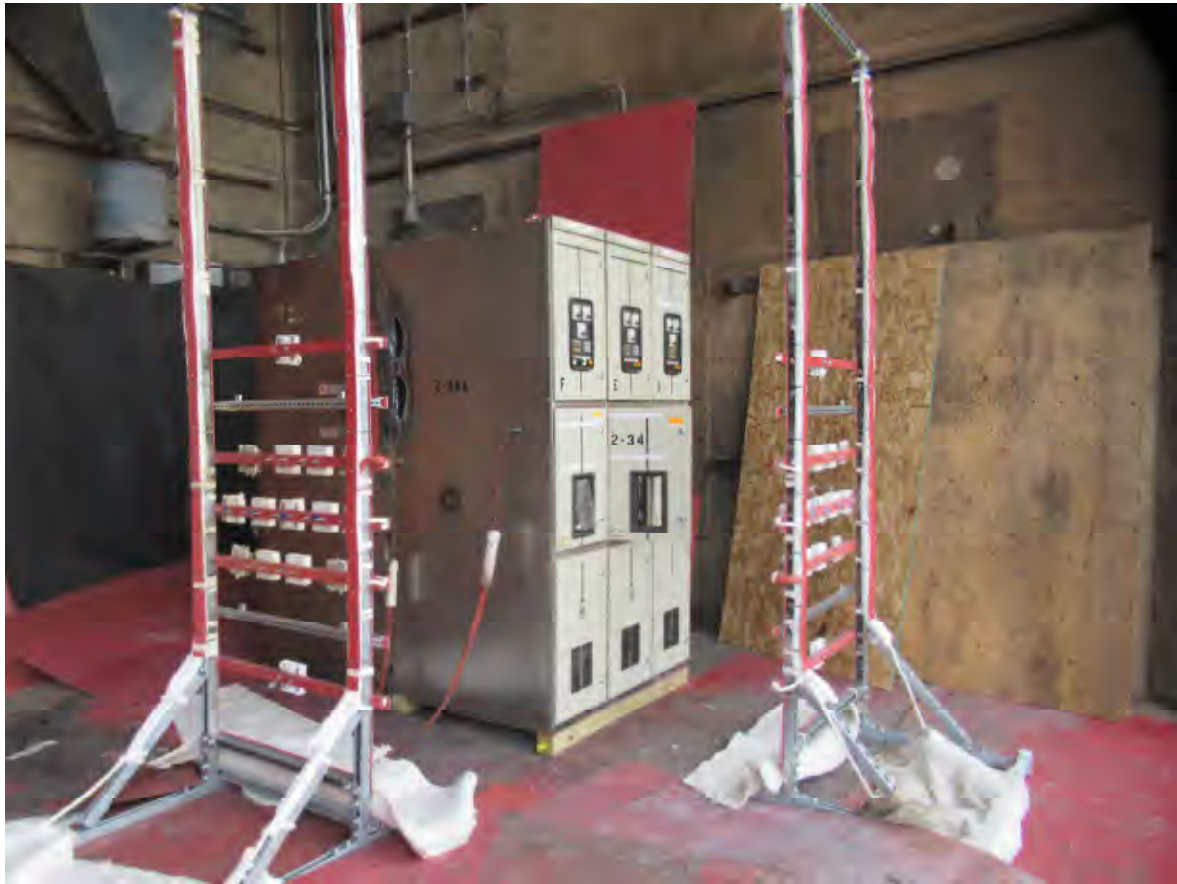
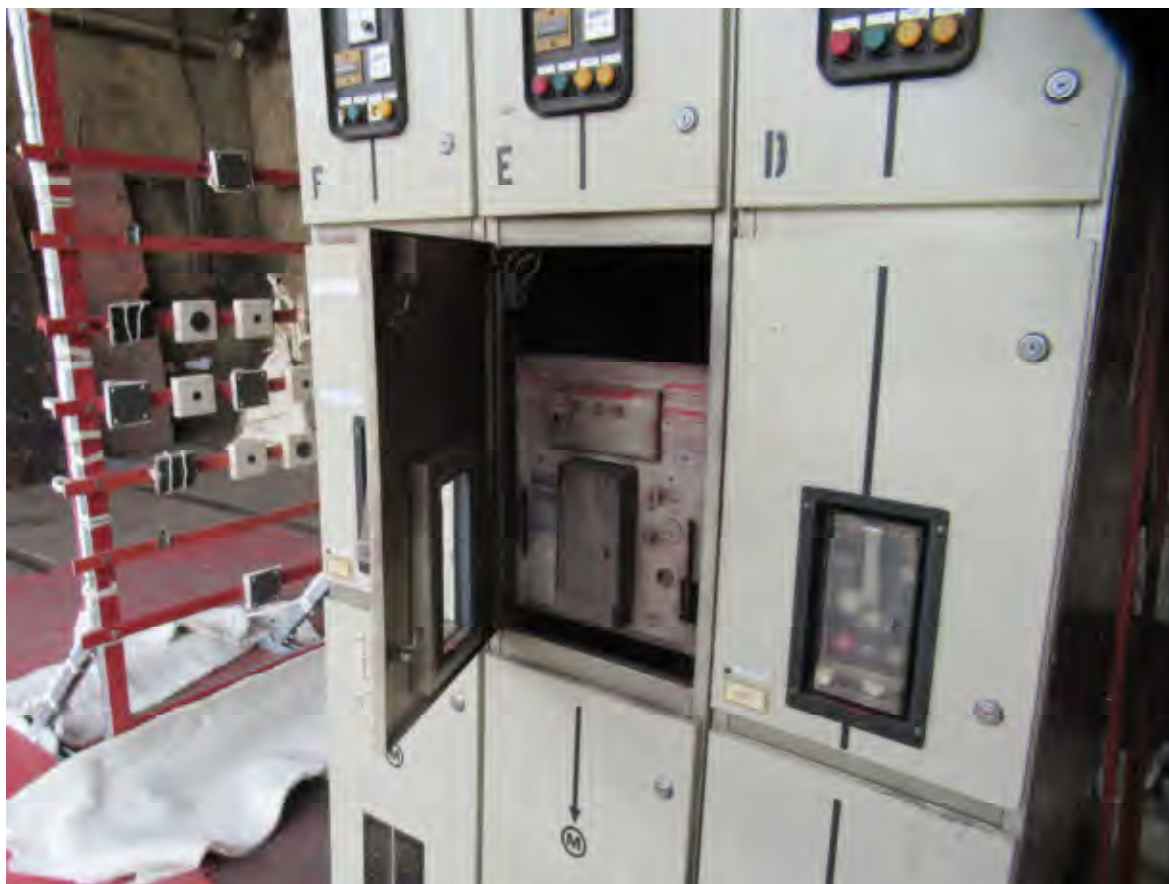
**16.6 Photograph after test**

Burn-through of enclosure on the side of the cabinet in which arc was initiated.

Observations: Emission of flames and gas observed.  
 Arc self-extinguished. Test source voltage held on for 17.5 seconds.  
 PT#1 0.114 psi above atmospheric.  
 PT#2 0.121 psi above atmospheric.
