## **Fire Resilience in Steel-Concrete Structures Part I: Insights from Full-Scale Testing**

Course No: S07-002  
Credit: 7 PDH

*This course was adapted from the NIST U.S. Department of Commerce, Publication No. NIST TN 2165, “Fire Resilience of a Steel-Concrete Composite Floor System: Full-Scale Experimental Evaluation for U.S. Prescriptive Approach with a 2-Hour Fire-Resistance Rating (Test #1)”, which is in the public domain.*

The Test #1 was aimed to quantify the fire resistance and behavior of the 9.1 m × 6.1 m steel-concrete composite floor assembly constructed in accordance with the 2-hour fire-resistance rating requirements for steel buildings in the United States. The fire test compartment, measuring 10 m × 6.9 m in plan, was situated on the ground floor of the two-story test building to heat the composite floor above. The fire condition was created using natural gas burners to mimic a standard fire environment in a large compartment. During fire exposure, the test floor assembly was subjected to a mechanical load of 2.7 kPa, determined from the gravity load combination for extraordinary events as permitted by the applicable building code. This experimental study showed

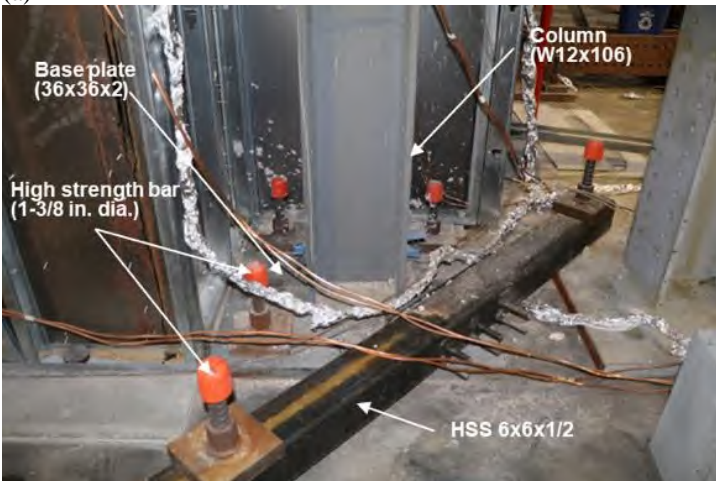
Fig. 2-14. Column support conditions: (a) typical; (b) modified at the southeast column of test bay. (unit = inch).

The support column was fabricated with a W12×106 shape and a 5 cm (2 in.) thick plate welded at its base, as shown in Fig. 2-14. The base of the column was anchored to the strong floor by tensioning 35 mm (1-3/8 in.) diameter high strength steel bars, with a total tension force of 445 kN (100 kip). The anchor points on the strong floor were situated in a 61 cm × 61 cm (24 in. × 24 in.) grid. It should be noted that the southeast column of the test bay was anchored differently due to damage in one of the anchor holes. As shown in Fig. 2-14b, a hollow structural section (HSS) 6×6×1/2 shape was bolted to top of the base plate over its southeast corner. The ends of this HSS shape were then anchored to the strong floor using the same bars tensioned to 222 kN (50 kip) force each.

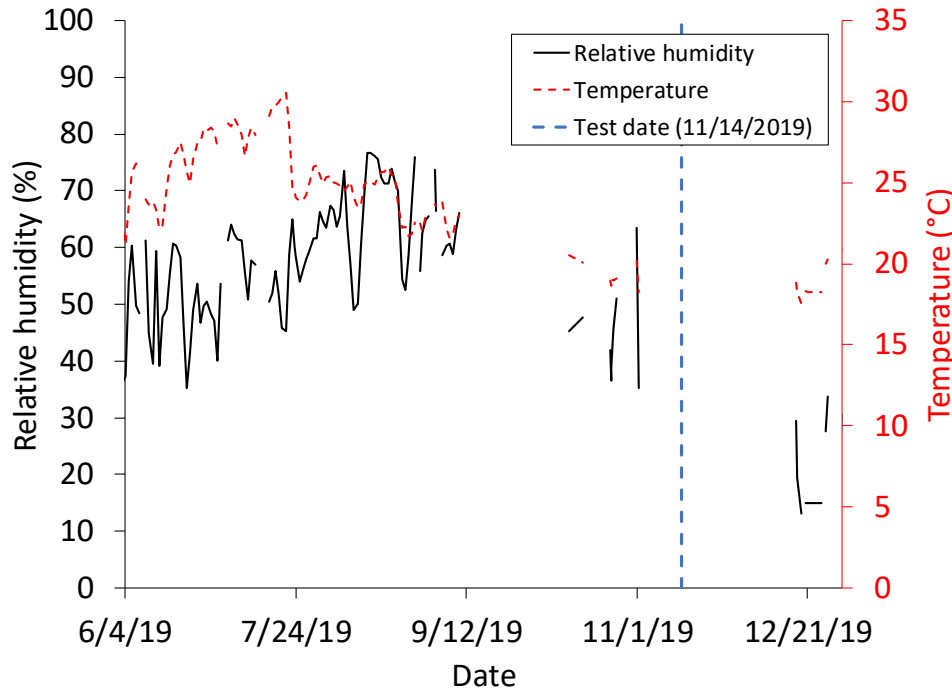
Fig. 2-25. Air temperature and relative humidity in test hall.

The measured relative humidity and air temperature in the test hall where the specimens were cured from the date of casting until fire testing are plotted in Fig. 2-25. There are gaps in the data because the building monitoring systems went offline and were subsequently replaced.

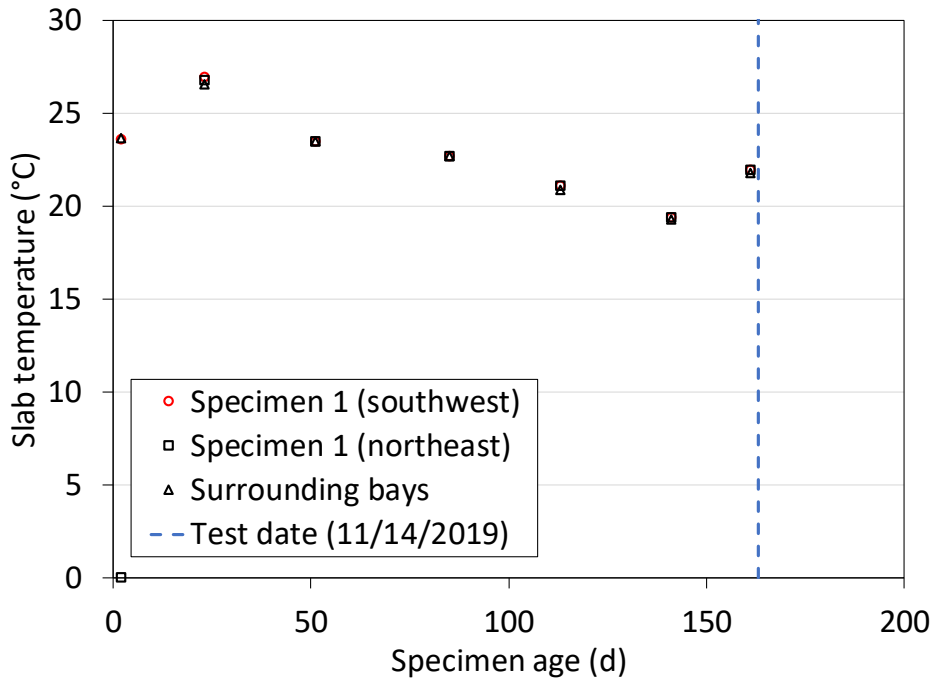
Fig. 2-26. Temperature in the test specimen and surrounding bays.

The relative humidity and temperature in the concrete during curing were measured using wired probes placed into perforated sleeves embedded in the concrete during casting. The manufacturer specified accuracy of the temperature and relative humidity in the applied temperature range are  $\pm 0.2$  °C and less than  $\pm 2.5$  %, respectively. The temperatures measured in the concrete are shown in Fig. 2-26 and the relative humidity measurements in Fig. 2-27. Measurement locations in the test specimen were in the southwest and northeast quadrants of the specimen to provide an indication of variation across the specimen. The measurement location for the surrounding bays was in the middle of the center north bay. The moisture content of the specimens, which is related to the relative humidity, was measured separately on concrete cylinders cured under the same conditions as the slabs (See Sect 2.3.2).

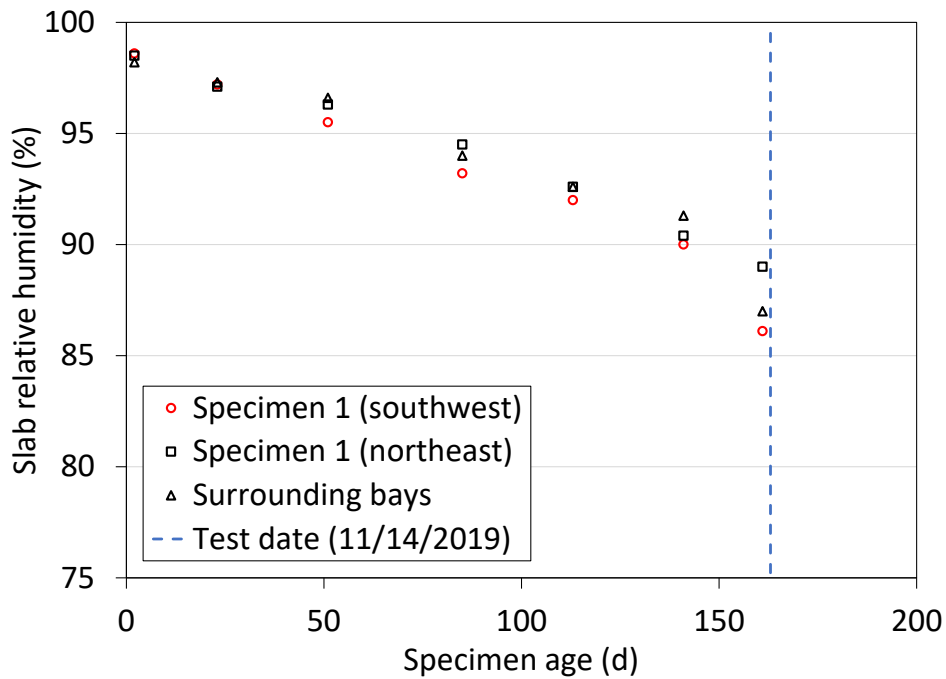
Fig. 2-27. Relative humidity in the test specimen and surrounding bays.

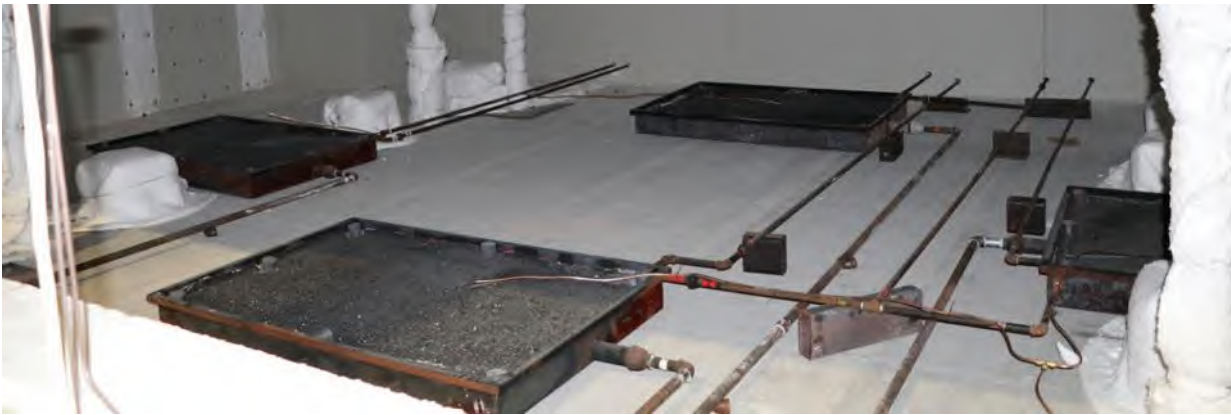
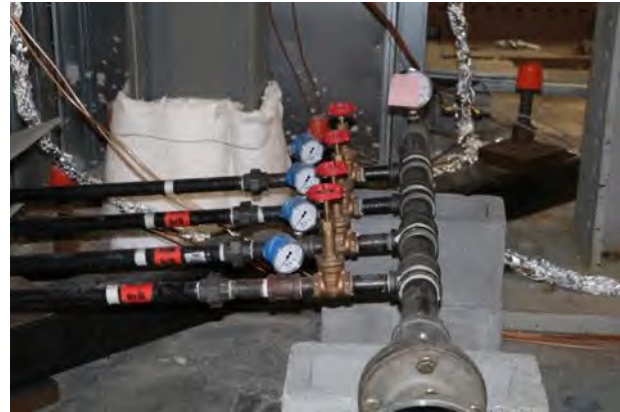
Fig. 2-36 shows photographs of the natural gas burners, NFRL fuel delivery system, and valves for the burners. The test fire was created using four natural gas fueled burners (150 cm long and 100 cm wide each) distributed across the floor of the test compartment. The four burners were made from steel sheet metal boxes and had the fuel inlet tube at the bottom of each burner box. Steel mesh screens were placed to keep the ceramic fiber blanket inside the burner box. A copper pilot flame tube was placed on the top of each burner to aid the burner ignition. The pilot flame was fed by a small propane bottle outside of the test compartment. The NFRL's natural gas fuel delivery system (Bryant and Bundy, 2019) supplied the burners. The flow of natural gas was regulated using a computer controlled pneumatic valve. A balancing valve manifold at upstream of each of the four burners was used to distribute the fire inside the compartment.

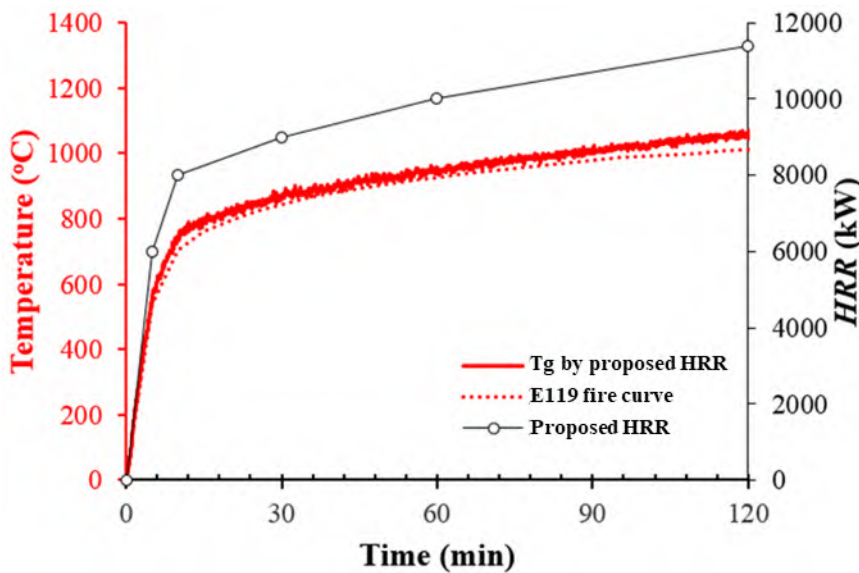
Fig. 2-37. Proposed heat release rate versus time relationship and predicted gas temperatures compared with ASTM E119 temperature-time curve.

The test fire was controlled by the total Heat Release Rate (HRR) of the natural gas burners. In order to replicate the standard time-temperature curve (ASTM E119 or ISO834), the time-dependent values of the burner HRR as proposed by Zhang et al. (2019) were used. This proposed relationship was determined by the NIST’s Fire Dynamics Simulator (FDS) (McGrattan et al. 2018), accounting for thermal boundary conditions of the test compartment, distribution of the burners, and vent scheme as described in previous sections. A series of mockup fire tests (Sauca et al. 2019) were conducted in a similar room to verify the applicability of the proposed HRR versus time curve, shakedown the burner control and check uniformity of the upper layer gas temperatures within the compartment. Fig. 2-37 shows the proposed burner HRR versus time curve considered in this study and the predicted gas phase temperatures ( $T_g$ ) at 30.5 cm below the ceiling of the compartment.

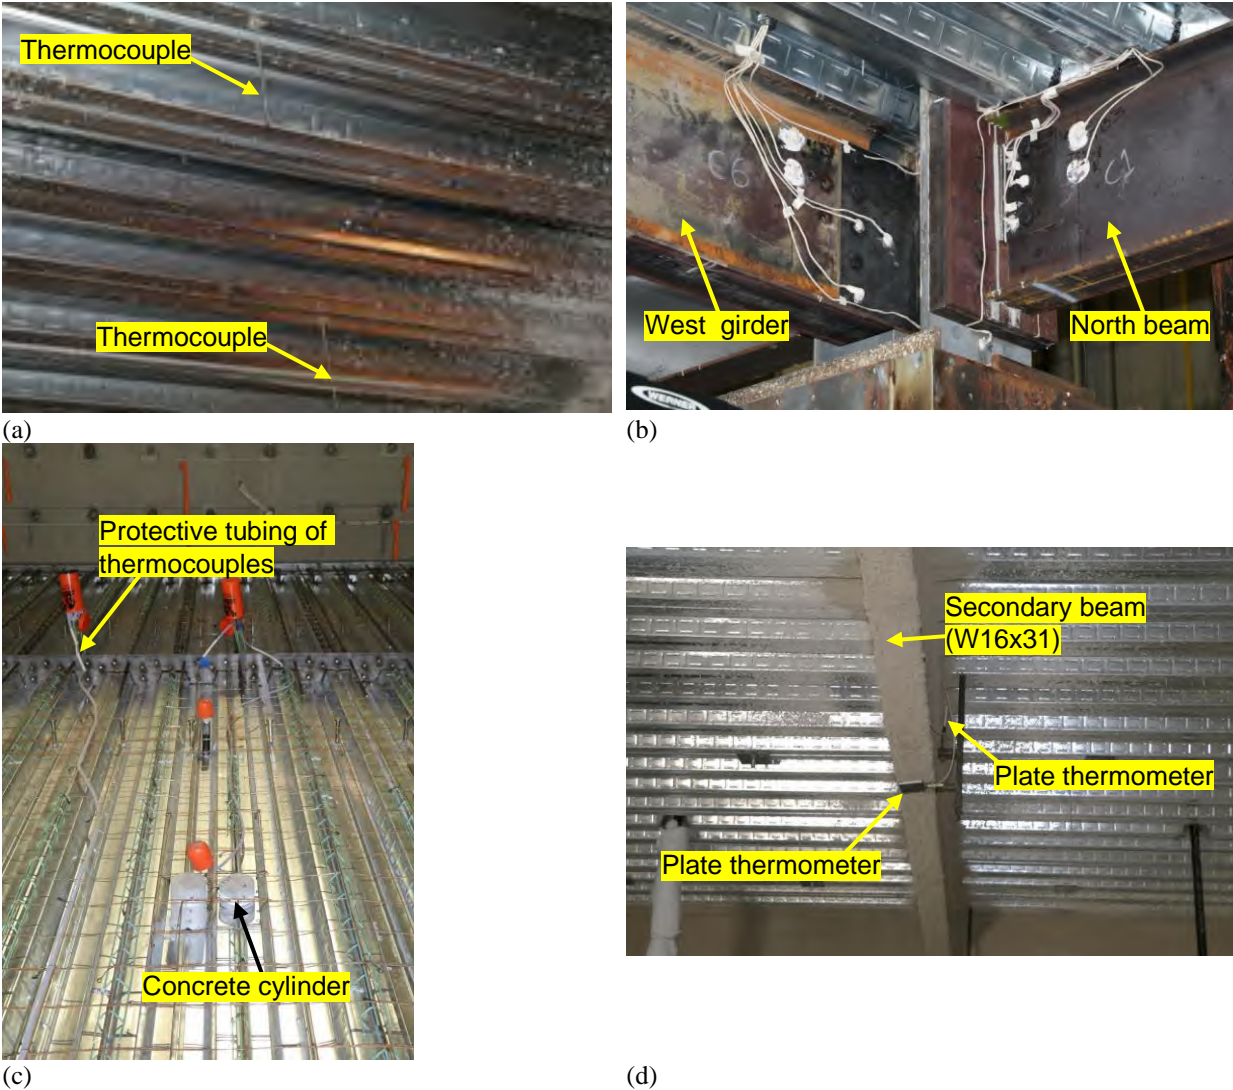
**Fig. 3-4.** Photographs of temperature sensors installed at (a) 305 mm below exposed steel deck; (b) ends of the west girder and the north beam prior to fireproofing; (c) top of the steel deck prior to concrete casting; (d) midspan of secondary beam.

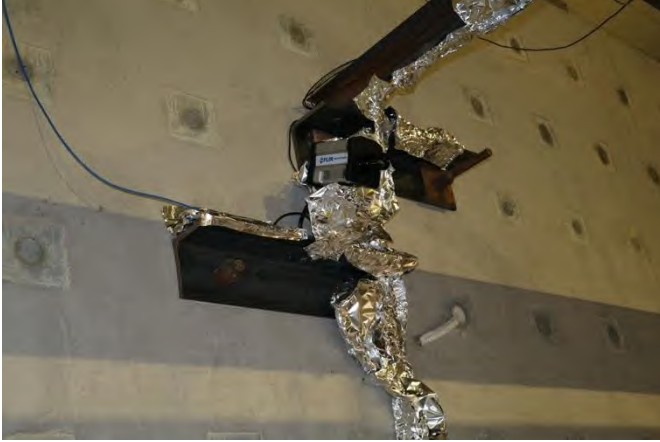
**Fig. 3-8. Infrared camera mounted on the strong wall.**

Temperature data were collected at 15 fps during this test. The thermal imaging camera preset parameters used in this test are summarized in Table 3-1. However, the uncertainty in temperature data from this system was not estimated since the calculated output was highly sensitive to a transient fire environment. Several images presented in Chapter 4 are intended to describe the integrity failure of the composite slab in the test bay. Future work will be performed to better understand the factors influencing the uncertainty in temperature measurements with the same camera.

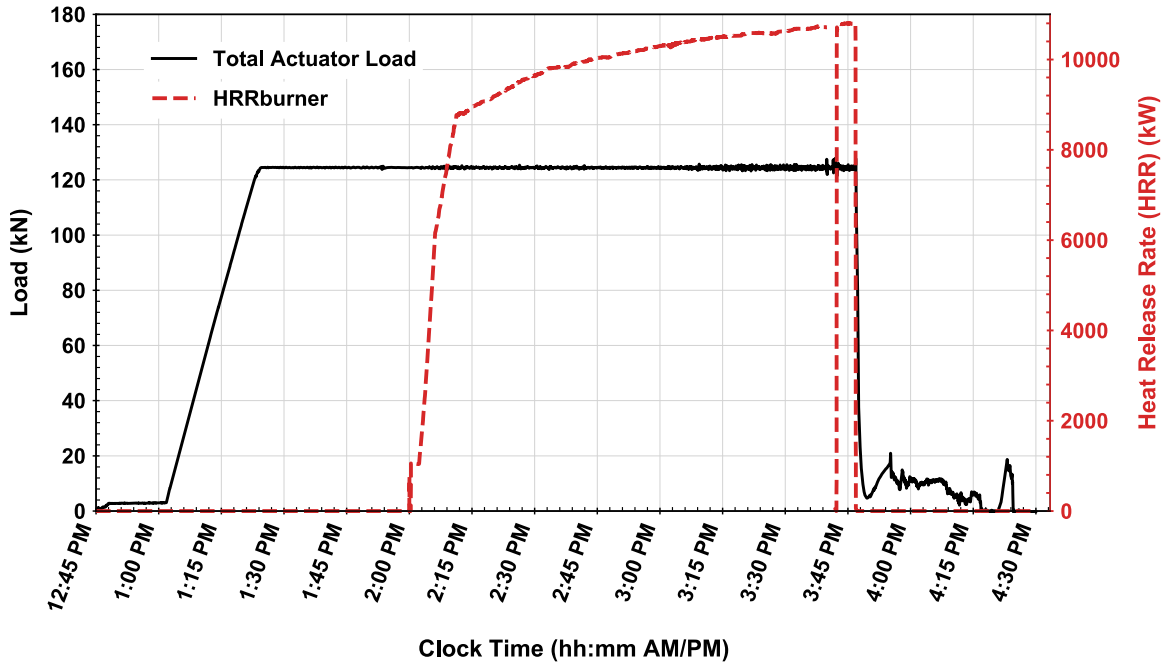
Fig. 4-1 Timeline of Test #1 conducted on Thursday, November 14, 2020.

The recorded timeline of the fire experiment is illustrated in Fig. 4-1. The mechanical loading was initiated at 12:45 PM. A target load value of 125 kN was achieved at 1:20 PM. The test fire was ignited at 2:00 PM. It should be noted that there was about 2 min break in fire loading application from 3:40 PM to 3:42 PM. The burner flames went out as a network switch connecting the natural gas fuel delivery system momentarily lost power, thereby activating a safety shutoff valve. Finally, the fire and mechanical loads were manually removed at 3:47 PM due to safety concerns after a severe breach of the test floor assembly was witnessed. The exhaust flow of the hood was terminated afterwards. The recorded fire duration was approximately 107 min while the mechanical load was applied.

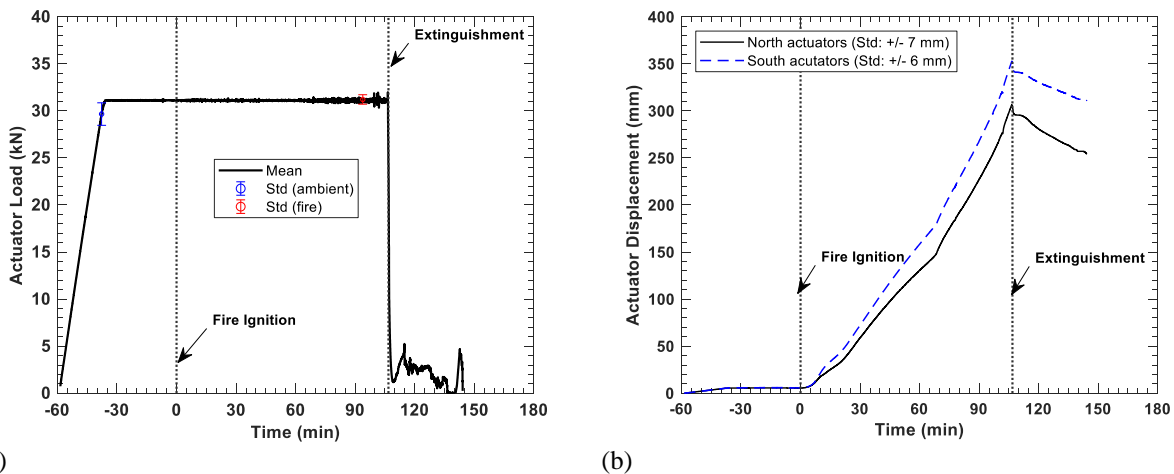
Fig. 4-3. (a) Average mechanical load applied by four actuators and (b) average stroke displacement of the north actuators (NE and NW) and the south actuators (SE and SW).

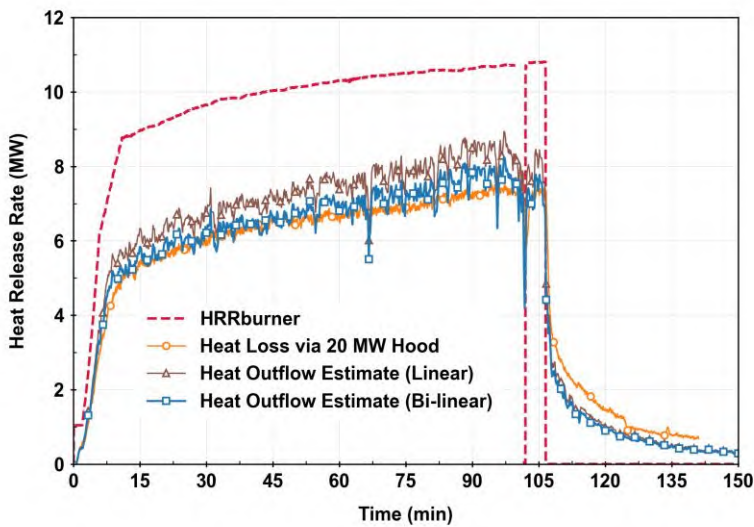
Fig. 4-14. Estimated convective heat loss.

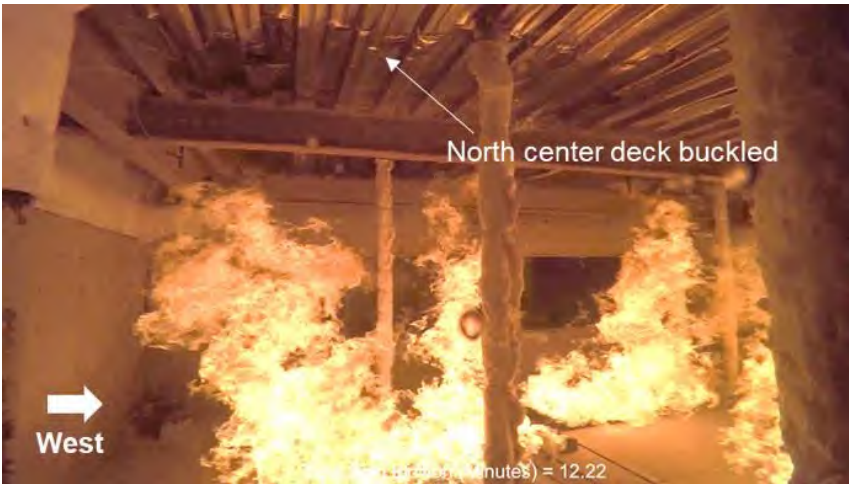
Fig. 4-25. A snapshot of the test video showing local buckling of the north steel deck at about 12 min.

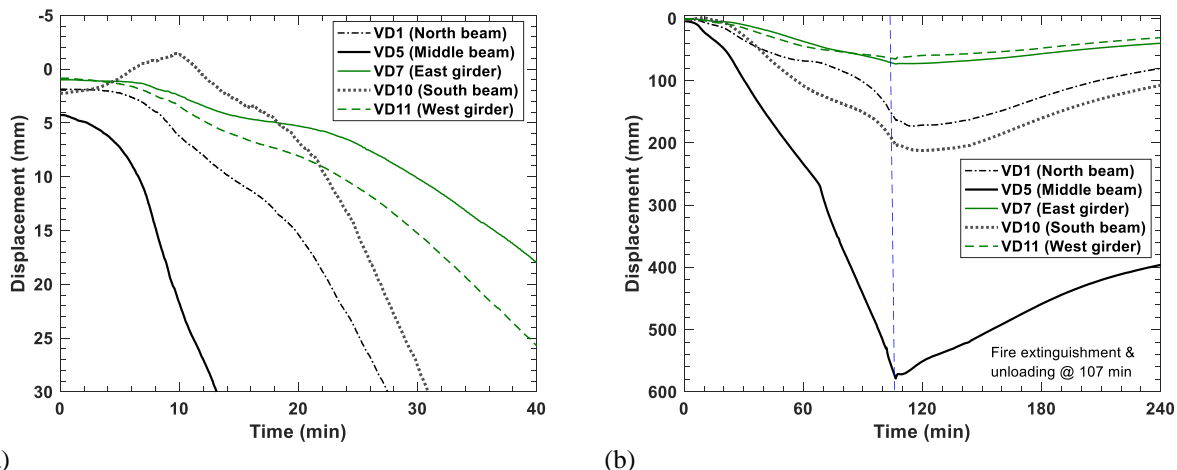
Fig. 4-31. Measured vertical displacements of the exposed steel members at midspan (a) up to 40 min and (b) up to 240 min including cooling (beginning at 107 min).

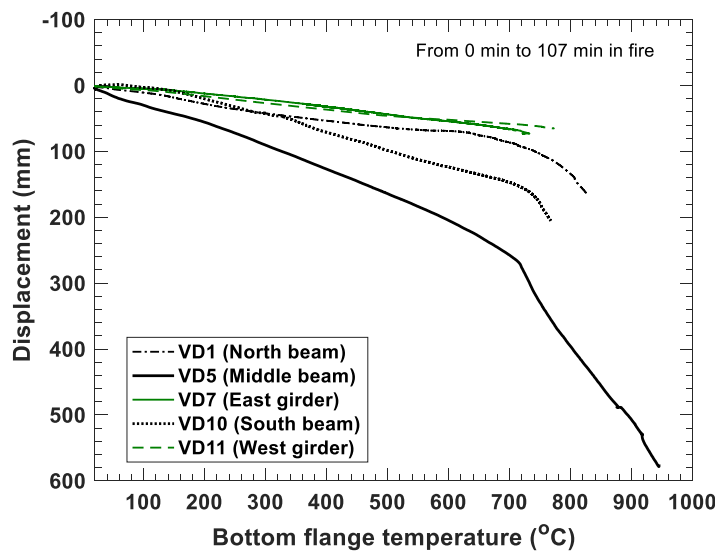
Fig. 4-32. Measured vertical displacements of the exposed steel members at midspan as a function of the bottom flange temperatures from 0 min to 107 min.

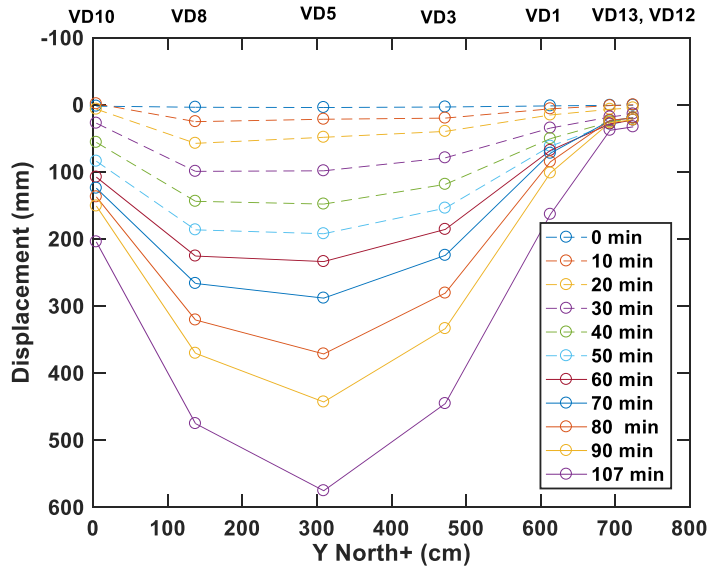
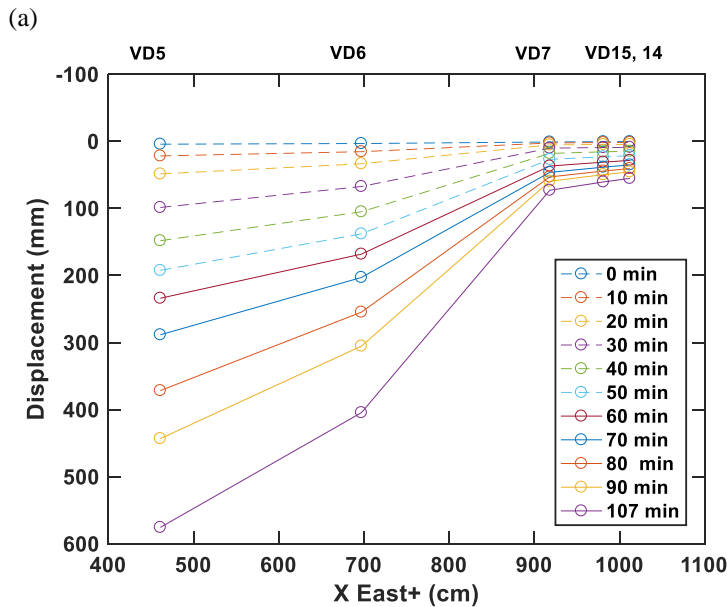
Fig. 4-33. Vertical displacement profile of the test floor assembly at (a) the north-south centerline and (b) the east-west centerline. The upper horizontal axes indicate the corresponding position of each vertical displacement sensors.

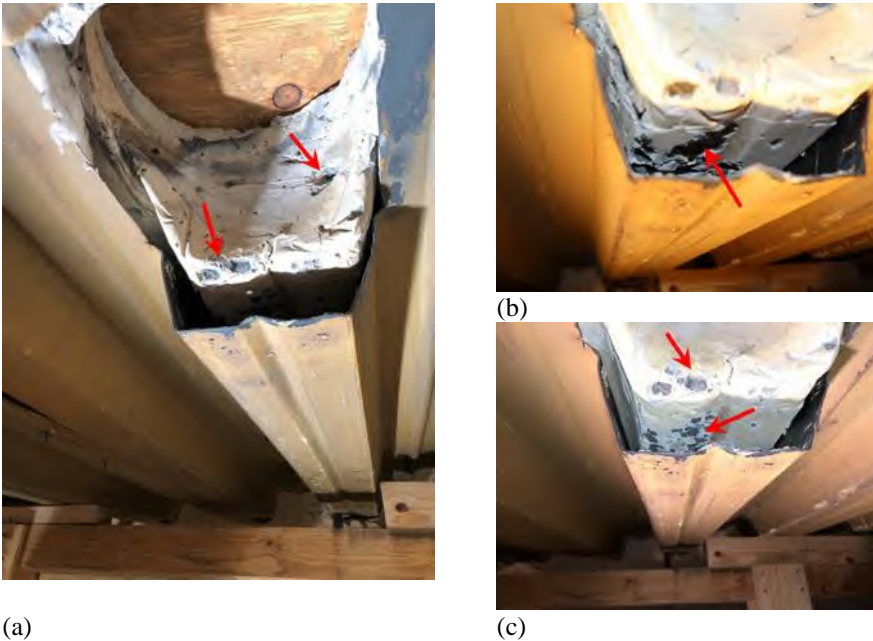
Fig. 4-40. Post-test photographs: (a) slab through-hole used for running a water-cooled loading tube; (b-c) deck delamination from concrete. Localized spalling is indicated by arrows.

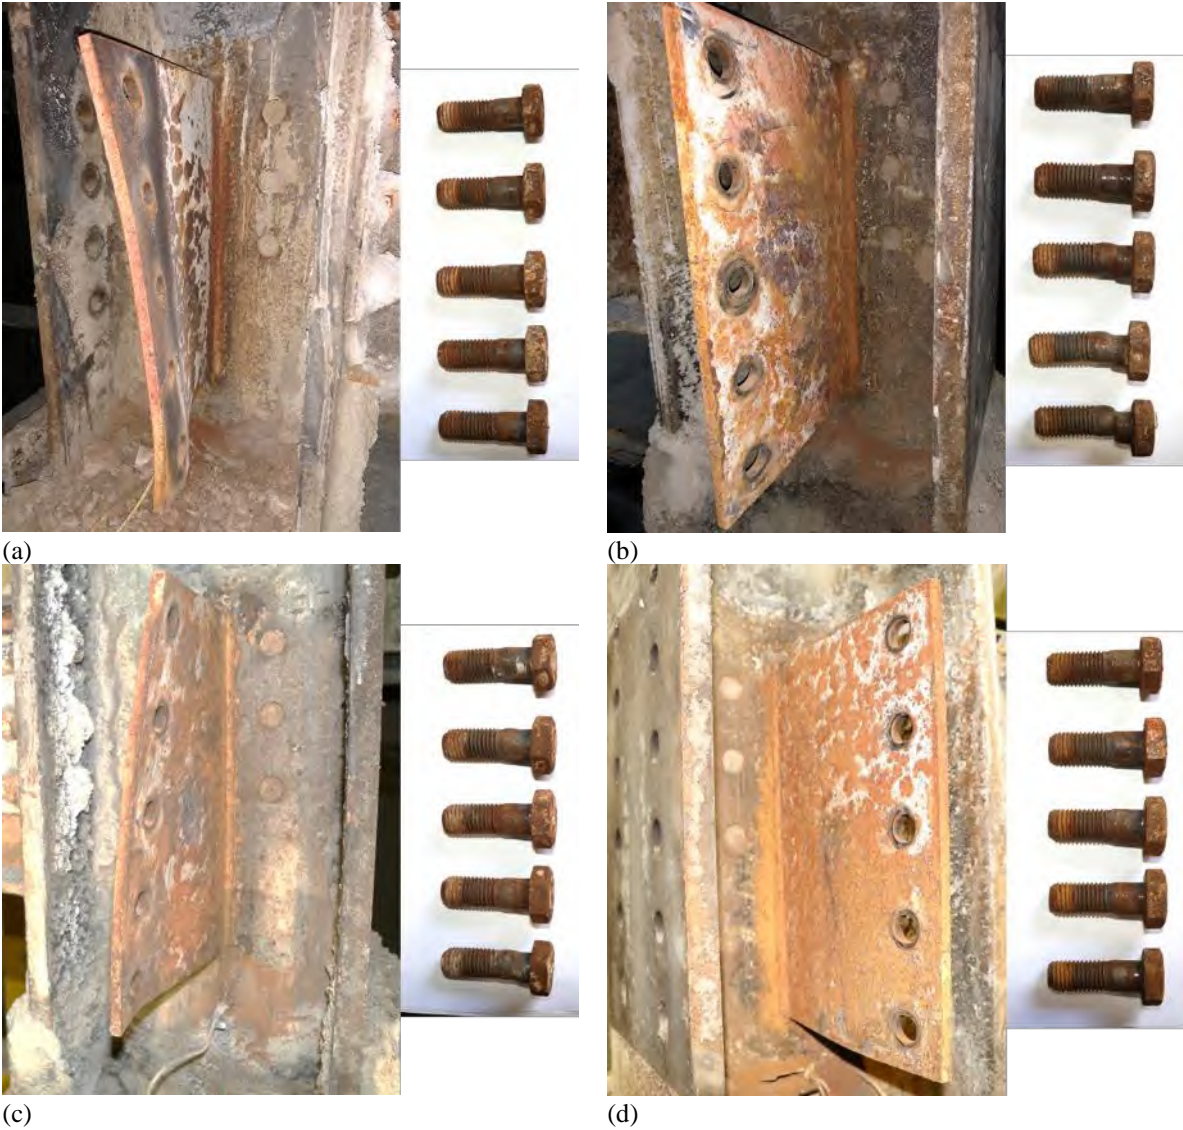
**Fig. 4-48.** Post-test photographs of extended shear tab (girder-to-column) connections: (a) north end of the east girder; (b) south end of the east girder; (c) north end of the west girder; (d) south end of the west girder.

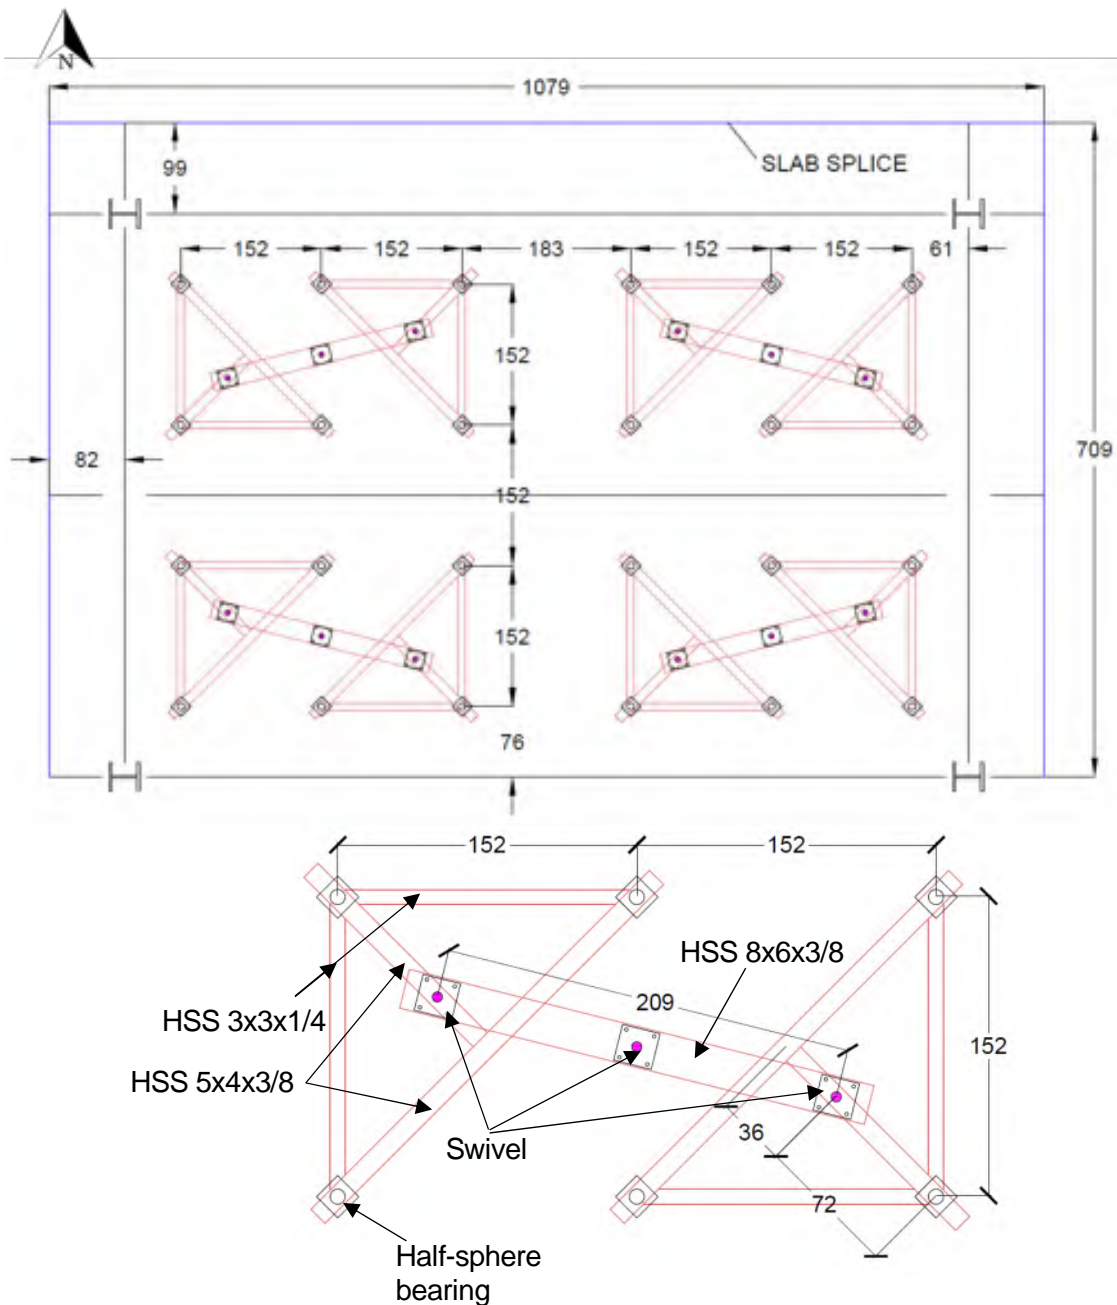
Fig. A-8. Scale drawings of gravity loading system. Dimensions in cm.

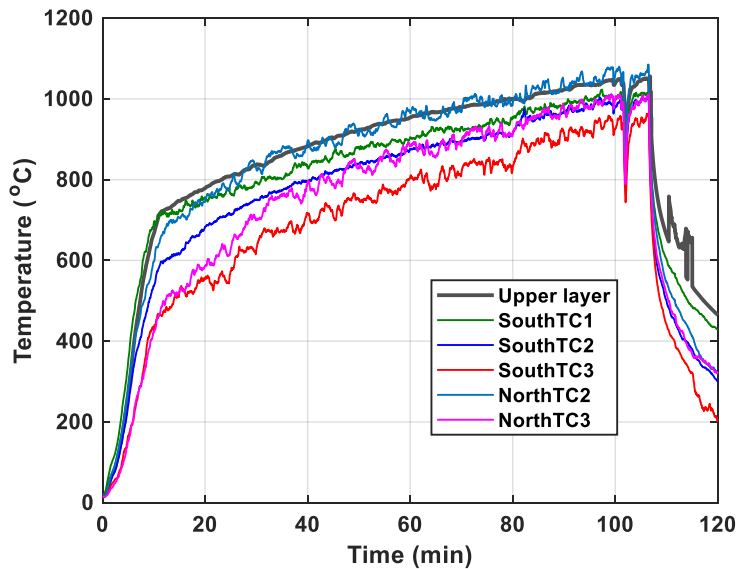
Fig. B-6. Gas temperature measured using South TC and North TC trees.

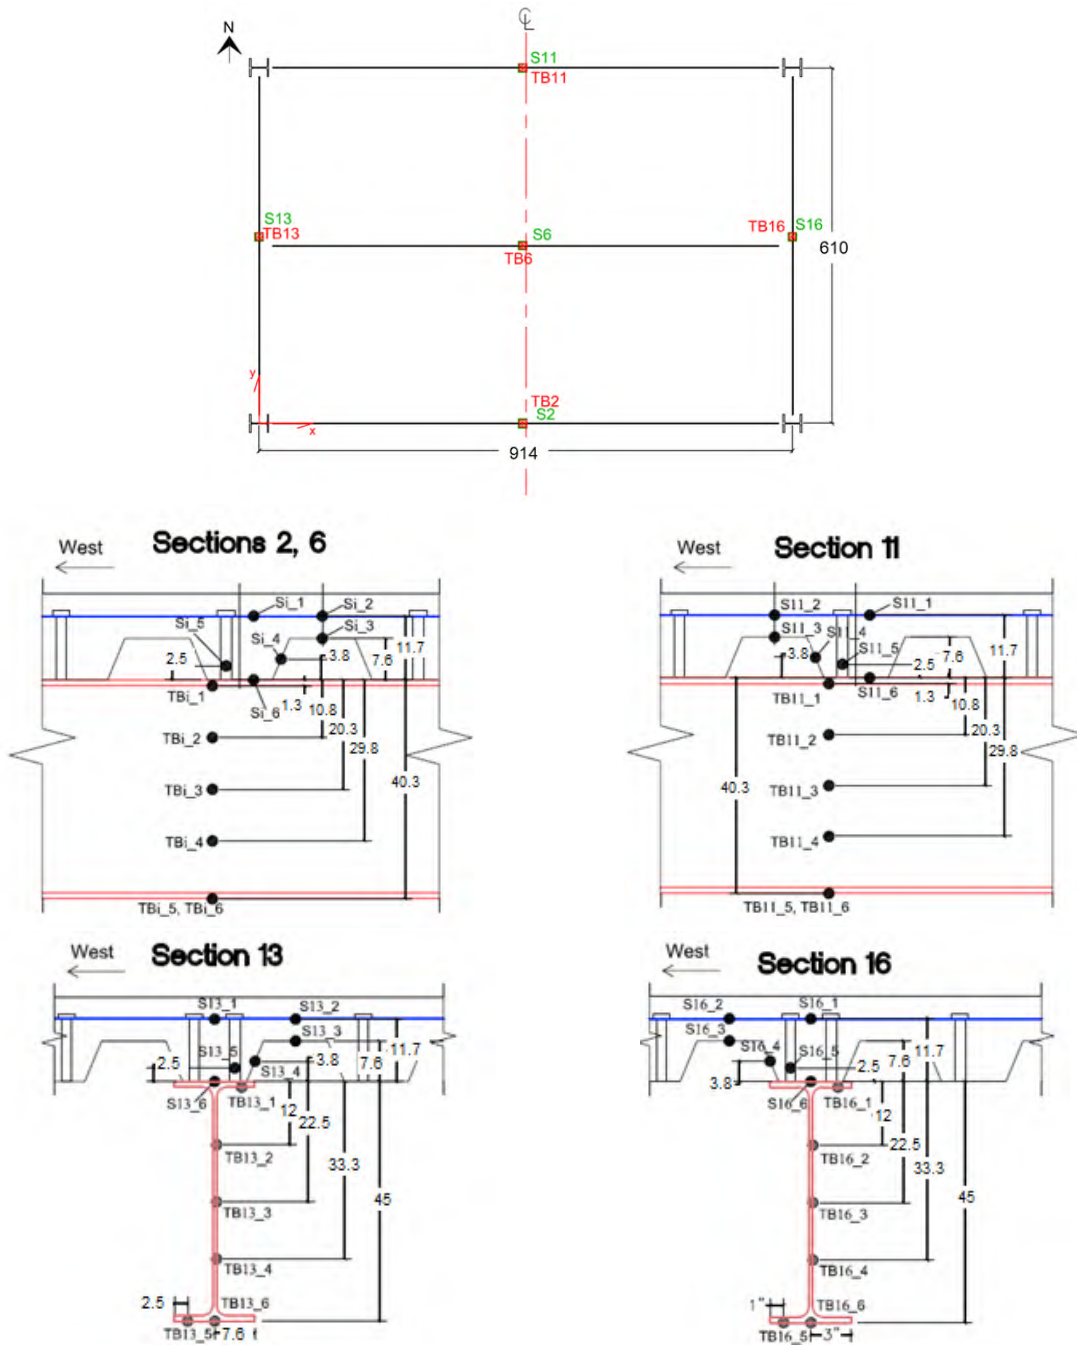
Fig. B-11. Locations of thermocouples mounted at the midspan composite sections, where i is the section number.
