## **Fire Resilience in Steel-Concrete Structures Part II: Advanced Solutions**

Course No: S03-033

*This course was adapted from the NIST U.S. Department of Commerce, Publication No. NIST TN 2203, “Fire Resilience of a Steel-Concrete Composite Floor System: Full-Scale Experimental Evaluation for Influence of Slab Reinforcement (Test #2)”, which is in the public domain.*

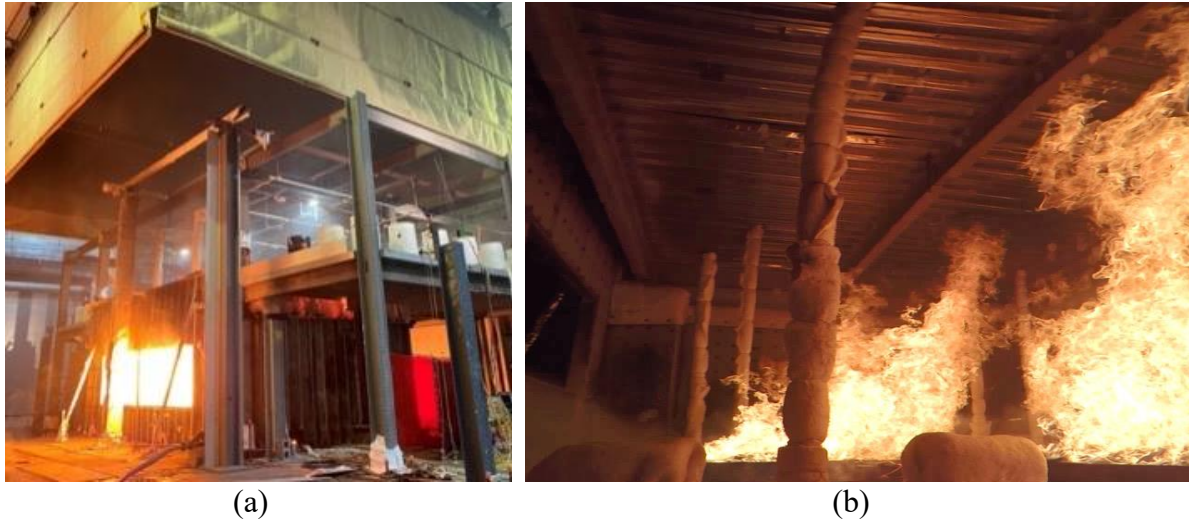
**Fig. 1. (a) Compartment fire test in the south middle bay of the two-story building under 20 MW exhaust hood; (b) Composite floor soffit exposed to natural gas fueled compartment fire.**

The full-scale two-story steel frame two bays by three bays in plan was used to mimic the realistic boundary conditions of composite floors when exposed to fire (Fig. 1). The fire test compartment (10 m × 6.9 m × 3.8 m) with the main opening (5.8 m × 1.5 m) on the exterior wall was situated in the south middle bay of the two-story test building. There was a 5.8 m × 0.3 m slit on the north wall designed for air intake only. Four natural gas burners (1 m × 1.5 m each in size and rated 16 MW total) distributed on the floor of the test compartment created standard fire exposure to the soffit of the composite floor in the test bay (Fig. 2). During fire exposure, the composite floor in the test bay was hydraulically loaded to 2.7 kPa which resulted in a total design gravity load of 5.2 kPa according to the ASCE 7 [16] load combination for fire conditions (1.2 × dead load + 0.5 × live load). The composite floors in the adjacent bays, which remained cool during fire loading, were loaded to 1.2 kPa (equivalent to 0.5 times live load) using water-filled drums. Over 300 data channels were used to characterize the fire testing conditions as well as thermal and structural responses of the two-story building to a test fire at a variety of locations.

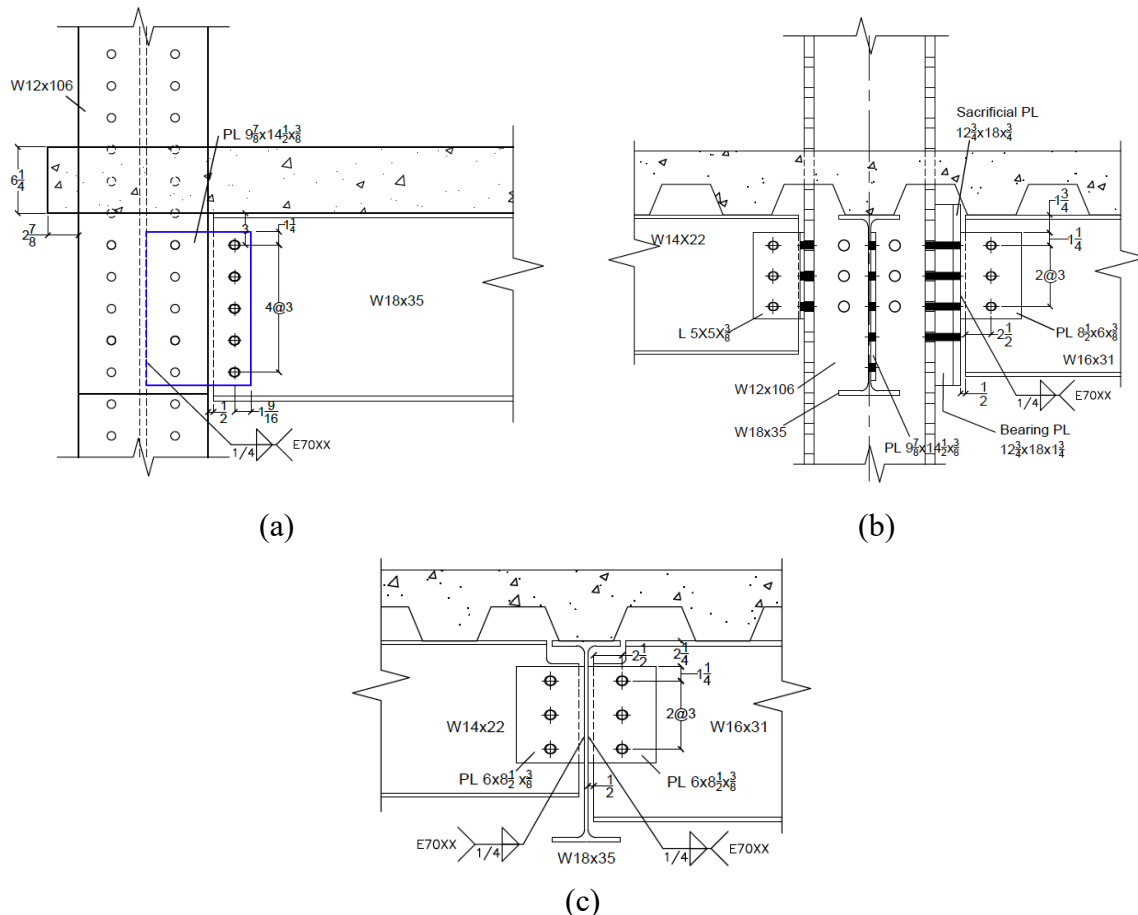
Fig. 6. Scale drawings of connection details in the test bay. Units are in inches.

The steel frames within the fire test bay consisted of three 914 cm (30 ft.) long W16×31 shapes and two 610 cm (20 ft.) long W18×35 shapes as shown in Fig. 3b. Refer to AISC Steel Construction Manual [23] for the dimensions of the steel shapes. The ends of the W16×31 beams were connected via standard shear tabs (PL8½×6×3/8) with three 1.9 cm (0.75 in.) diameter structural bolts whereas the W18×35 girders were connected to the webs of W12×106 columns using extended shear tabs (PL9-7/8×14½×3/8) with five 1.9 cm diameter structural bolts. The weld size used in the shear tab connections was 6.3 mm (0.25 in.). Short-slotted holes, 2.1 cm (13/16 in.) wide and 2.5 cm (1 in.) long, were drilled on the connecting elements, whereas the standard holes with the diameter of 2.1 cm were drilled on the webs of beams and girders. Details of the beam-end connections are shown in Fig. 6.

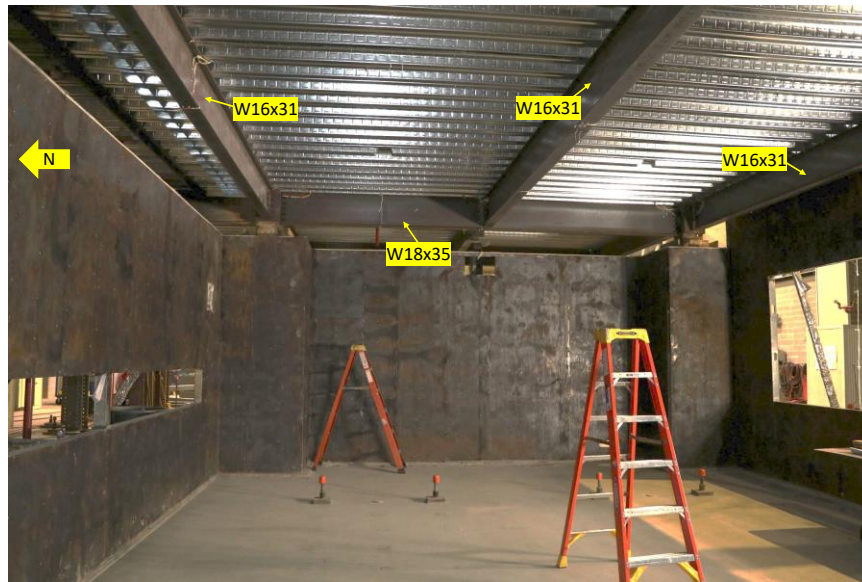
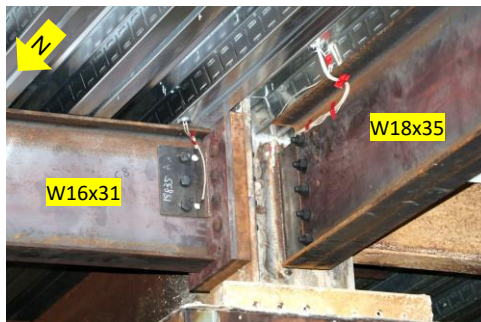
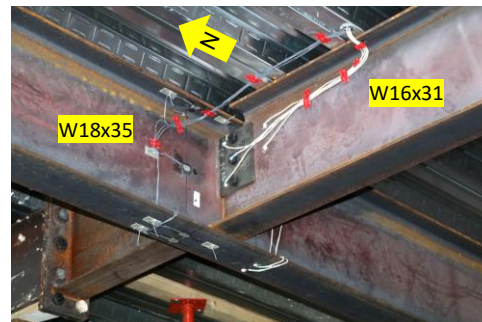
Fig. 8. Photographs of Test #2 floor specimen: (a) steel work; (b) beam-to-column connections; (c) beam-to-girder connections prior to fireproofing insulation.

The composite floor was constructed with lightweight aggregate concrete and 7.6 cm (3 in.) deep profiled steel decking as shown in Fig. 7. The deck flute was oriented perpendicular to the 914 cm long beams. The topping concrete (above top ribs) was 8.3 cm (3.25 in.) thick as required to achieve the 2-hr fire resistance rating. Steel headed stud anchors with 19 mm shaft diameter were welded to the top flange of the W16×31 and W18×35 shapes at 30 cm (12 in.) and 36 cm (14 in.), respectively. The corresponding composite action was estimated to be about 65 % of the yield strength of steel shapes at ambient temperature. Photographs of the floor specimen soffit, beam framing, and connections are shown in Fig. 8.

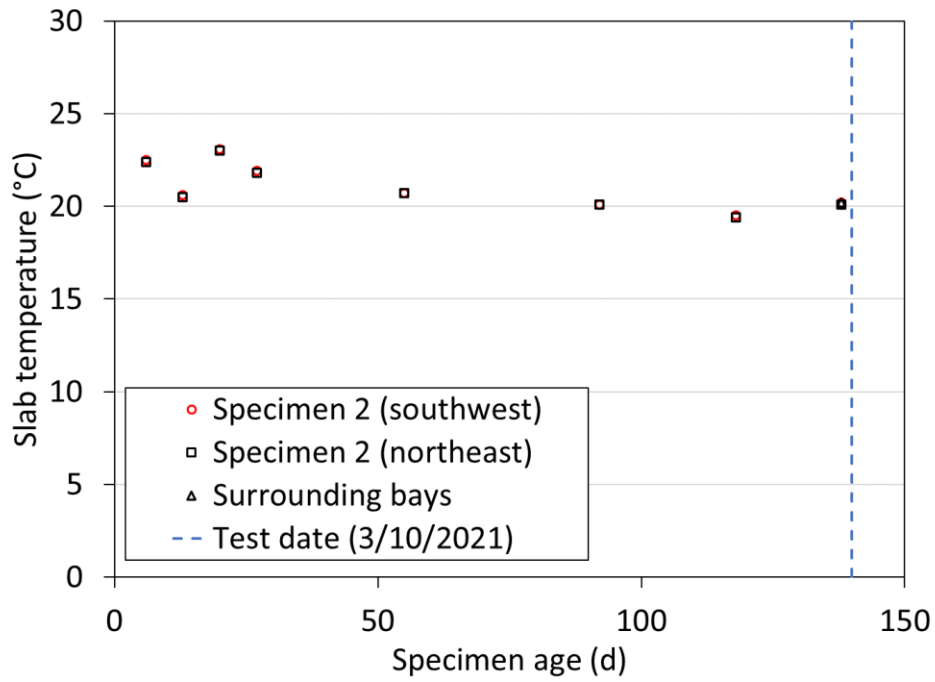
Fig. 12. Temperature in the test specimen and surrounding bays.

The relative humidity and temperature in the concrete during curing were measured using probes placed into perforated sleeves embedded in the concrete during casting. The manufacturer specified accuracy of the temperature and relative humidity in the applied temperature range are  $\pm 0.2$  °C and less than  $\pm 2.5$  %, respectively. The temperatures measured in the concrete are shown in Fig. 12 and the relative humidity measurements in Fig. 13. Measurement locations in the test specimen were in the southwest and northeast quadrants of the specimen to provide an indication of variation across the specimen. The measurement location for the surrounding bays was in the middle of the center north bay. No measurements were made in the surrounding bays until the time of testing. Therefore, the relative humidity in the concrete in the surrounding bays is significantly lower than in the test specimen. The moisture content of the specimens, which is related to the relative humidity, was measured separately on concrete cylinders cured under the same conditions as the slabs.

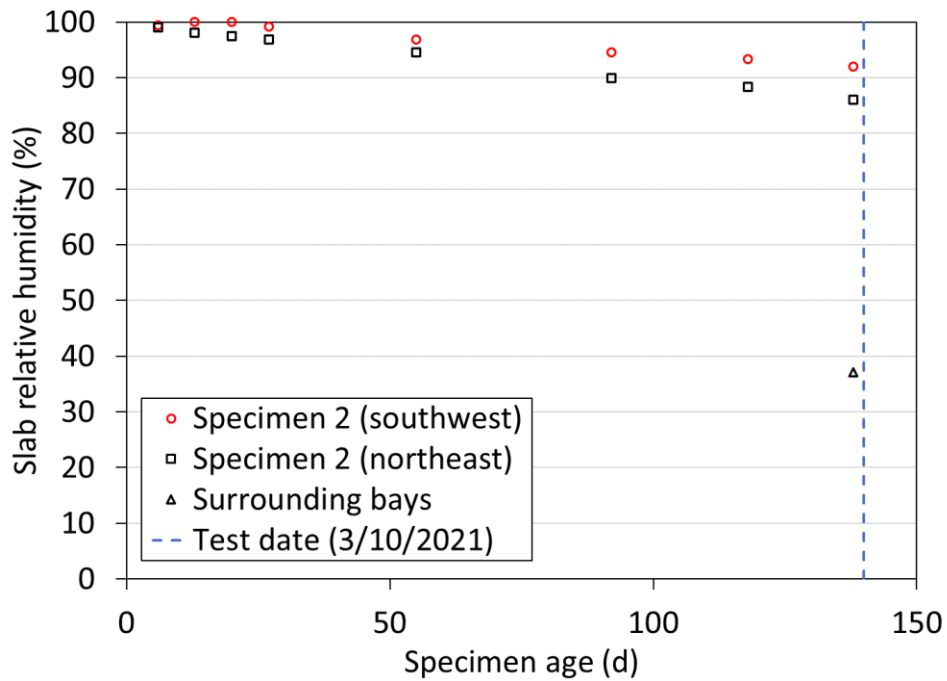
Fig. 13. Relative humidity in the test specimen and surrounding bays.

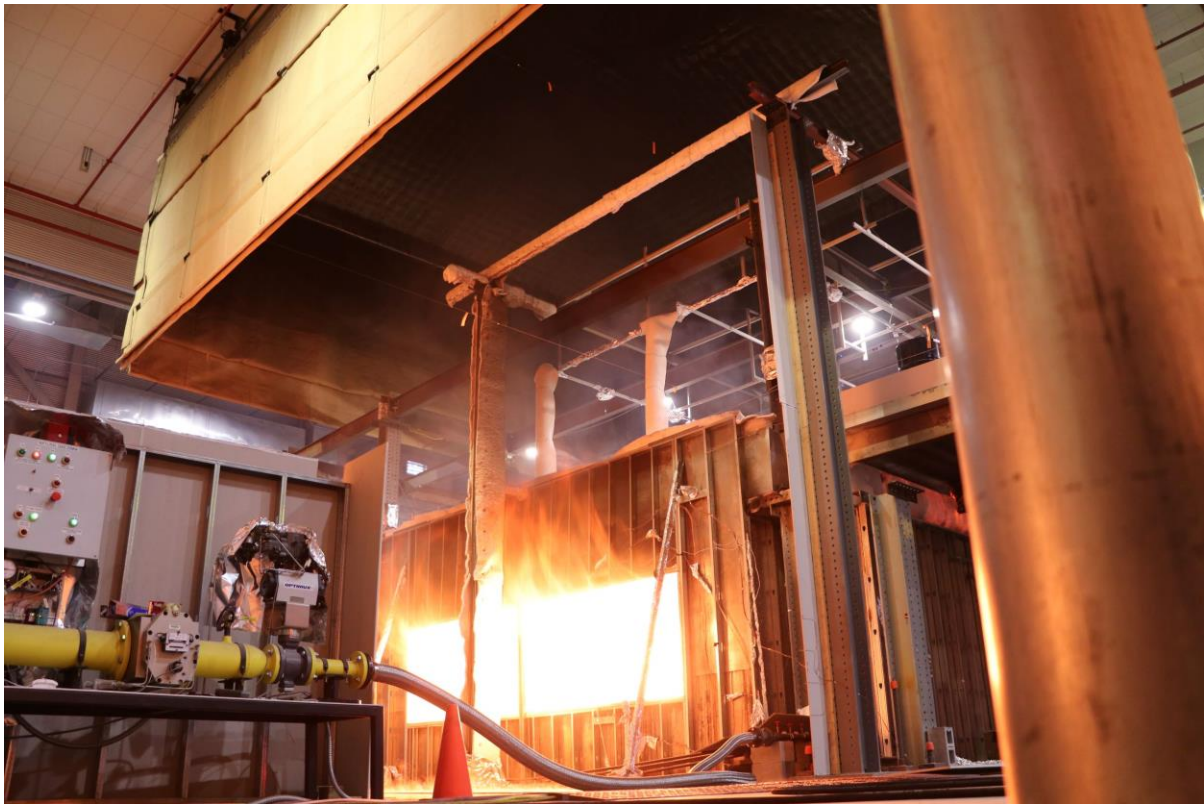
**Fig. 18. Front view of the main vent opening of the fire test compartment during Test #2.**

Some images showing inside the test compartment and the test building captured during fire loading are shown in Fig. 17 and Fig. 18.

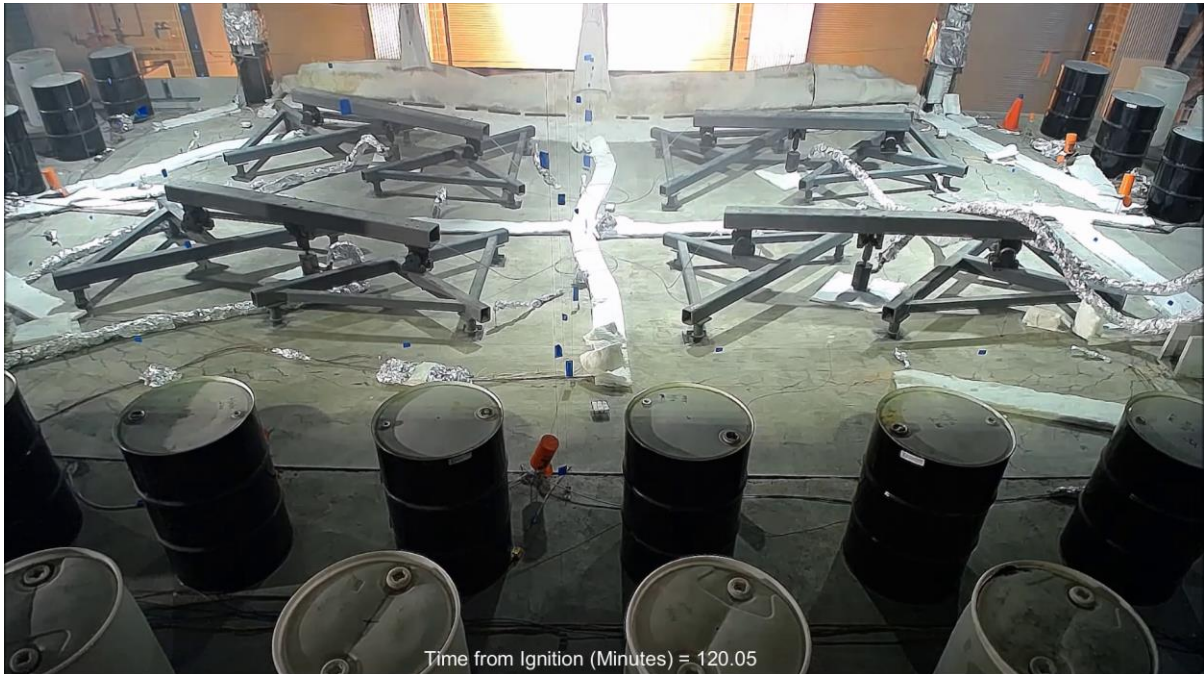
Fig. 29. Video image showing top of the test floor at 120 min after fire ignition.

VD7 and VD11) because of their connectivity to the surrounding bays. A snapshot of the test video recording top of the test floor is shown in Fig. 29

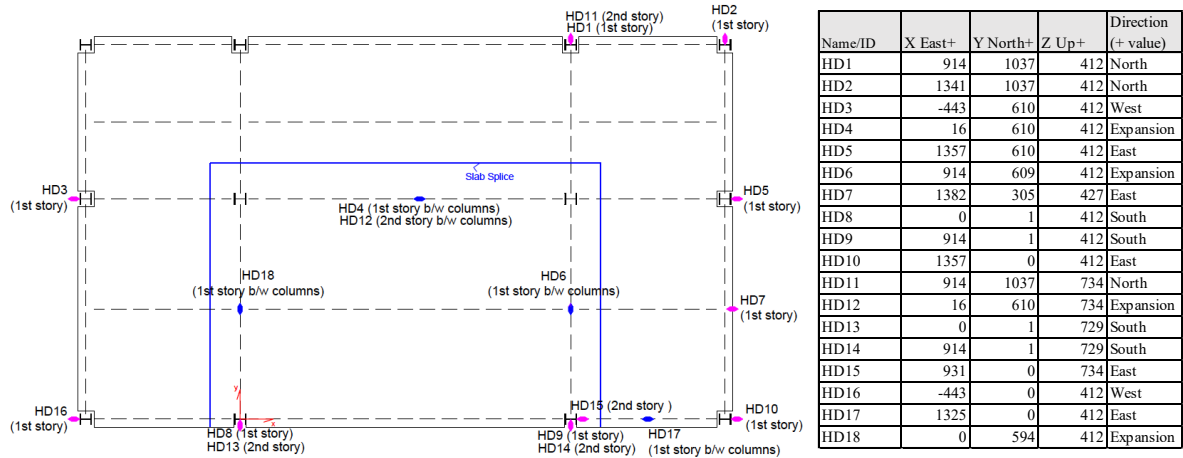
Fig. 31. Location of horizontal displacement (HD) measurements. The Z datum is defined at the laboratory strong floor. Coordinates are in cm.

A total of eighteen string potentiometers (HD1 through HD18) were deployed to measure the horizontal displacement of the test floor assembly and at the perimeter of the two-story prototype building; See Fig. 31. The HD4, HD6, HD18 sensors were used to measure thermal expansion of the north, east, and west edges of the fire test bay, respectively. The lateral displacements of the first-story columns (HD1 through HD3, HD5, HD8 through HD10, and HD16) as well as HD4 and HD6 were measured at 15 cm above the top surface of the test floor slab.

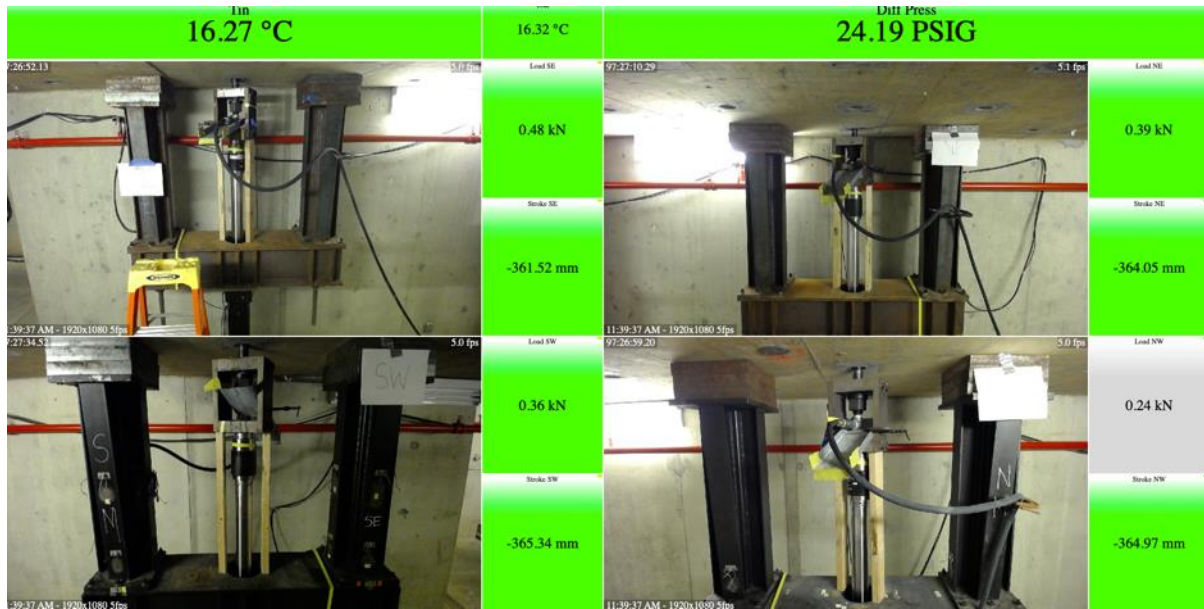
Fig. 39. Screenshot of the test video to monitor hydraulic actuators at the basement of the NFRL strong floor (prior to fire testing).

Four servo-hydraulic actuators (each named as NW, NE, SW, and SE) were used to apply mechanical loads that were uniformly distributed at twenty-four points across the test floor slab. Those actuators were mounted at the NFRL basement below the fire test bay (Fig. 39). Each actuator provided mechanical loading on the test floor at six points spaced 152 cm apart (Fig. 40a). The beam strains were measured using strain gauges during mechanical loading at ambient temperatures only (Fig. 40b). Measured actuator loads, actuator displacements, and the beam strain values are provided in Fig. 41 and Fig. 42.

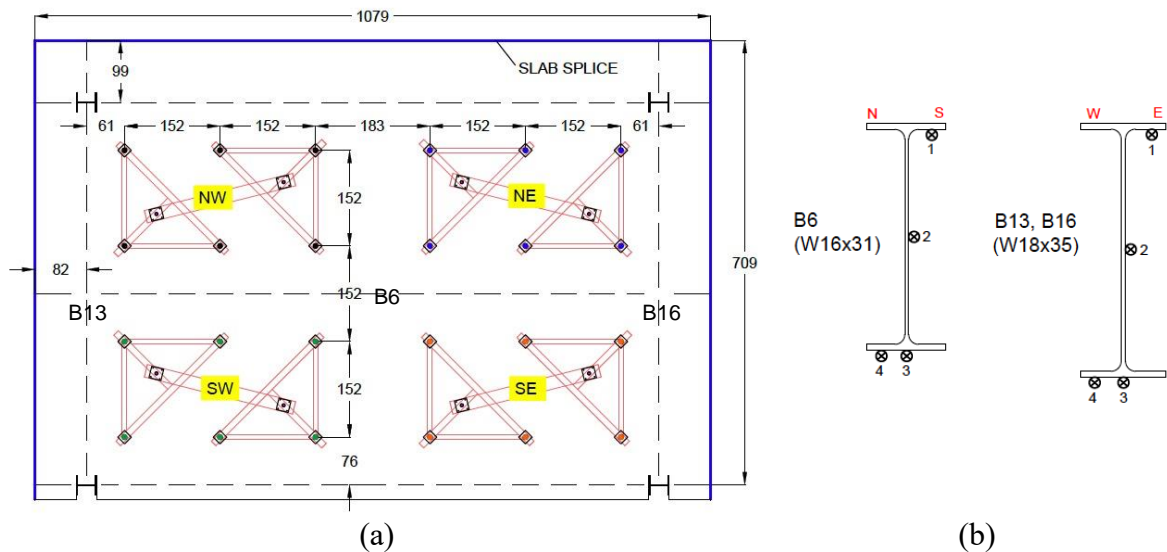
Fig. 40. Locations of (a) loading points tied to four hydraulic actuators (NE, NW, SE, SW) and (b) strain gauges installed at midspan of the test bay floor beams. Dimensions are in cm.

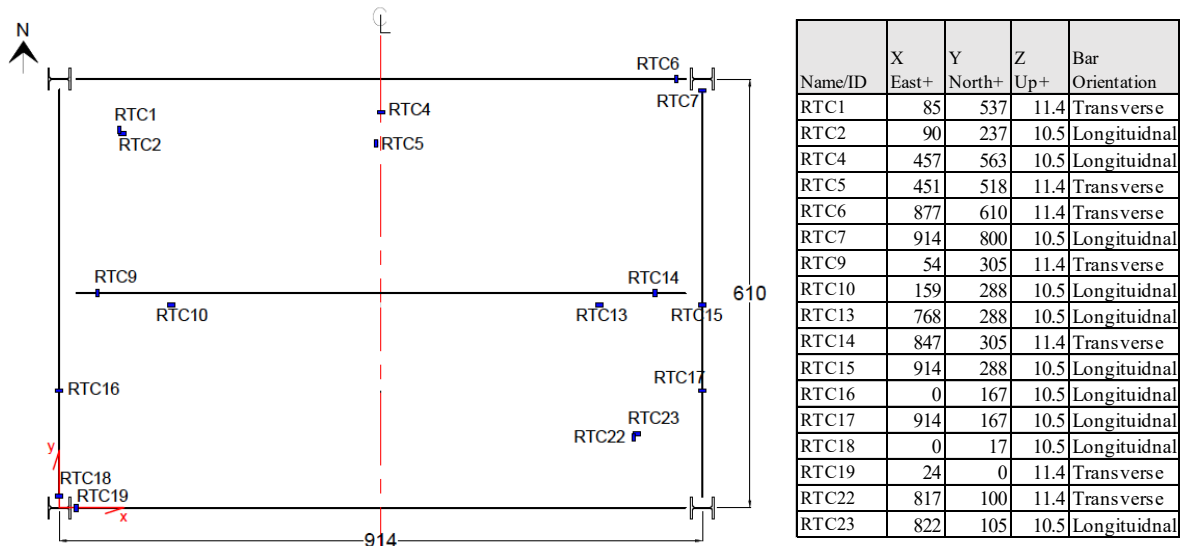
Fig. 51. Distribution of thermocouple probes mounted on No.3 deformed bars. Dimensions and coordinates are in cm.

Glass sheathed thermocouples (model: GG-K-24) [32] were used to measure temperatures of embedded No. 3 bars in the test-bay floor slab. Locations of thermocouples and raw data are presented in Fig. 51 and Fig. 52, respectively. Temperatures of the No.3 bars above the steel beams and girders at midspan are measured using the S group thermocouples as described in Sect. A.5.

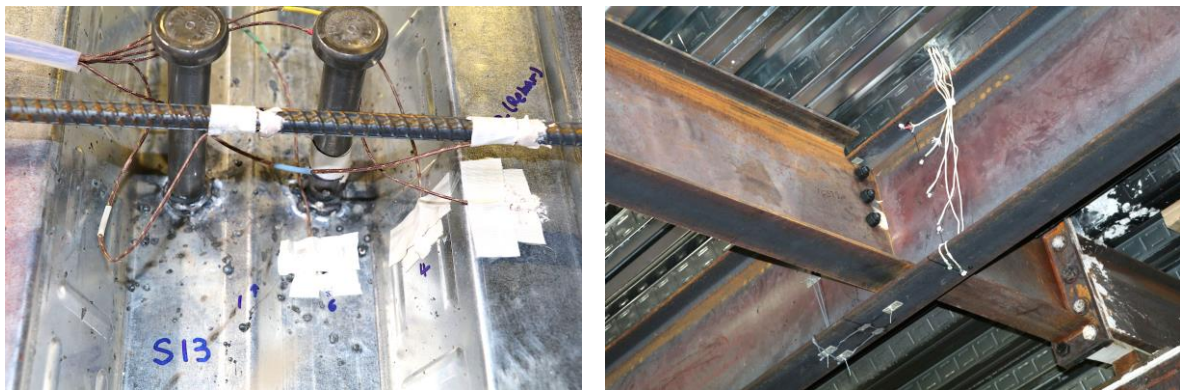
Fig. 53. Photographs of typical thermocouples installed in the composite girder near its midspan.

For the composite beam sections, temperature measurements were performed using K-type thermocouples with two different wire insulation techniques: glass sheathed thermocouples (model: GG-K-24) mounted within the concrete slab and the ceramic sheathed thermocouples (model: XT-K-20-SLE) [33] directly peened on the surface of the steel beam shapes. An example of thermocouples installed prior to the slab cast and fireproofing spray is shown in Fig. 53. Locations of thermocouples and raw data are provided in Fig. 54 through Fig. 56. As shown, some temperature readings acquired at section 6 (TB6 and S6 groups) appeared to be significantly influenced by concrete cracks or failure in thermocouple probes particularly after 60 min into heating due to deformations in the test floor. Table 15 shows the list of thermocouple probes used to estimate the average temperatures at specific depths across the composite beam section, which are plotted in Fig. 23.

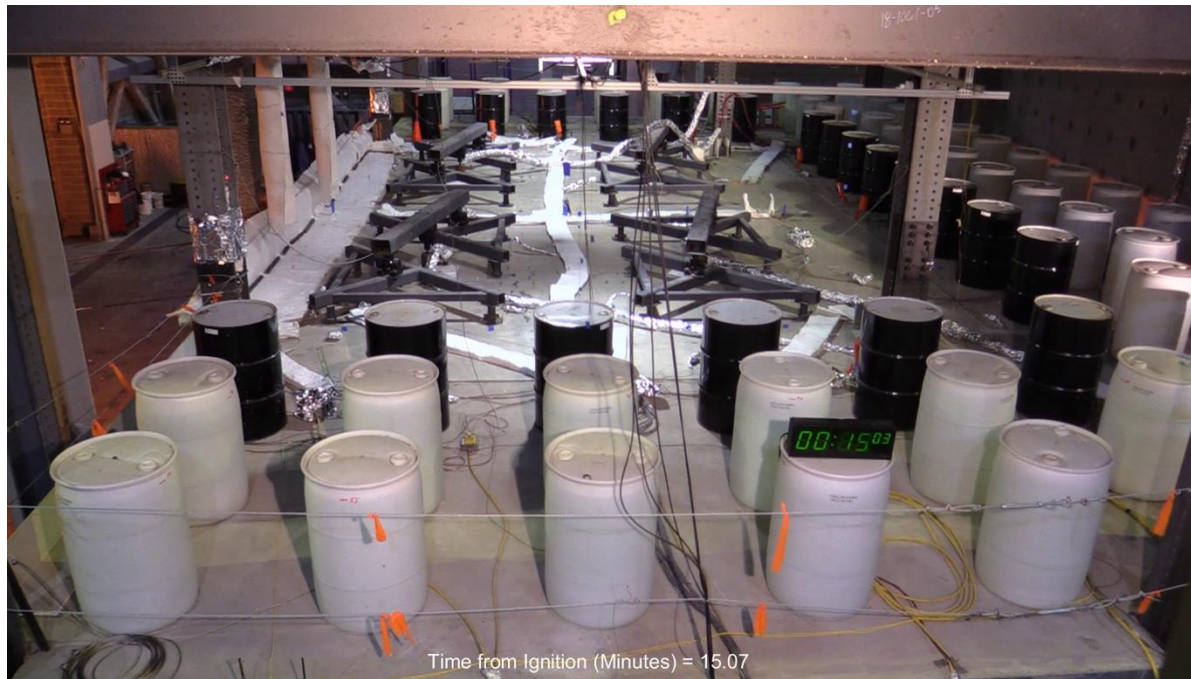
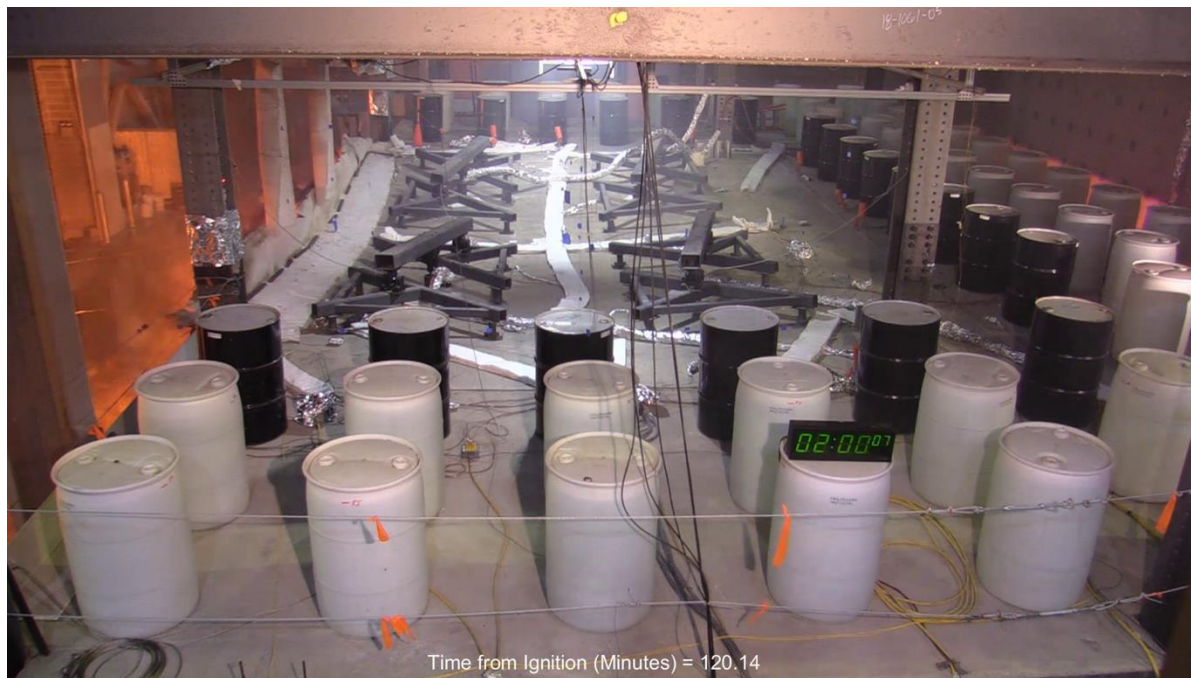
Fig. 63. Video snapshots showing the test floor at 15 min and 120 min after fire ignition.

Displacement measurements were performed using string potentiometers (model: PA series manufactured by UniMeasure [34]) All sensors were installed using mounting frames isolated from the test structure, except for VD11 which was used to measure the relative vertical displacement between the first and second story girders at midspan. Refer to Sect. 3.4 for locations of installed sensors. Fig. 62 shows the displacement data not presented in Sect. 3.4. The positive values on the y axes of the graph charts below indicate either the vertical displacement (VD) toward the strong (ground) floor or the horizontal displacement (HD) at various locations of the test building in response to thermal expansion of the test floor during fire. Some video snapshots showing the top of the test floor during fire loading are provided in Fig. 63.

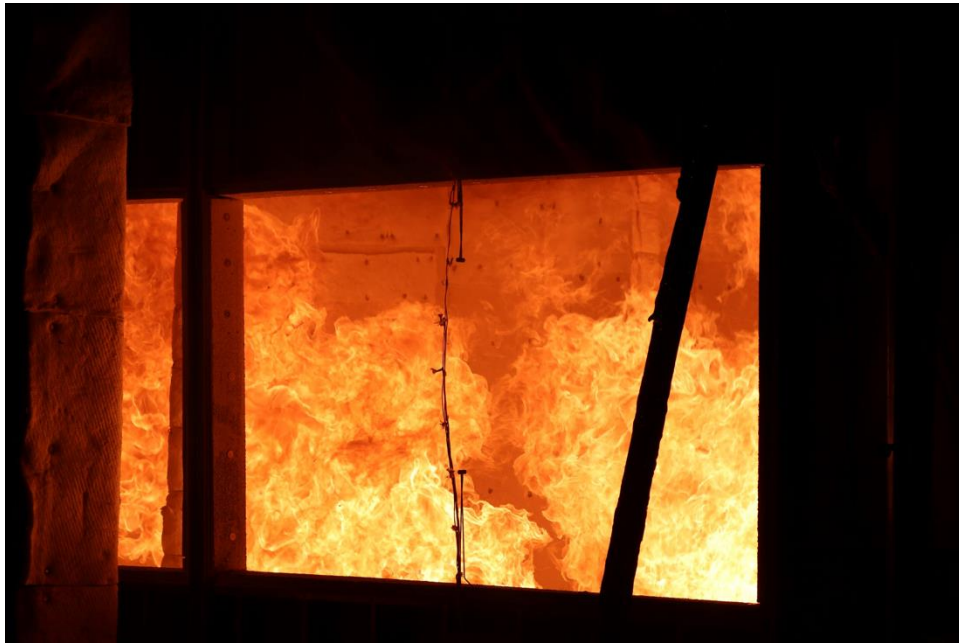
**Fig. 68. Installed bi-directional probes and thermocouples on south and north vent openings of the test compartment during fire loading.**

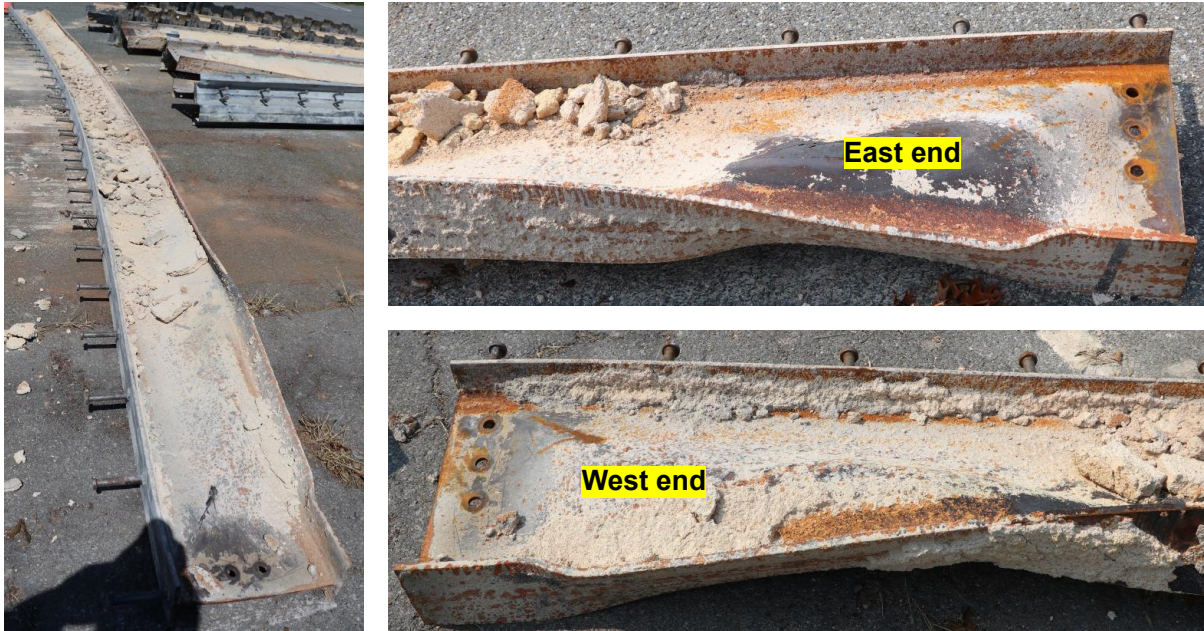
Fig. 73. Post-test photographs: South edge beam.

Post-test photographs of the support beams and girders are shown in Fig. 72 through Fig. 75. It is noteworthy that the west girder exhibited a local rupture of the bottom web toe at the north end because of web local buckling (Fig. 76).
